D2-117017-3 REV. C

OFFICE OF MANNED
SPACE FLIGHT

APOLLO PROGRAM

FINAL FLIGHT EVALUATION REPORT APOLLO 6 MISSION

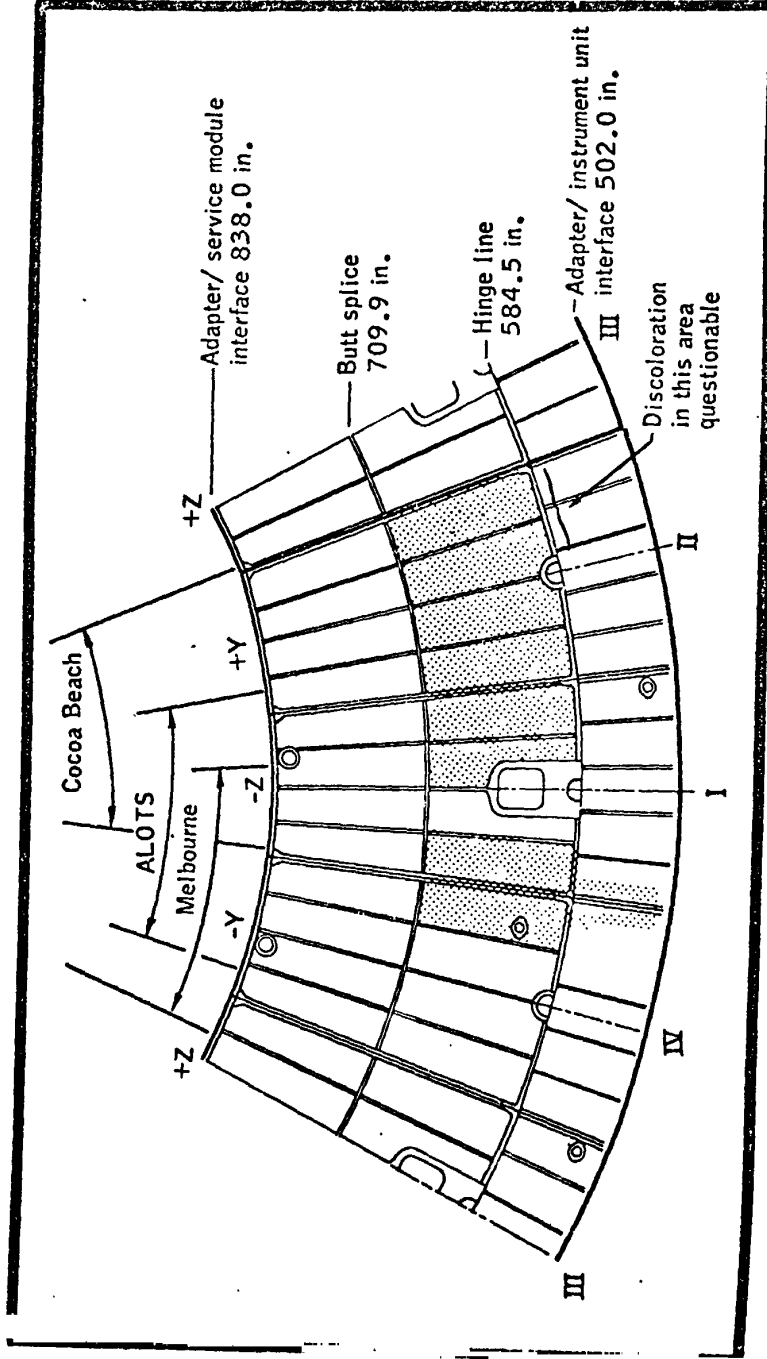
- C. PHOTOGRAPHIC EVIDENCE OF ANOMALOUS EVENTS
A FRAME-BY-FRAME REVIEW OF THE APOLLO 6 FLIGHT FILMS SHOWS THE FOLLOWING:
SEVERE OSCILLATIONS OF THE LAUNCH ESCAPE TOWER WERE OBSERVED AT 01:28, 01:44, 01:47, AND 01:48. THE MOST SEVERE OSCILLATIONS OCCURRED AT 01:28.
BULGING ON THE PLUS Z AXIS AND INDENTATIONS ON THE MINUS Z AXIS OF THE ADAPTER SURFACE WERE FIRST OBSERVED AT 02:13:15, AND INTERMITTENTLY FOR ABOUT ONE SECOND. LATERAL DEFLECTIONS ALONG THE VEHICLE WERE OBSERVED TO ACCOMPANY THE BULGING AND BUCKLING.
A DARK AREA WHICH APPEARS ON THE SLA AT 00:02:13 IS SHOWN SCHEMATICALLY IN FIGURE 2.1.1-1. THE DARK AREA IS MORE THAN TWICE THE AREA OF THE PIECES SEEN FALLING FROM THE SLA; CONSEQUENTLY, THE REMAINDER OF THE DARK AREA MUST HAVE BEEN LACK OF REFLECTION FROM A PERMANENT DEFORMATION OF THE SLA SURFACE. DENSITOMETER CONTOURS OF FAILED AREA WERE STUDIED. BECAUSE OF THE SHAPE OF THE TERMINATORS IT MAY BE PRESUMED THAT CONTOURS REPRESENT INWARD BUCKLING.

Figure 2.1.1-1. Photographic Coverage of SLA Showing Approximate Area of Color Change

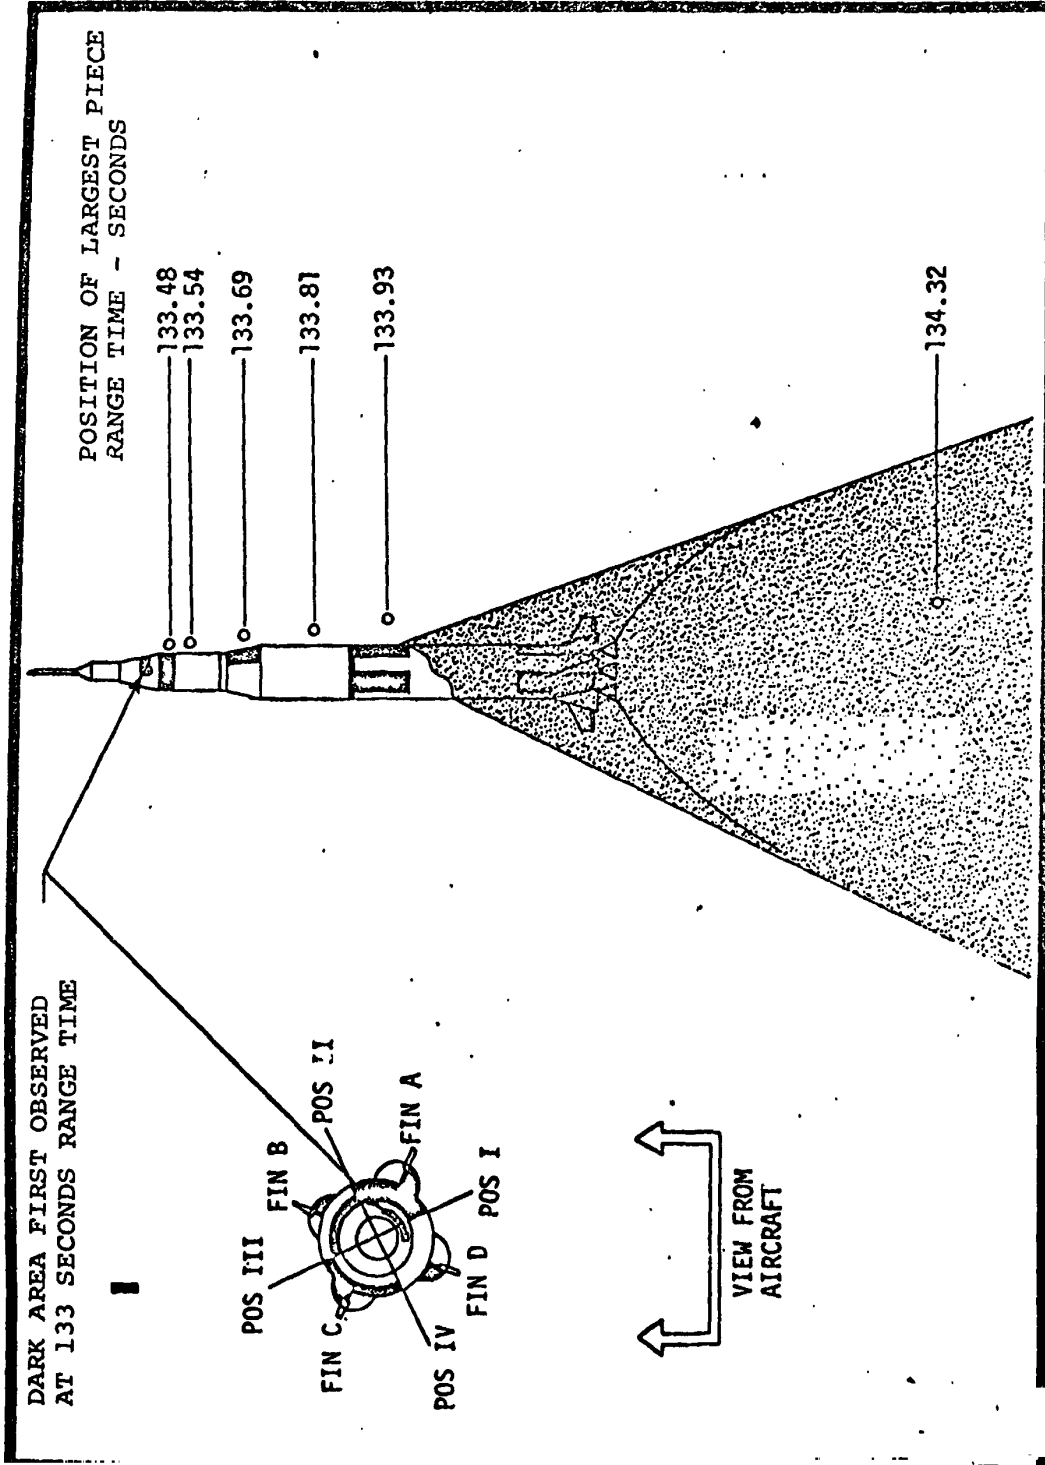
SEPARATION OF THREE SMALL AND FIVE OR SIX LARGE PIECES OF SHEET MATERIAL FROM THE SURFACE OF THE ADAPTER WAS OBSERVED FROM 02:13.31 TO 02:13.68. THE APPROXIMATE POSITIONS OF THE LARGEST OF THESE PIECES ARE SHOWN IN FIGURE 2.1.1-2, ALONG WITH THE CORRESPONDING RANGE TIME FOR EACH POSITION. SOME PIECES BROKE UP INTO SMALLER PIECES WHEN PASSING THROUGH THE MORE TURBULENT AREAS. AT LEAST ONE SURFACE OF EACH PIECE WAS HIGHLY LIGHT-REFLECTIVE.
TRAJECTORY ANALYSIS WAS USED TO ESTIMATE THE MATERIAL PROPERTIES OF TWO OF THE PIECES OBSERVED FALLING FROM THE SLA. IT HAS BEEN CONCLUDED THAT THEY WERE PIECES OF ALUMINUM STRUCTURE.

FIGURE 2.1.1-2 PLOT OF LARGEST PIECE - ALOTS 70 MM FILM - 133 TO 135 SECONDS RANGE TIME

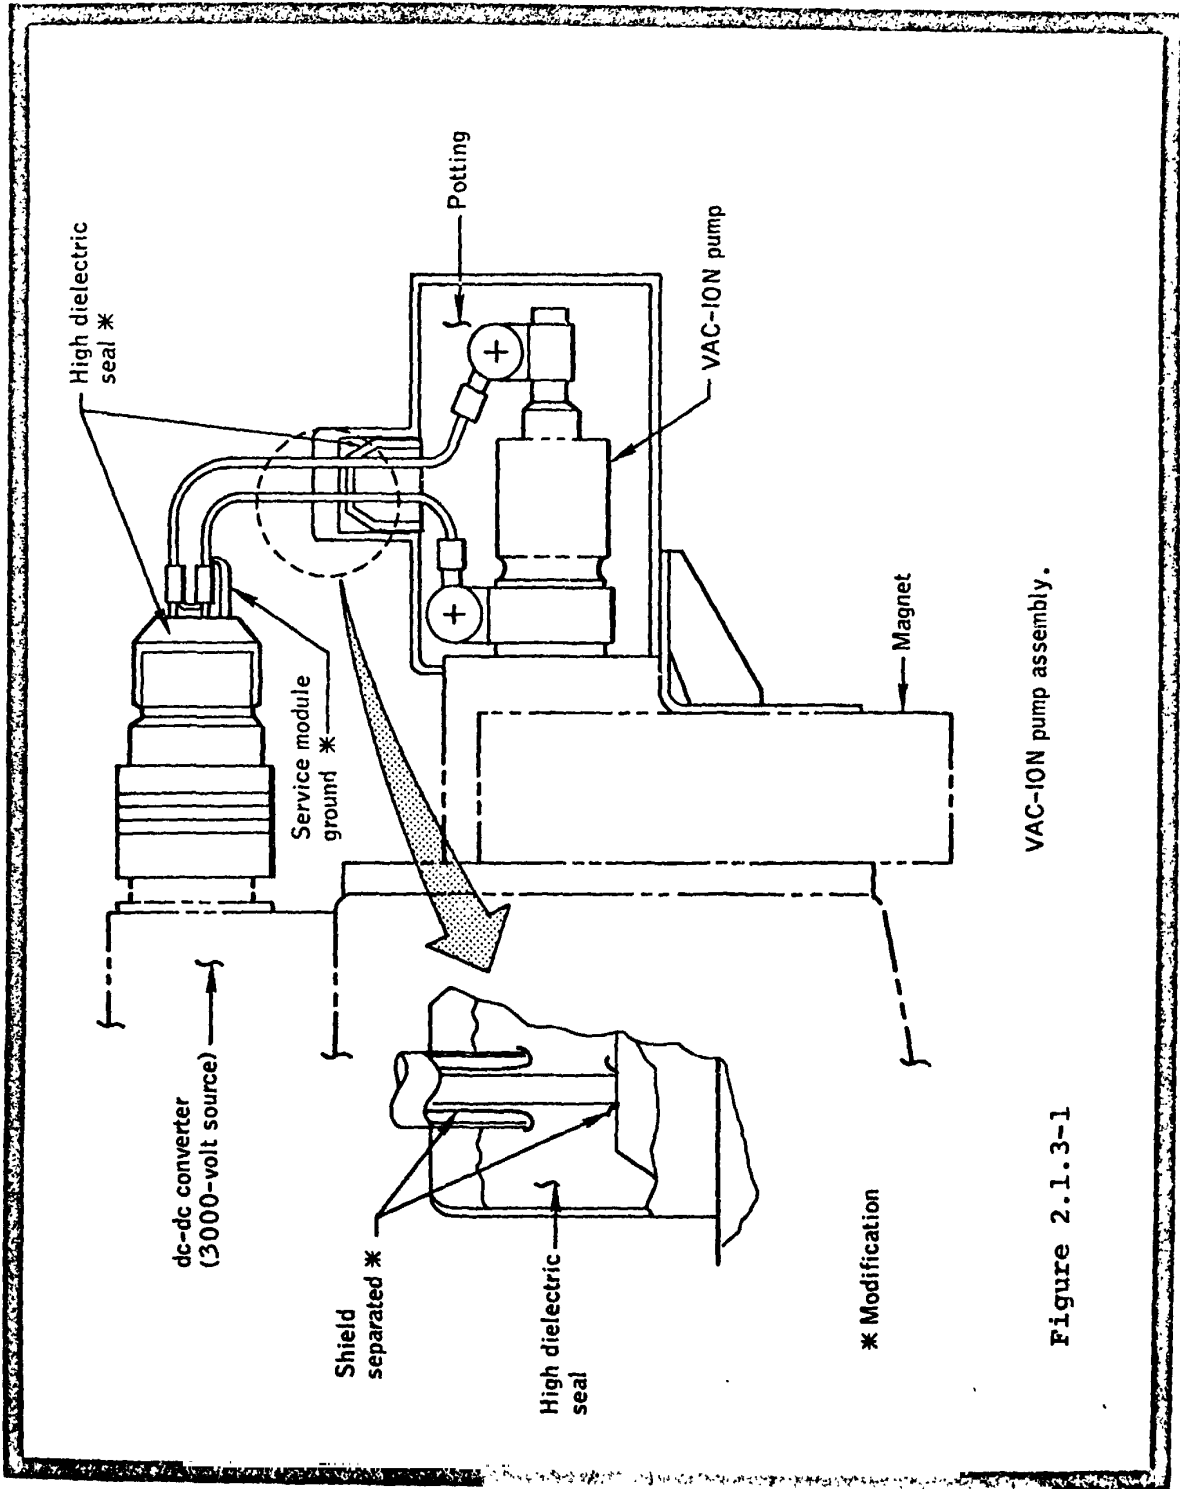
Figure 2.1.3-1

VAC-ION pump assembly.

DURING CHAMBER TESTS OF SPACECRAFT 101, ELECTROMAGNETIC INTERFERENCE WAS GENERATED BY INADVERTENT DISCHARGE OF THE 3000-VOLT SUPPLY OF THE VAC-ION PUMPS IN THE SERVICE MODULE CRYOGENIC TANKS, AND DATA WERE ERRATIC IN THE SAME MANNER AS IN THE APOLLO 6 MISSION. THE RADIATION FROM SUCH A DISCHARGE PROBABLY CAUSED THE ERRATIC DATA, SINCE THE RESULTS WERE COMPARABLE TO THE SPACECRAFT 101 PROBLEM. SEVERAL PUMPS HAVE DEMONSTRATED A BREAKDOWN AND DISCHARGE OF THE 3000-VOLT POTENTIAL UNDER ALTITUDE CONDITIONS INVESTIGATED AFTER THE PROBLEM ON SPACECRAFT 101. FOR SPACECRAFT 101, 103, AND 104, THE PUMPS WILL NOT BE OPERATIVE. FOR SUBSEQUENT SPACECRAFT, THE PUMPS IN THE HYDROGEN TANKS WILL NOT BE OPERATIVE DURING THE MISSION, AND A CIRCUIT BREAKER IN THE CABIN WILL BE PROVIDED FOR THE PUMPS IN THE OXYGEN TANK. ALSO, POTTING AND SHIELDING OF THE PUMPS AND ASSOCIATED WIRING WILL BE IMPROVED.

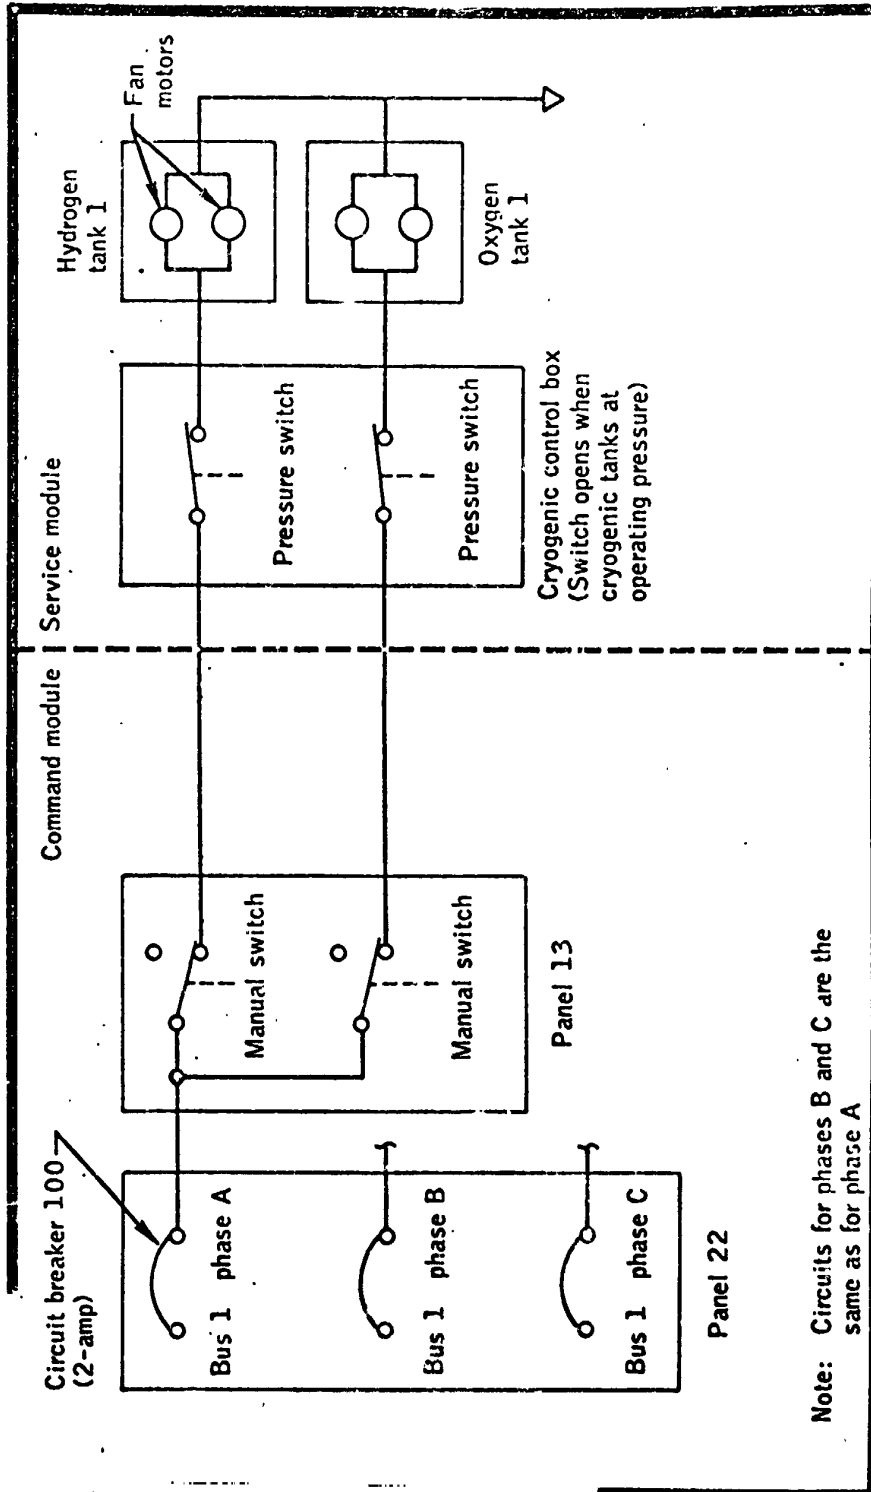
THE ESSENTIAL AC LOADS WERE TRANSFERRED FROM AC BUS 1 TO AC BUS 2 AS A RESULT OF A SHORT IN THE CRYOGENIC TANK NO. 1 CIRCUIT. THE MOST PROBABLE CAUSE WAS A FAULT TO GROUND IN PHASE A OF THE OXYGEN TANK NO. 1 FAN MOTOR CIRCUIT.

Figure 2.1.1.5-1. Fan motor circuit for hydrogen and oxygen tank 1.

NO CORRECTIVE ACTION IS REQUIRED. BLOCK I FAN MOTORS HAD SEVERAL FAILURES BECAUSE OF PHASE-TO-GROUND FAULTS. THE BLOCK II FANS WERE REDESIGNED TO PREVENT THIS OCCURRENCE BY CHANGING THE WIRE LENGTH AND ROUTING, IN ADDITION TO OTHER DESIGN CHANGES. ALL EIGHT FANS (TWO FANS PER TANK) IN CSM 103, 104, 106, AND SUBSEQUENT WILL BE PROTECTED BY INDIVIDUAL FUSES IN EACH PHASE OF THE MOTOR SO THAT A FAULT IN ONE MOTOR WILL NOT RESULT IN AN OPEN CIRCUIT BREAKER THAT WOULD CAUSE LOSS OF POWER TO FOUR FAN MOTORS.

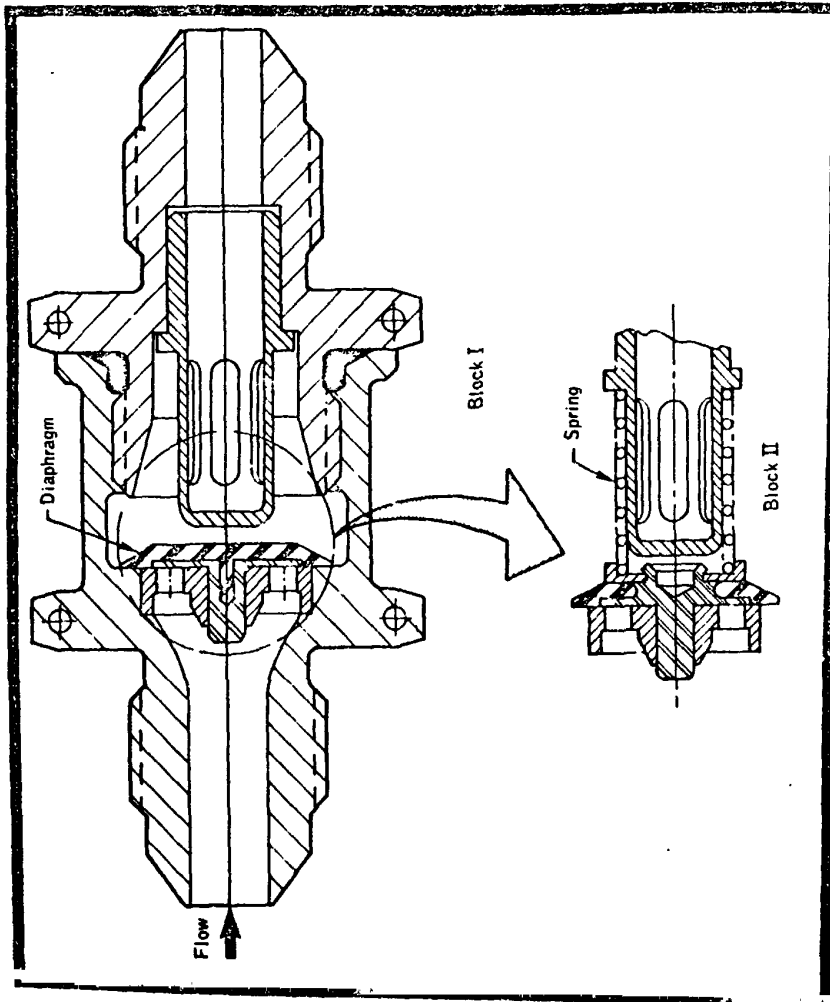
NO. 2.1.8	TITLE: OXYGEN CHECK VALVE FAILURE	MISSION: APOLLO 6
SYSTEM: CM		EVENT TIME: ORBIT
SUBSYSTEM: ENVIRONMENTAL CONTROL SYSTEM (ECS)		
DESCRIPTION:	THE PRESSURE IN THE ECS OXYGEN SURGE TANK WAS OBSERVED TO VARY IN PHASE WITH THE PRESSURE IN CRYOGENIC OXYGEN SUPPLY TANK 2. THIS INDICATES THAT ONE OR BOTH OF THE OXYGEN INLET RESTRICTOR ASSEMBLY CHECK VALVES FAILED TO SEAT WHEN THE CRYOGENIC TANK 2 PRESSURE DECREASED BELOW THE SURGE TANK PRESSURE. THE ECS PERFORMANCE WAS NOT ADVERSELY AFFECTED BECAUSE THERE WAS NO FAILURE IN ANY OTHER PORTION OF THE SYSTEM.	
STATUS:	DURING POST-FLIGHT BENCH TESTING, BOTH OF THE CHECK VALVES LEAKED IN THE REVERSE DIRECTION AT DIFFERENTIAL PRESSURES LESS THAN 25 PSI. THERE WAS NO EVIDENCE OF CORROSION OR CONTAMINATION. A HISTORY OF SIMILAR FAILURES ON BLOCK I CHECK VALVES HAS RESULTED IN A DESIGN CHANGE FOR BLOCK II CHECK VALVES. THE BLOCK I CHECK VALVE SEATING IS ACCOMPLISHED BY A DIAPHRAGM OPERATED BY DIFFERENTIAL PRESSURE; FOR BLOCK II VALVES, THE DIAPHRAGM SEATING HAS BEEN AUGMENTED BY THE ADDITION OF A SPRING TO ASSURE SEATING UNDER LOW DIFFERENTIAL PRESSURE (SEE FIGURE 2.1.8-1). THIS ANOMALY HAS BEEN CLOSED BY MSC.

Figure 2.1.1.8-1. OXYGEN CHECK VALVE

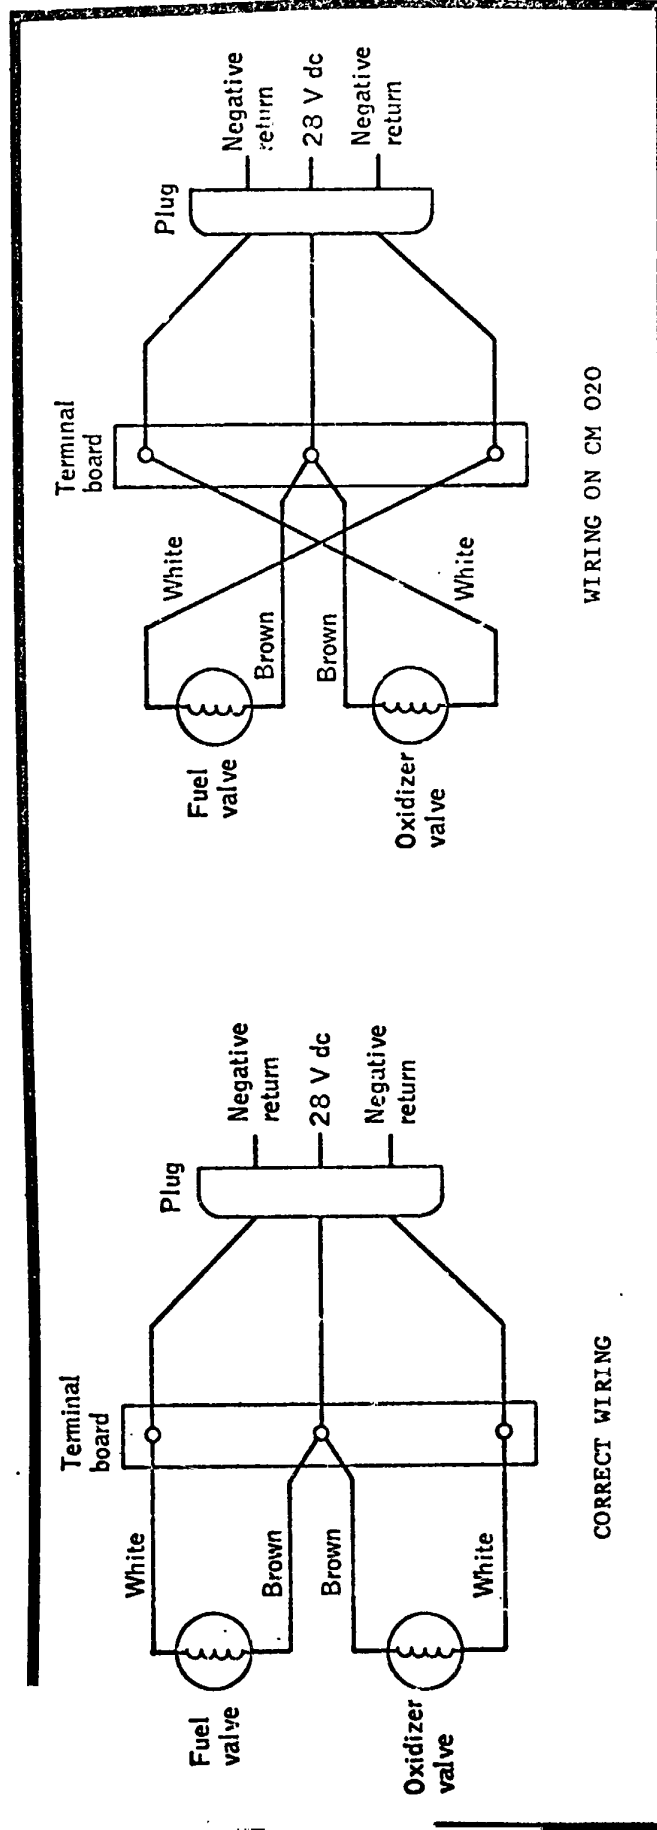
NO. 2.1.12	TITLE: CROSSWIRING OF CM RCS VALVES	MISSION: APOLLO 6 POST-FLIGHT TESTING
SYSTEM: CM		EVENT TIME:
SUBSYSTEM:		
DESCRIPTION:	DURING THE DE-ACTIVATION OF THE CM REACTION CONTROL SYSTEM, THE CONNECTOR FROM THE REACTION CONTROL SYSTEM CONTROL BOX TO THE ENGINE VALVES WAS REMOVED AND RECONNECTED TO GROUND SUPPORT EQUIPMENT FOR VALVE ACTUATION. WHEN THE MINUS YAW AND THE PLUS YAW FUEL VALVES WERE OPENED, BROWNISH-RED VAPOR CLOUDS AND LIQUID DROPLETS INDICATIVE OF OXIDIZER WERE OBSERVED. FUEL WAS NOTED WHEN THE MINUS YAW AND THE PLUS YAW OXIDIZER VALVES WERE ACTIVATED. A PRE-FLIGHT GAS FLOW CHECK NORMALLY DEMONSTRATES ENGINE OPERATION, BUT THE VALVES ARE NOT CHECKED INDIVIDUALLY.	
STATUS:	A POST-FLIGHT TEST HAS SHOWN THAT THE ELECTRICAL WIRES TO THE FUEL AND OXIDIZER VALVES WERE CROSSED ON ALL FOUR YAW ENGINES AS SHOWN IN FIGURE 2.1.12-1. THE WIRES TO THE VALVES WERE THE SAME COLOR, CAME FROM THE SAME AREA, AND WERE NOT SEPARATELY IDENTIFIED. THE CROSSED WIRES WERE BETWEEN THE TWO VALVES ON EACH ENGINE, NOT BETWEEN VALVES ON DIFFERENT ENGINES. VALVE WIRING WAS NOT INDEPENDENTLY VERIFIED AFTER INSTALLATION. THE RCS OPERATED SATISFACTORILY IN FLIGHT BECAUSE THE OXIDIZER AND FUEL VALVES ARE WIRED IN PARALLEL AND RECEIVE A COMMON COMMAND SIGNAL. ON THIS MISSION, THE PROPELLANTS WERE DUMPED BEFORE LANDING AND ONLY VAPOR REMAINED IN THE TANKS AT DE-ACTIVATION. ON APOLLO 7, AND POSSIBLY OTHER MISSIONS, THE PROPELLANTS WILL NOT BE DUMPED BEFORE LANDING AND MIXING OF PROPELLANTS IN THE COLLECTION TANKS COULD OCCUR. A SPECIAL FUNCTIONAL TEST OF INDIVIDUAL VALVE ACTUATION WILL BE PERFORMED ON ALL BLOCK II SPACECRAFT. PROPER WIRING HAS BEEN VERIFIED ON CM 101 (APOLLO 7), 103 AND 104. IN ADDITION, ON CM 102, 106 AND SUBS., THIS WIRING WILL HAVE IDENTIFICATION SLEEVING. THIS ANOMALY HAS BEEN CLOSED BY MSC.

Figure 2.1.12-1. YAW ENGINE WIRING

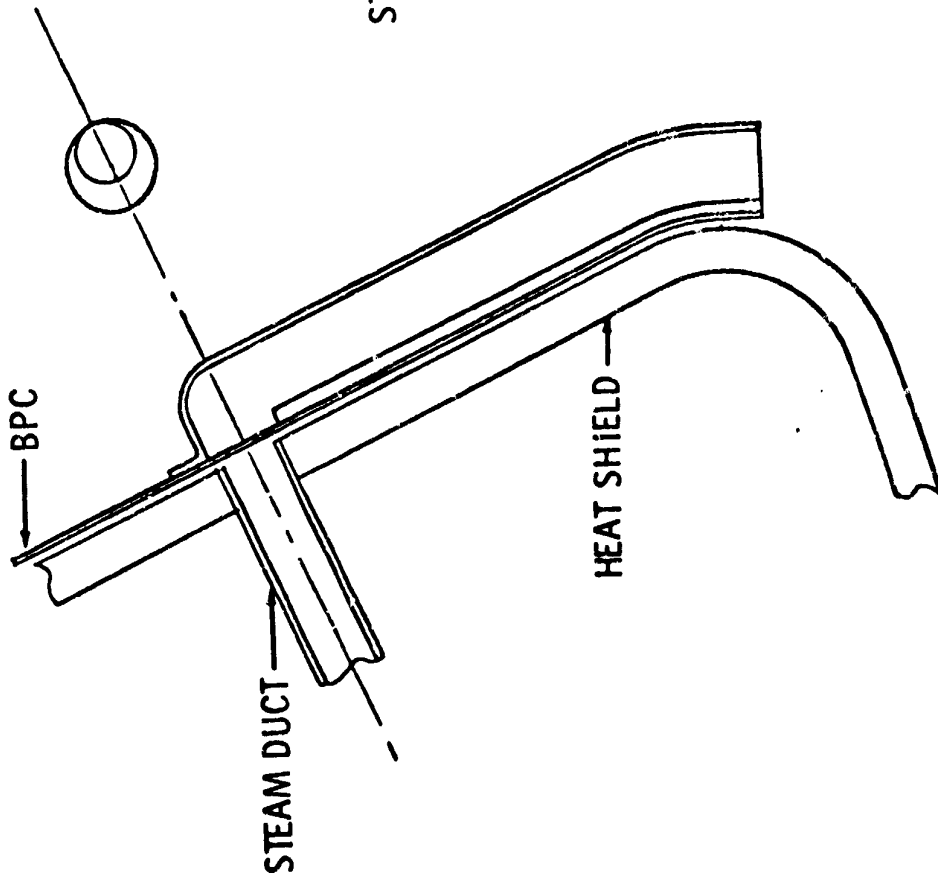
TESTS CONDUCTED BY NR INDICATE THAT THERE MAY HAVE BEEN NO HOLE IN THE BOOST PROTECTIVE COVER, THEREBY RESTRICTING FLOW THROUGH THE STEAM DUCT. A BOOST PROTECTIVE COVER WAS FOUND WHICH HAD NO HOLE TO VENT STEAM DUCT FLOW, THOUGH ALL DOCUMENTATION INDICATED THAT THE HOLE SHOULD BE PRESENT. TESTS SIMULATING THE EFFECT OF THIS CONDITION MATCHED THE FLIGHT DATA FROM APOLLO 6 (SEE FIGURE 2.1.13-2).

Figure 2.1.13-1
STEAM DUCT VENT THROUGH BPC

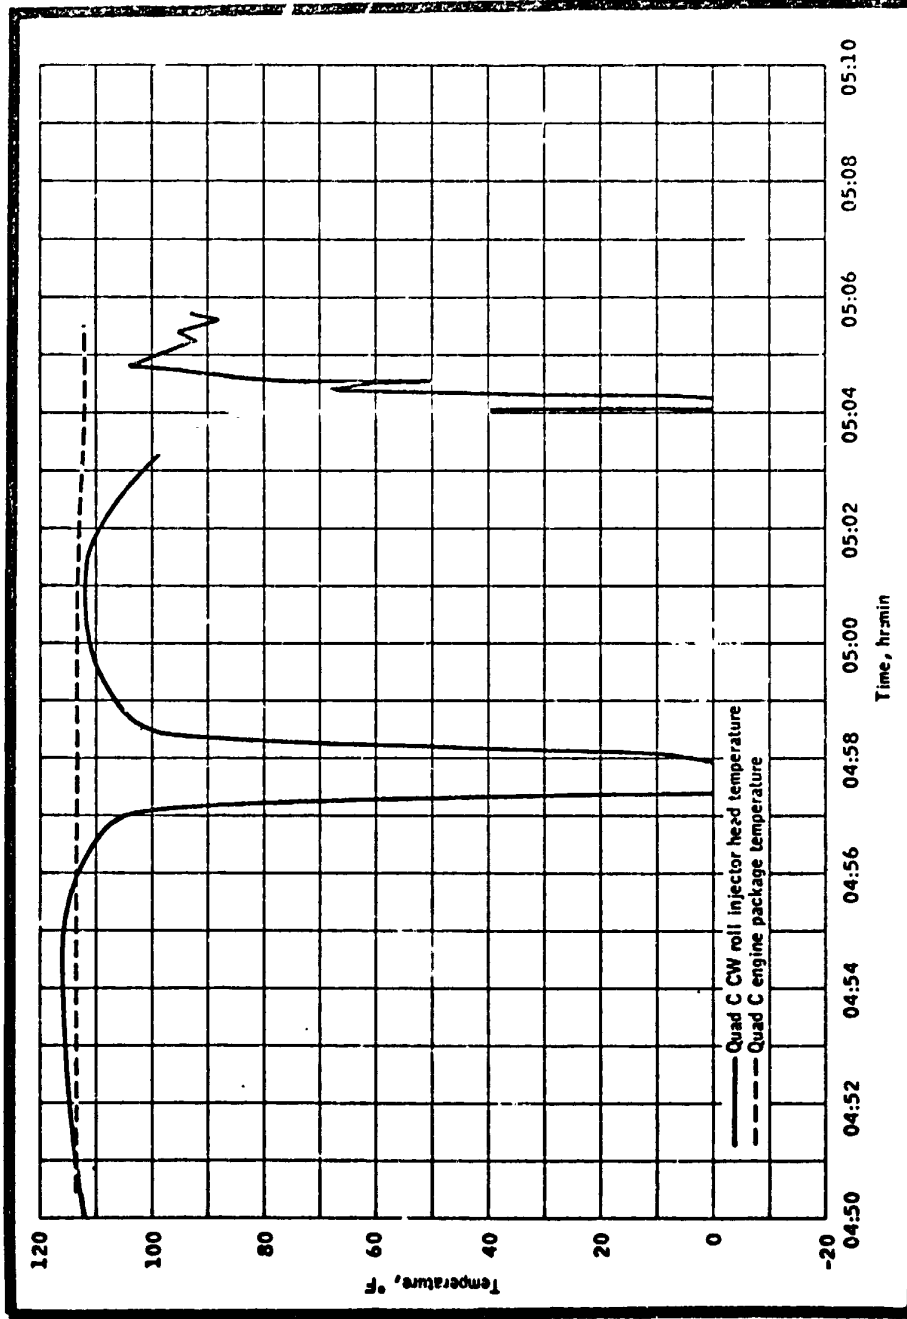
THE QUAD C HEATERS WERE ACTUATED "ON" AT APPROXIMATELY 03:50:00 AT A MOUNTING STRUCTURE TEMPERATURE OF 114°F AND REMAINED ON THROUGHOUT THE ENTIRE COLD-SOAK PERIOD. THE MOUNTING STRUCTURE TEMPERATURE QUICKLY INCREASED TO 122.5°F THEN UNDERWENT A GRADUAL DECLINE, REACHING 86°F AT THE TERMINATION OF THE COLD-SOAK PERIOD. IN GENERAL, THE INJECTOR TEMPERATURE REMAINED 4° TO 6°F ABOVE THE MOUNTING STRUCTURE TEMPERATURE. DURING FOUR PERIODS BETWEEN 03:45:00 AND 05:32:00, HOWEVER, THE INDICATED TEMPERATURE OF THE CLOCKWISE ROLL ENGINE INJECTOR (THE ONLY ONE INSTRUMENTED IN THE QUAD) DECREASED SHARPLY (SEVERAL TIMES GOING BELOW 0°F), AND THEN RECOVERED TO ITS ORIGINAL TEMPERATURE AT ESSENTIALLY THE SAME RATE. AN EXAMPLE OF THIS BEHAVIOR BETWEEN 04:55:00 AND 05:05:00 IS SHOWN IN FIGURE 2.1.17-1.

Figure 2.1.17-1. Typical Quad C Temperature Excursions

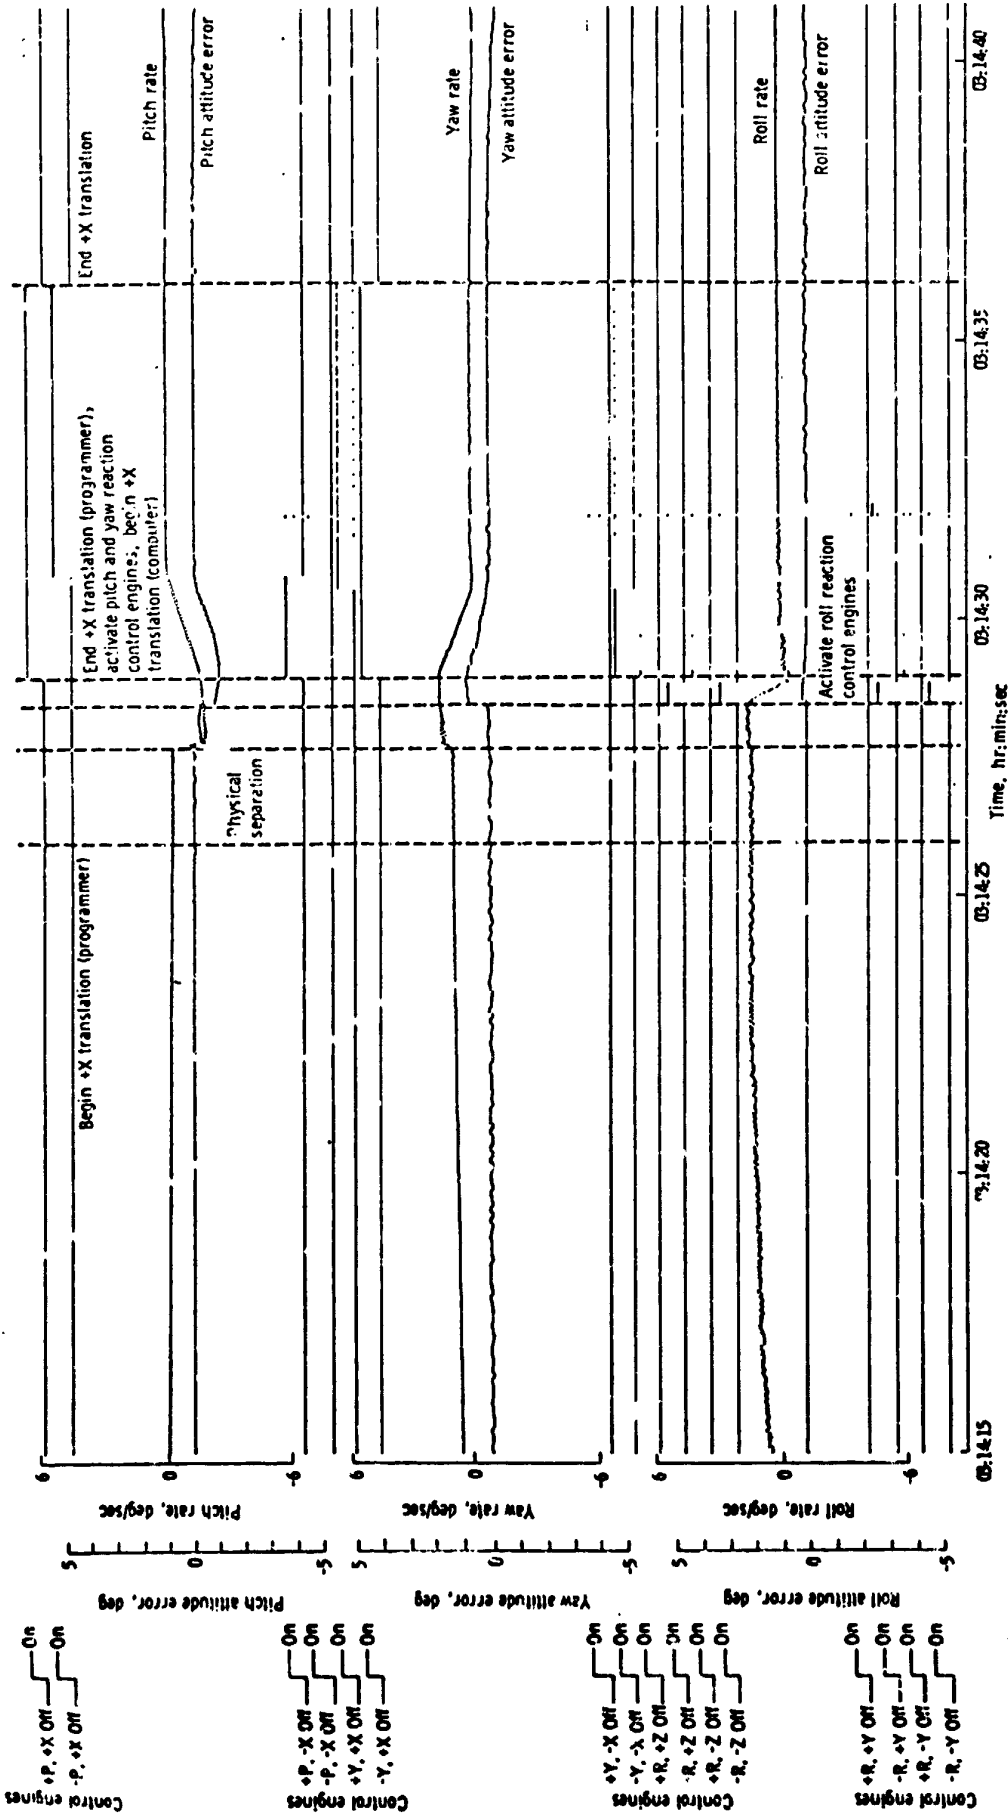
Figure 2.1.18-1. Dynamics During CSM/S-IVB Separation

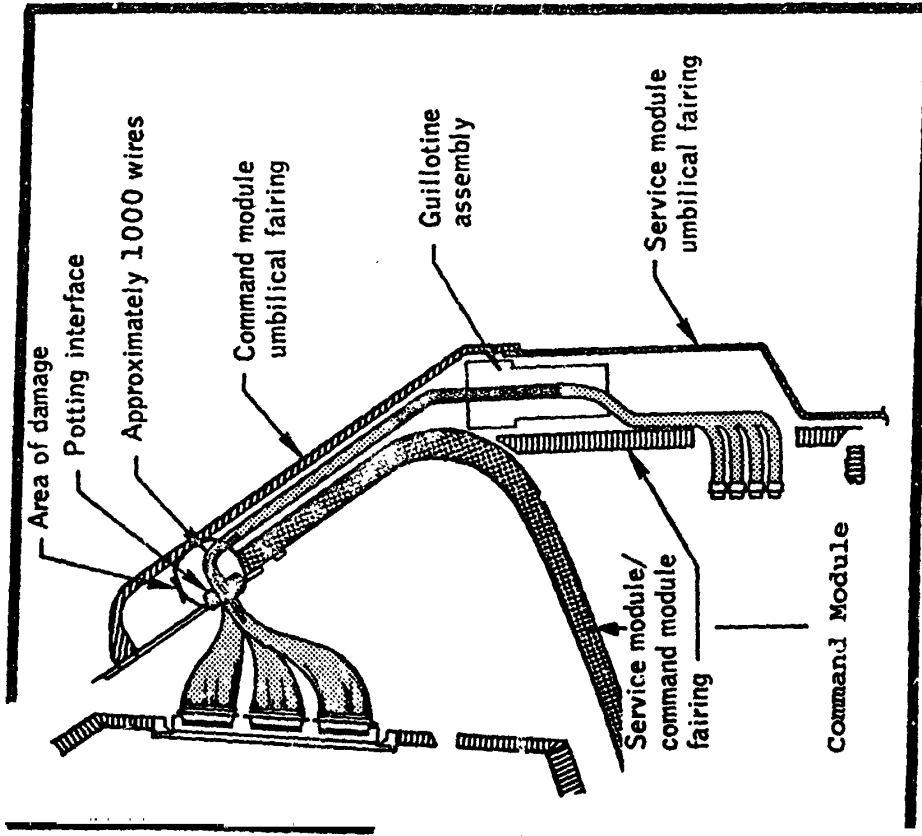
Figure 2.1.20-1. CM/SM Umbilical

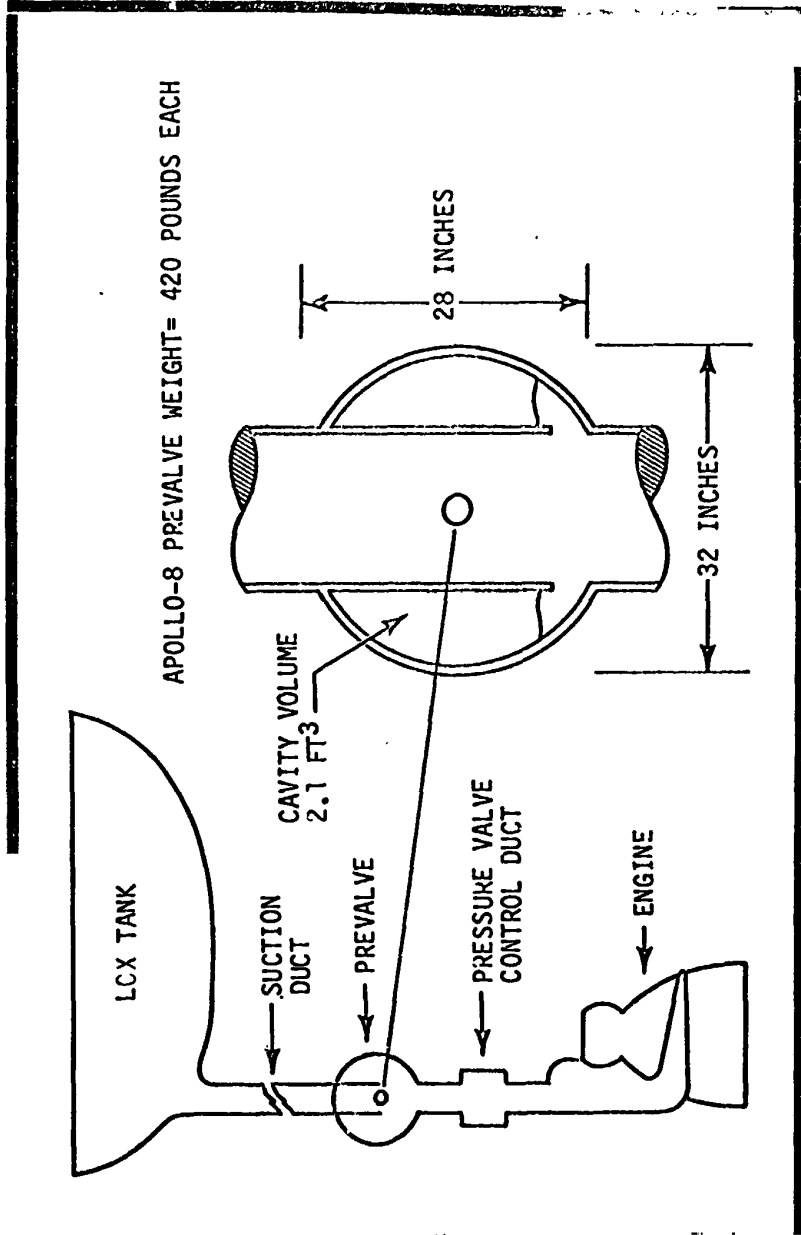
Figure 2.2.1-1

ORIGINAL STABILITY ANALYSIS INDICATED ADEQUATE MARGINS WITH PREVALVE ACCUMULATORS INSTALLED IN ALL S-IC ENGINES. FURTHER INVESTIGATION INTO THE CENTER ENGINE STABILITY REVEALED A COUPLING OF THE LOX LINE SECOND MODE WITH THE CENTER ENGINE STRUCTURAL MODE AND PRODUCED INSTABILITY FROM APPROXIMATELY T+40 TO T+87 SECONDS. ANALYSIS USING PREVALVE ACCUMULATORS, IN THE FOUR OUTBOARD ENGINE LINES ONLY, INDICATED STABLE CONDITIONS IN ALL MODES THROUGHOUT S-IC BOOST. S-IC-7 WAS STATIC FIRED SATISFACTORILY USING FOUR OUTBOARD ENGINE LOX LINE ACCUMULATORS. THE FOUR ENGINE ACCUMULATOR SYSTEM DOES NOT ADVERSELY AFFECT THE GUIDANCE SYSTEM STABILITY OR PRODUCE SIGNIFICANT LONGITUDINAL/LATERAL LOADS IN THE SPACECRAFT. THE USE OF THE FOUR ENGINE LINE ACCUMULATOR CONFIGURATION WAS RECOMMENDED FOR USE FOR APOLLO 8. THE S-II ANALYSIS INDICATED ADEQUATE POGO STABILITY MARGINS AT IGNITION AND CUTOFF. THE RESULTS OF THE REMAINING S-II POWERED FLIGHT ANALYSIS WILL BE AVAILABLE NOVEMBER 11, 1968. THE S-IVB ANALYSIS INDICATED ADEQUATE POGO STABILITY MARGINS THROUGHOUT FLIGHT.

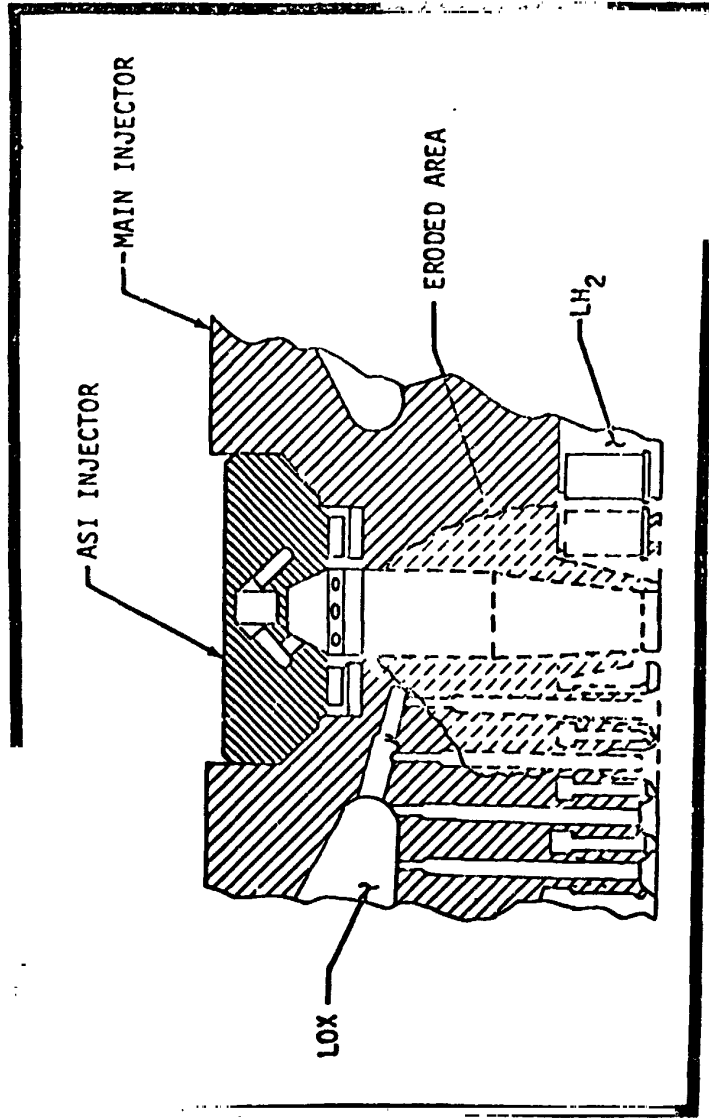
Figure 2.2.2-1

S-II Injector After 28 Second Test at High ASI Mixture Ratio

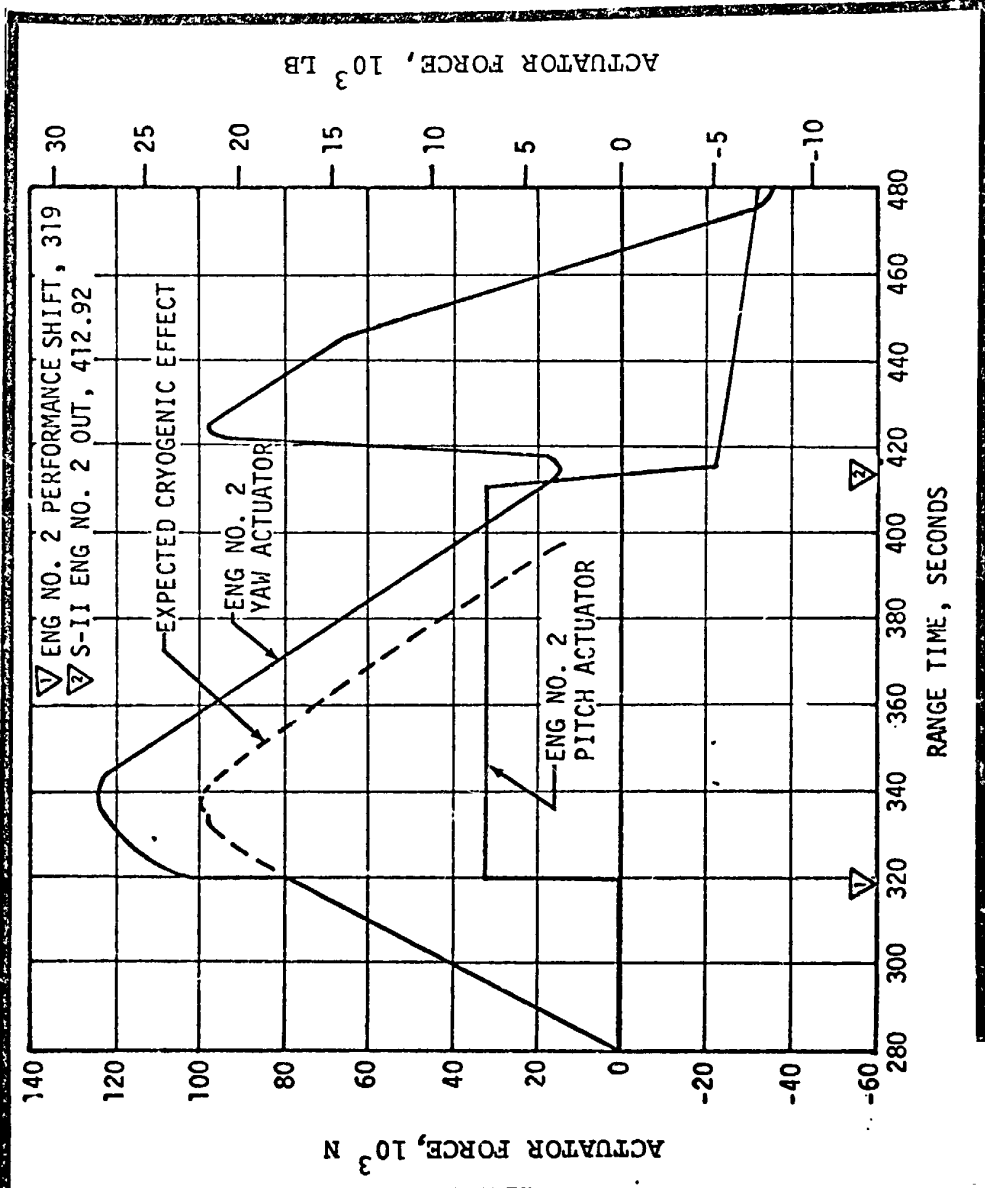
FIGURE 2.2.3-1 NUMBER 2 ENGINE ACTUATOR FORCES

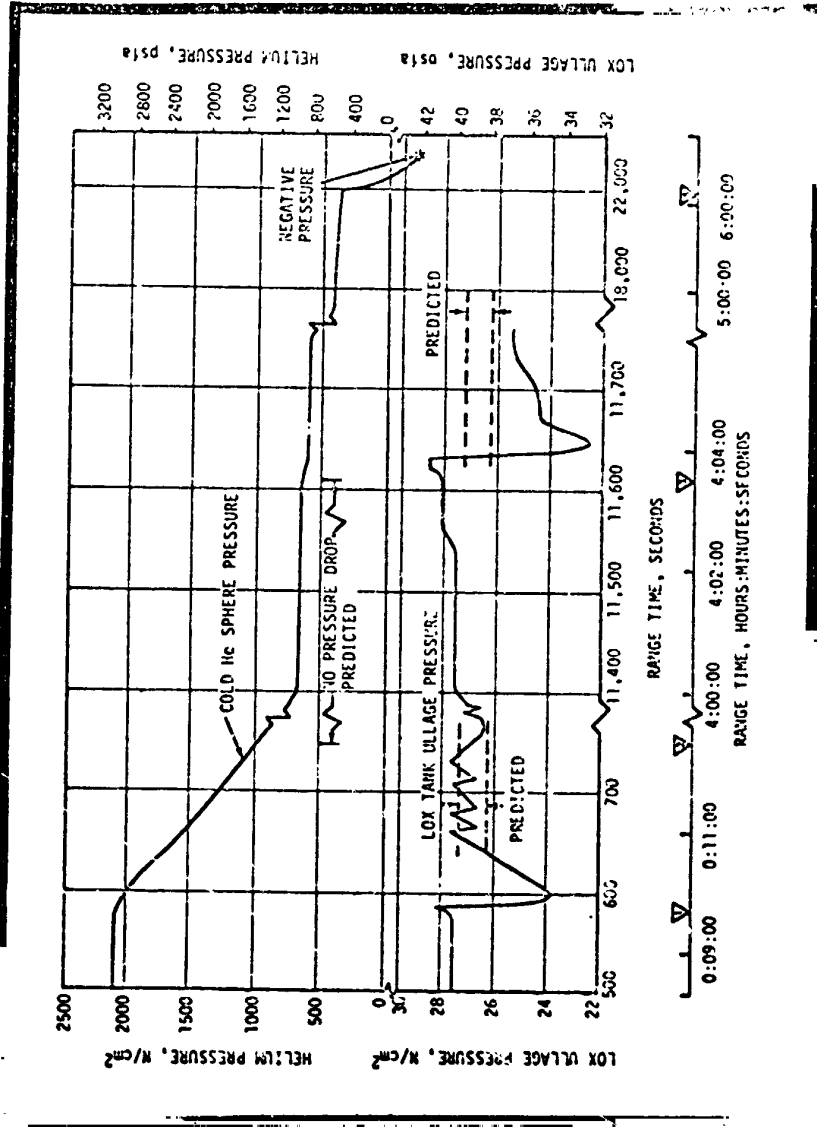
APOLLO 6 S-IVB COLD HELIUM SUPPLY DECAY
FIGURE 2.2.7-1

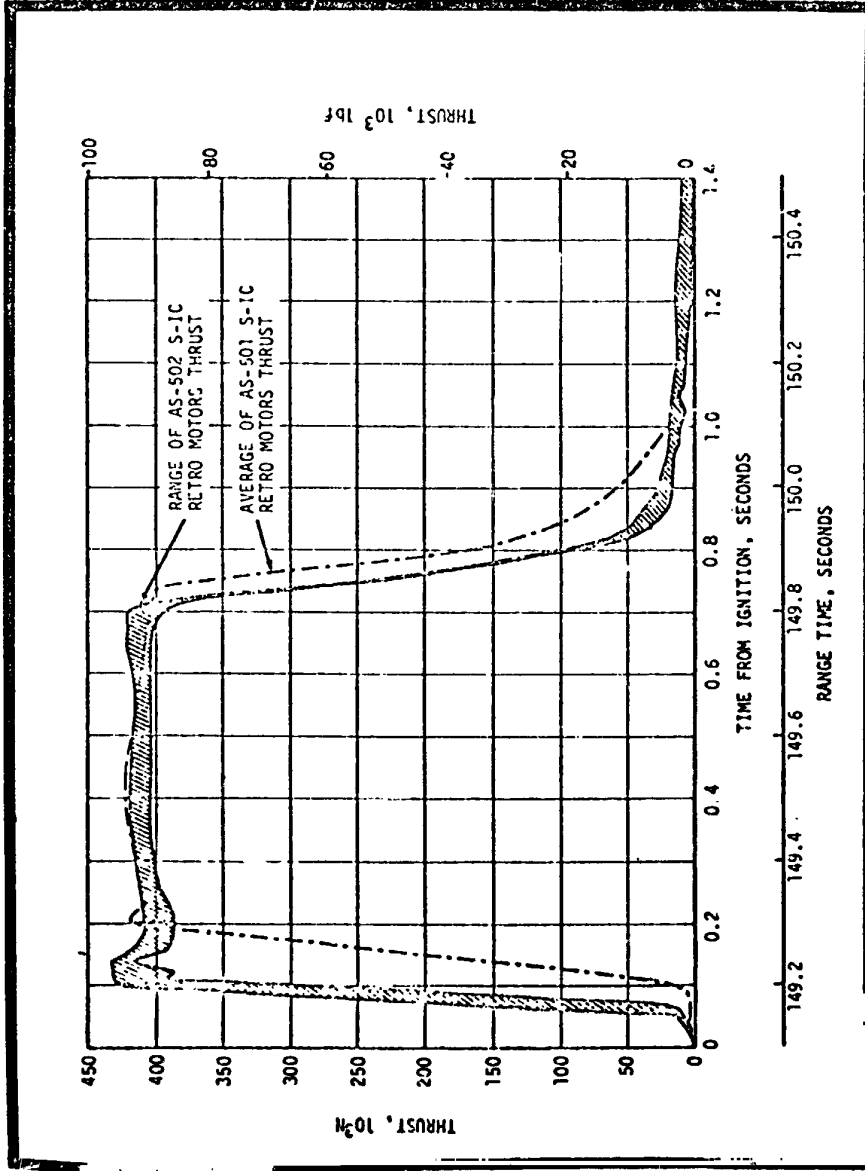
Figure 2.2.13-1. S-1C Retro Motor Thrust

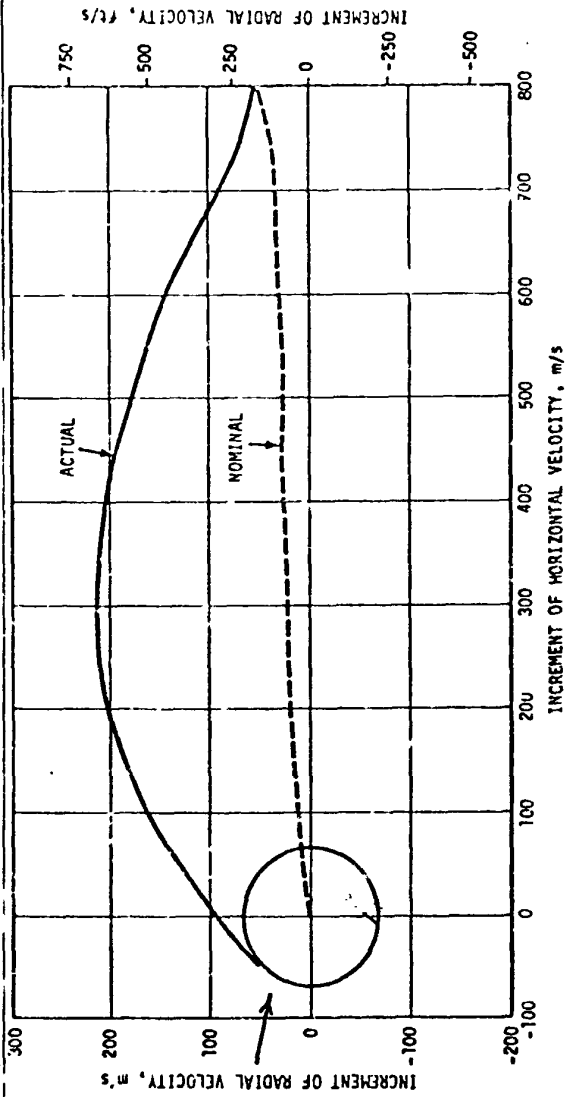
FIGURE 2.2.15-1

ON ENTERING THE CUTOFF LOOP, THE AS-502 TOTAL VELOCITY WAS IN EXCESS OF THE DESIRED VALUE OF 7790.9 M/S (25,560.7 FT/S), AND CUTOFF SIGNAL WAS IMMEDIATELY GIVEN AT 747.04 SECONDS WITH AN OVERSPEED OF 48.9 M/S (160 FT/S).

FIGURE 1 IS A PLOT OF THE RADIAL VELOCITY (X) TO-BE-GAINED VERSUS THE HORIZONTAL VELOCITY (Z) TO-BE-GAINED. THE CIRCLE ABOUT THE ORIGIN REPRESENTS THE CUTOFF LOOP WHICH IS ENTERED WHEN TOTAL VELOCITY-FALLS BELOW APPROXIMATELY 65 M/S (213 FT/S). THE DIFFERENCE IN THE ACTUAL AND NOMINAL VELOCITIES-TO-BE-GAINED IS A RESULT OF PITCH DOWN ATTITUDE COMMANDS TO CORRECT ALTITUDE DURING THE INITIAL PORTION OF S-IVB GUIDANCE. THE PITCH DOWN ATTITUDE TENDED TO INCREASE THE RADIAL VELOCITY-TO-BE-GAINED RATHER THAN DECREASE IT.

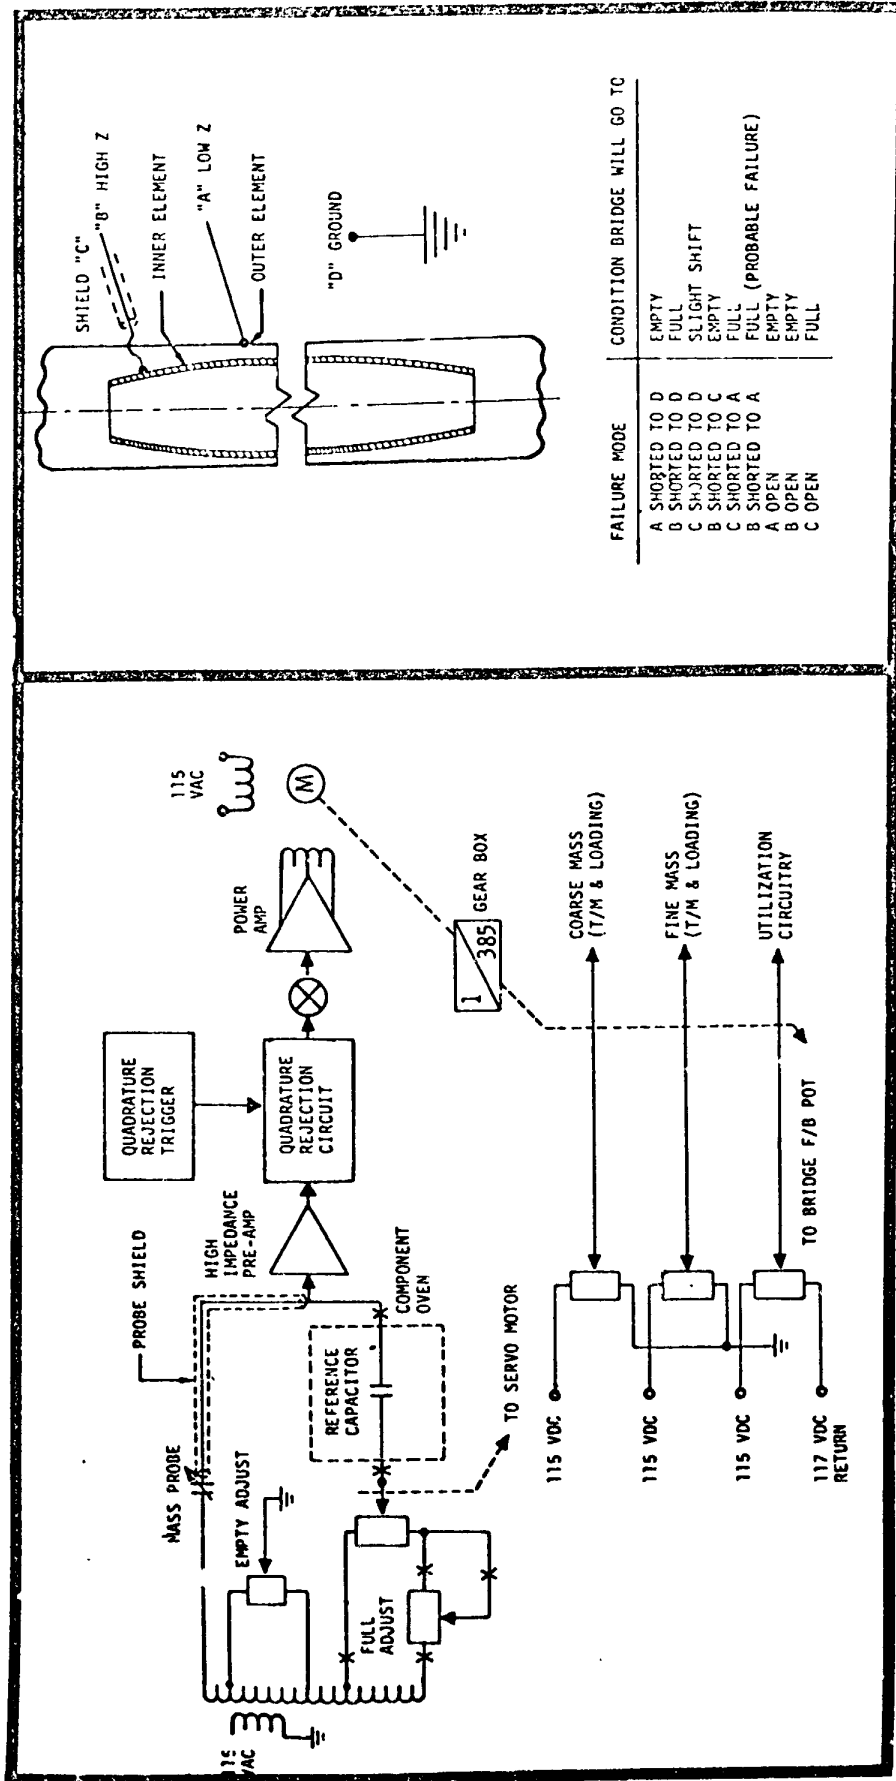
Figure 2.2.17-1 S-IVB Servo Bridge

Figure 2.2.17-2 Failure Modes of S-IVB PU Probe

ADDITIONAL TESTS WILL BE CONDUCTED TO CHECK THE CRIMPING OF THE CABLE CONNECTOR. THE DESIRABILITY OF INSULATING ONE OR BOTH OF THE PROBE ELEMENTS TO PREVENT SHORTING BY DEBRIS IS ALSO BEING CONSIDERED.
