Russia's Proton crashes with a trio of navigation satellites

Published: July 1; updated: July 2, 3, 4, 5, 9, 11, 15, 18, 19; 23; Aug. 11

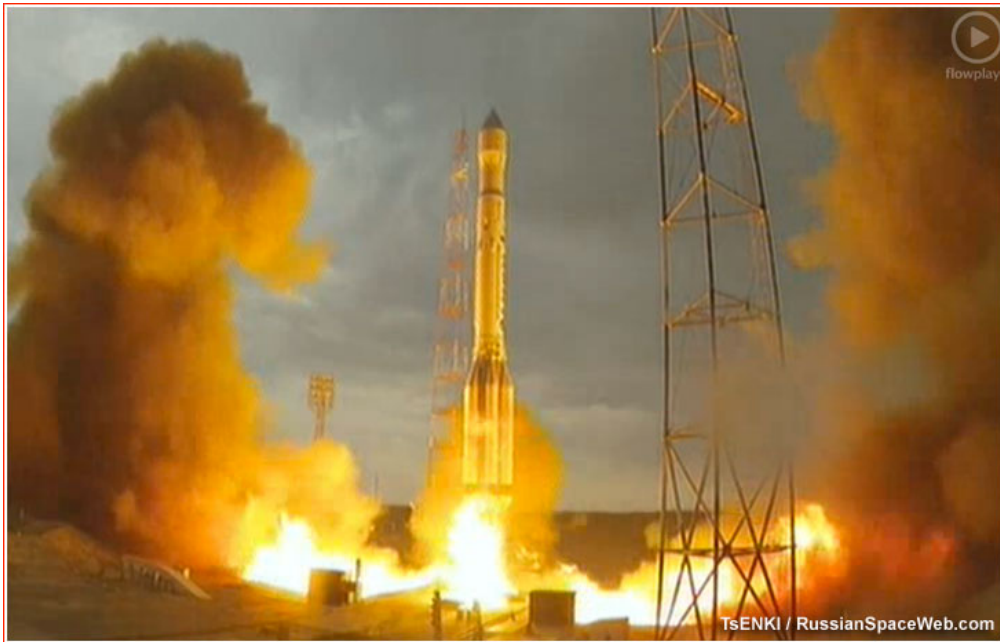
The ill-fated Proton rocket lifts off on July 2, 2013, at 06:38:21.585 Moscow Time (July 1, 10:38 p.m. EDT). The rocket crashed approximately 32.682 seconds later, Roskosmos said on July 18, 2013.

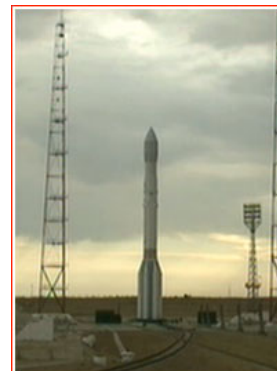
A Proton rocket with the Block D 11S861 stage and 813GLN34 payload firing shortly before liftoff on July 2, 2013.

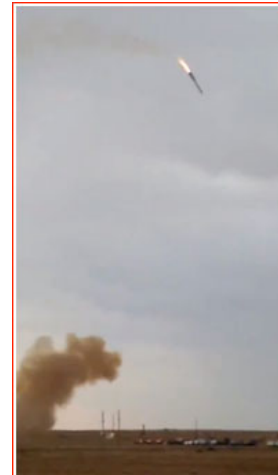
Shortly before crash the vehicle gyrated wildly, then arced toward the ground.

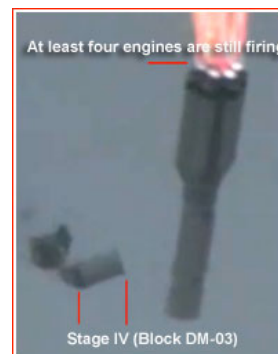
Images reveal the overstressed payload section of the rocket and its fourth stage being torn off, while main [engines](#) of the first stage continue firing. Click to enlarge.

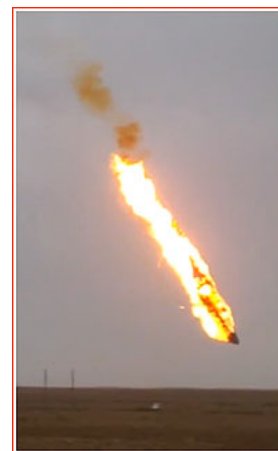
A close-up view reveals Proton's external tanks breaking off seconds before hitting the ground. Click to enlarge.

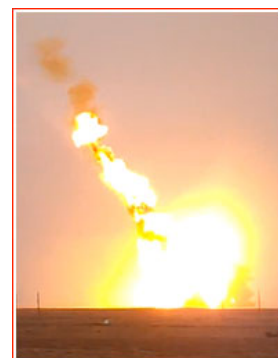
The rocket turned into a fireball moments before impacting the ground just few kilometers from the launch site. Click to enlarge.

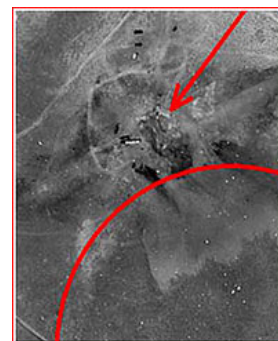
A close up satellite image of the Proton crash site released on July 11, 2013. Click to enlarge.

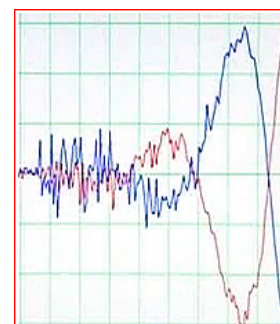
A telemetry recording from the failed launch shows reversed data from a angular velocity sensor responsible for the course (yaw) axis. Credit: Rossiya TV channel
