RESULTS OF THE SECOND U.S. MANNED ORBITAL SPACE FLIGHT, MAY 24, 1962

1. SPACECRAFT AND LAUNCH-VEHICLE PERFORMANCE

BY JOHN H. Boynton, Mercury Project Office NASA Manned Spacecraft Center; and E. M. Fields, Mercury Project Office NASA Manned Spacecraft Center

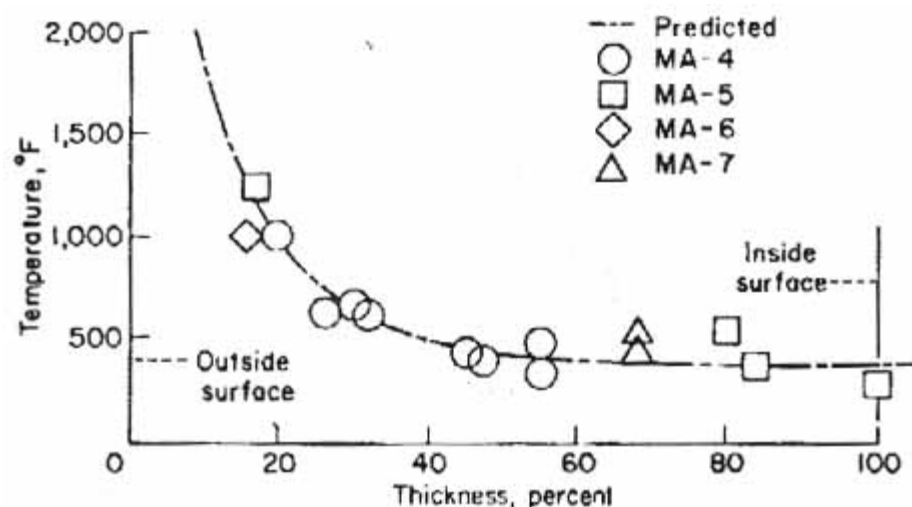
Figure 1-2.- Maximum ablation-shield temperatures.

Although the MA-7 reentry trajectory was slightly more shallow than for MA-6, the heating effects were not measurably different, as is evident in [figure 1-2](#).

Two temperature measurements were made in the ablation shield, one at the center and the other approximately 27 inches from the center. The maximum recorded values are graphically and compared with previously obtained orbital reentry values in [figure 1-2](#). The magnitude of these temperatures, as well as the ablation-shield weight loss during reentry, are comparable with previous flights. The supporting structure behind the ablation shield was found to be in excellent condition following the flight. A more complete temperature survey of points around the afterbody than on previous flights was conducted for MA-7. This survey was made possible by the addition of a low-level commutator circuit. The data, which are shown in [figure 1-3](#) were within expected ranges, and the integrity of the structure was not affected by the thermal loads experienced.

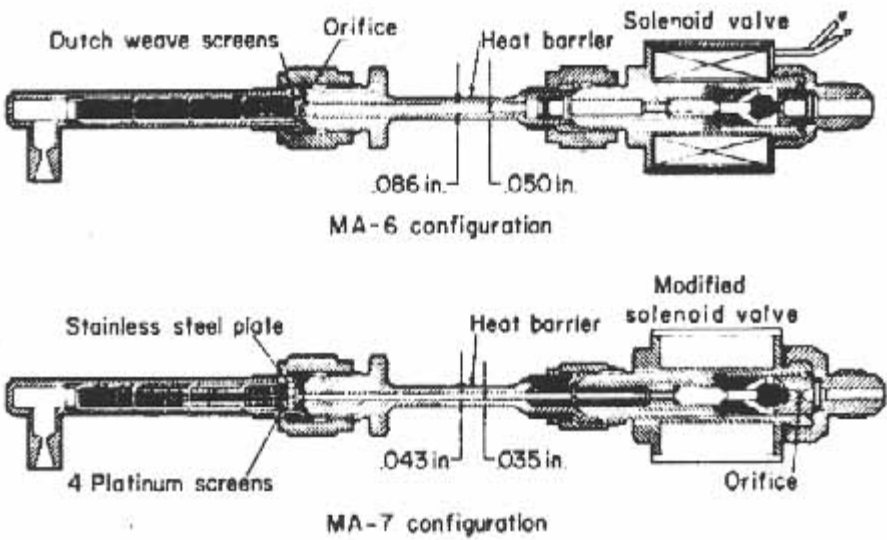
[5] Figure 1-4.-Comparison between MA-6 and MA-7 thrusters.

The reaction control components were of the standard configuration, with the exception of the 1-pound and 6-pound thruster assemblies which had been slightly modified to correct deficiencies which occurred on earlier flights. The...

....modification to the 1-pound units involved replacing the stainless-steel fuel distribution (Dutch weave) screens (see [fig. 1-4](#)) with platinum screens and a stainless-steel fuel distribution plate, reducing the volume of the heat barriers of the automatic RCS and moving the fuel-metering orifice to the solenoid inlet. The only modification to the 0-pound units was the replacement of the stainless-steel screens with platinum screens. These changes proved to be effective, as all thrust units operated properly throughout the flight.

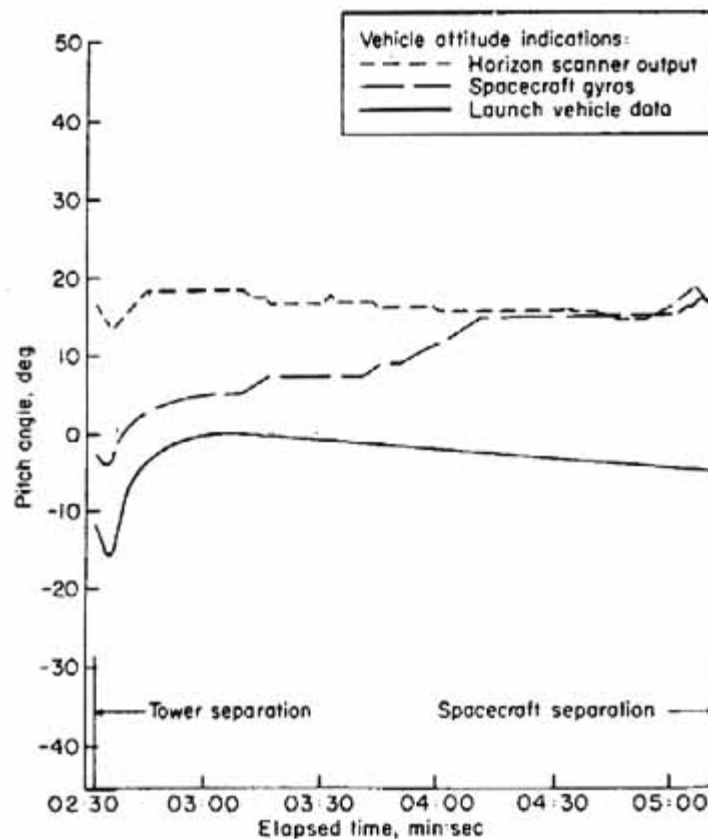
[6] Figure 1-6.- Spacecraft attitudes during launch.

Some 40 seconds after escape tower separation, the output of the pitch scanner indicated a spacecraft attitude of approximately 17° , which is graphically depicted in [figure 1-6](#). Also shown is the attitude of the launch vehicle and spacecraft as determined from launch vehicle data which is about -1° at this time indicating a scanner error of about 18° in pitch. This error apparently increased to about 20° at spacecraft separation. Radar tracking data at the time of retrofire provided the only additional independent information source and the radar data verify, in general, the scanner error. The thrust vector which produced the post retrograde velocity was calculated by using the radar measurements and since this vector is aligned with the spacecraft longitudinal axis, a retrofire attitude of about -36° in pitch was derived. This calculated attitude was compared with a scanner-indicated attitude of -16° during retrofire, yielding a difference of 20° . Although these two independent measurements and calculations would support a theory that a constant bias of about 20° was present, the attitudes as indicated by instruments and compared with observations by the pilot disclose possible horizon scanner errors of widely varying amounts during the orbital flight phase. Because of the malfunctioning scanner which resulted in pitch errors in the spacecraft attitude-gyro system, the pilot was required to assume manual control of the spacecraft during the retrofire period.

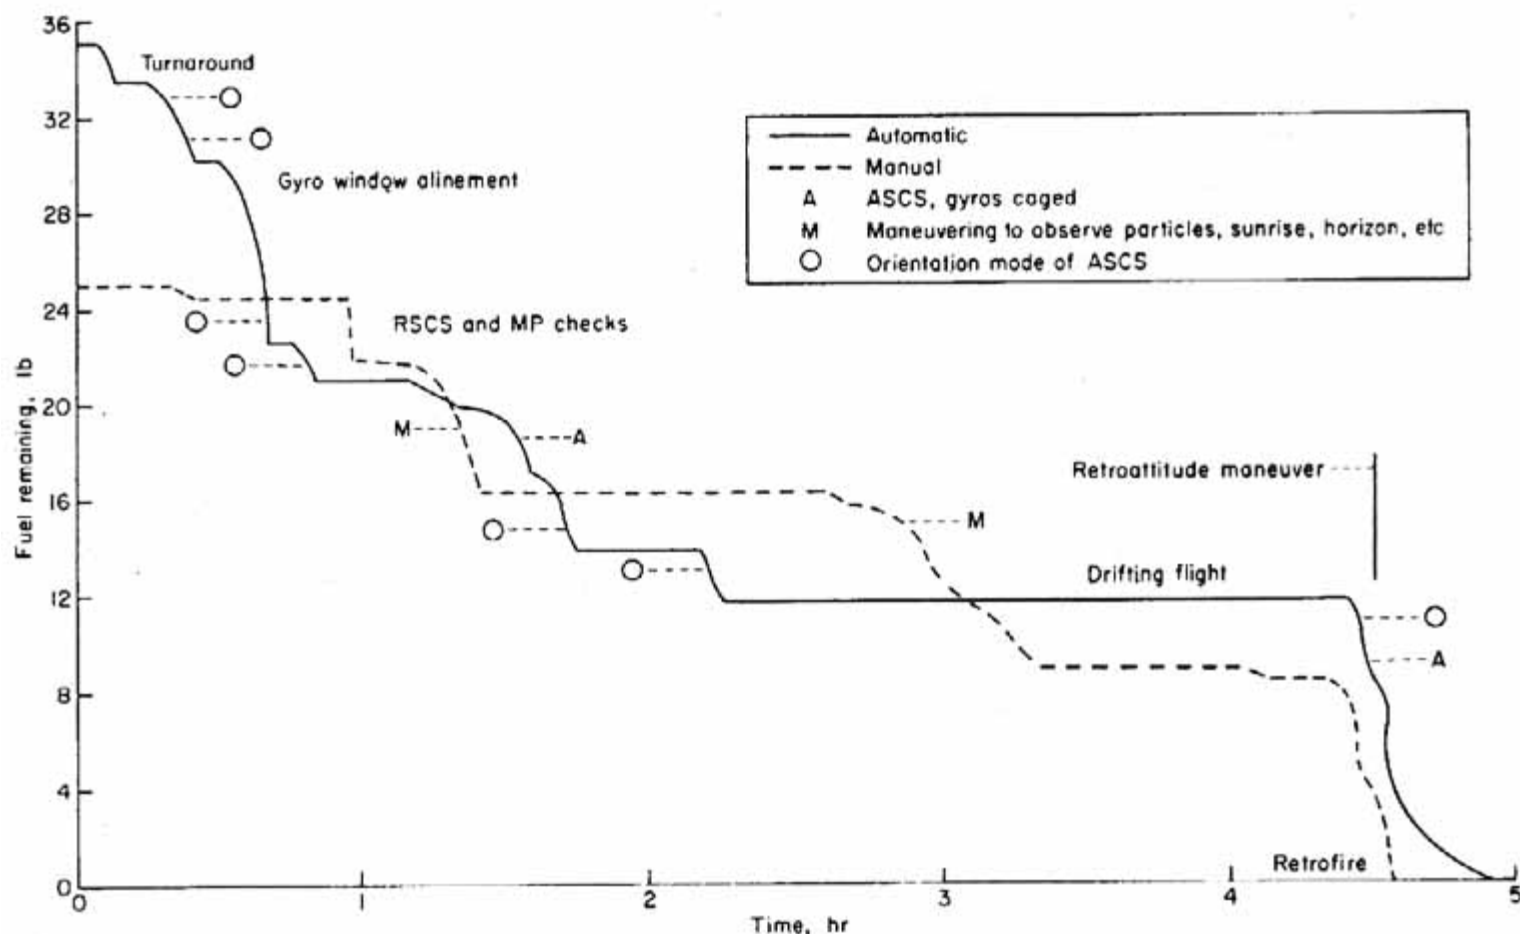
[7] Figure 1-7.-Fuel usage rates.

Double authority control was inadvertently employed at times during the flight, and the fly-by-wire high thrust units were accidentally actuated during certain maneuvers, both of which contributed to the high usage rate of spacecraft fuel indicated in [figure 1-7](#). In addition, operation of the ASCS mode while outside the required attitude limits resulted in unnecessary use of the high thrust units. The manual-system fuel was depleted at about the end of the retrofire maneuver, and the automatic-system fuel was depleted at about halfway through the reentry period.

Because of the early depletion of automatic-system fuel, attitude control during reentry was not available for the required duration as a result, attitude rates built up after the ASCS became inoperative because of the lack of fuel, and these rates were not sufficiently damped, as expected, by aerodynamic forces. These oscillations diverged until the pilot chose to deploy the drogue parachute manually at an altitude of approximately 25,000 feet to stabilize the spacecraft.

In order to prevent inadvertent use of the high-thrust jets when using FBW mode of control, the MA-8 and subsequent spacecrafts will contain a switch which will allow the pilot to disable and reactivate the high-thrust units at his discretion. An automatic override will reactivate these thrusters just prior to retrofire. Additionally, a revision of fuel management and control training procedures has been instituted for the next mission.

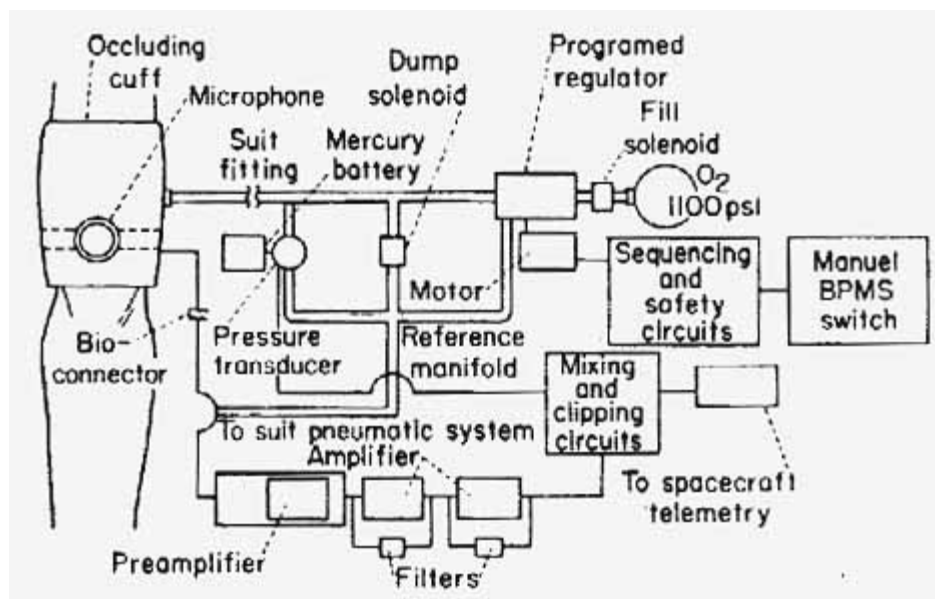
Figure 1-8.-Semiautomatic blood-pressure measuring system.

The data transmitted from the blood-pressure measuring system stem were questionable at times during the flight, primarily because of the magnitude of the data and the intermittency with which it was received. The intermittent signals were found to have resulted from a broken cable in the microphone pickup, shown in [figure 1-8](#). This malfunction, however, could not have affected the magnitude of the transmitted information, since an intermittent short either sends valid signals or none at all. The BPMS was thoroughly checked during postflight tests in the laboratory using actual flight hardware, with the exception of the microphone and cuff. Tests of the controller unit and amplifier

were also conducted, and no component failure or damage in the BPMS has been detected to date. However, a number of uncertainties regarding the calibration and operation of the BPMS still...

[9].... exist. Extensive testing is being conducted to correlate postflight and in-flight BPMS readings more accurately with clinically measured values.

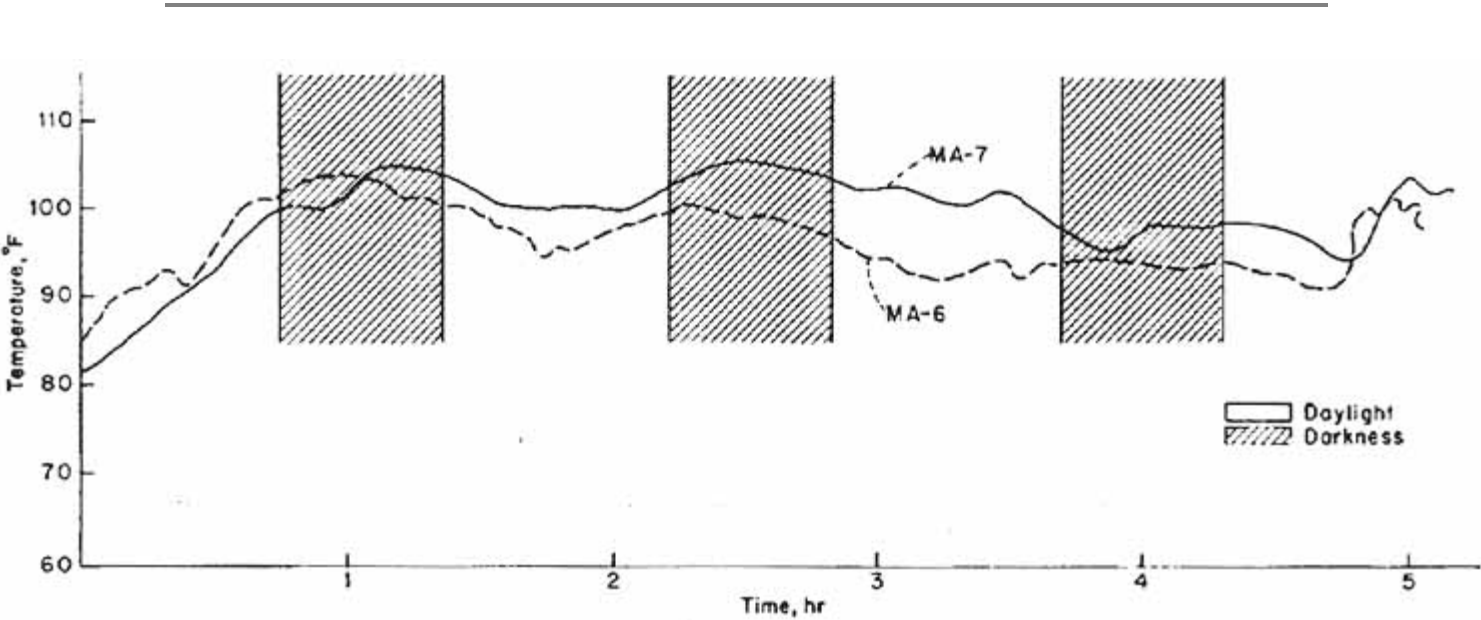
Figure 1-10. Cabin-air temperatures.

Higher-than-desired temperatures in the spacecraft cabin and pressure suit were experienced during the MA-7 flight, and these values...

...are plotted in [figures 1-10](#) and [1-11](#), respectively. In the same figures, the cabin and suit temperatures measured during the MA-6 mission are shown for comparison. The high temperatures were the only anomalies evident in the ECS during the flight.

The high cabin temperature is attributed to...

....a number of factors, such as the difficulty of achieving high air flow rates and good circulation of air in the cabin and vulnerability of the heat exchanger to freezing-blockage when high rates of water flow are used. Tests are currently being made to determine if the cabin temperature can be lowered significantly without requiring substantial redesign of the cabin-cooling system.

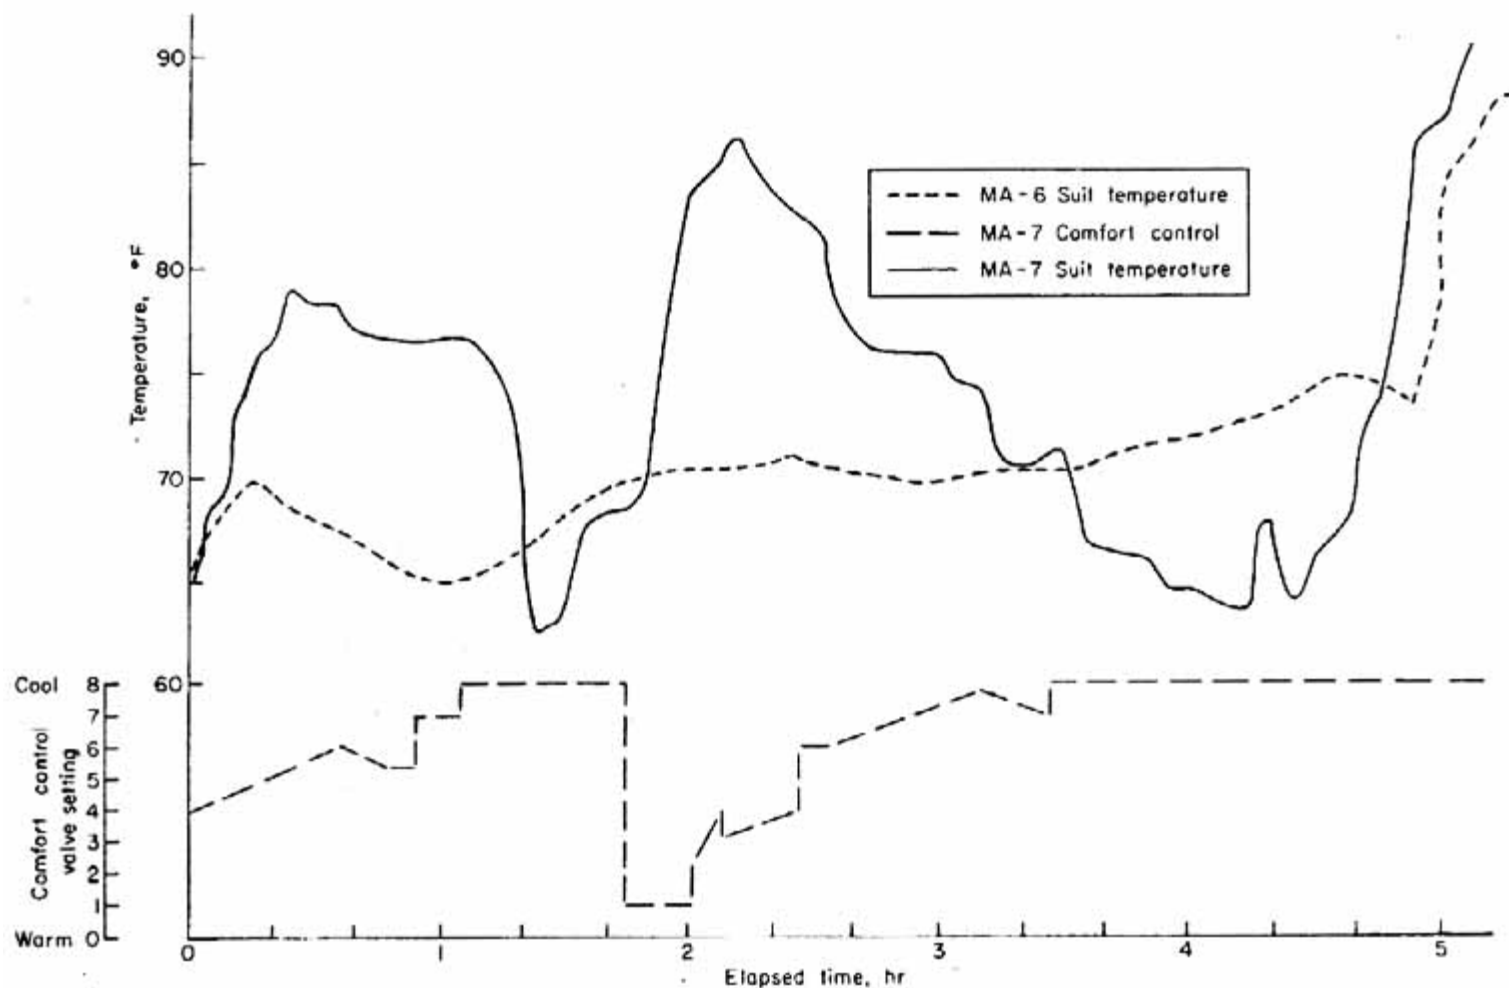
[10] Figure 1-11.-Suit-inlet temperature and comfort control valve setting.

In the case of the high suit temperatures, some difficulty was experienced in obtaining the proper valve setting for the suit-inlet temperature control, mainly because of the inherent lag at the temperature monitoring point with control manipulations. The comfort control valve settings are presented in [figure 1-11](#), and a diagonal line reflects a lack of knowledge as to when the control setting was instituted. It has been further ascertained in postflight testing in the altitude chamber that the suit temperature did respond to control valve changes. Based on the satisfactory performance of the suit system in the MA-6 flight, it is believed that the suit-inlet temperature could have been maintained in the 60° to 65° F range for the MA-7 flight, had not the comfort control valve been turned down early in the flight. The valve setting was reduced by the pilot during the first orbital pass when the cabin heat exchanger indicated possible freezing. It is believed that some freezing at the heat exchanger did occur during the flight which may have resulted in less efficient cooling but this is not the primary cause of the above-normal temperature.

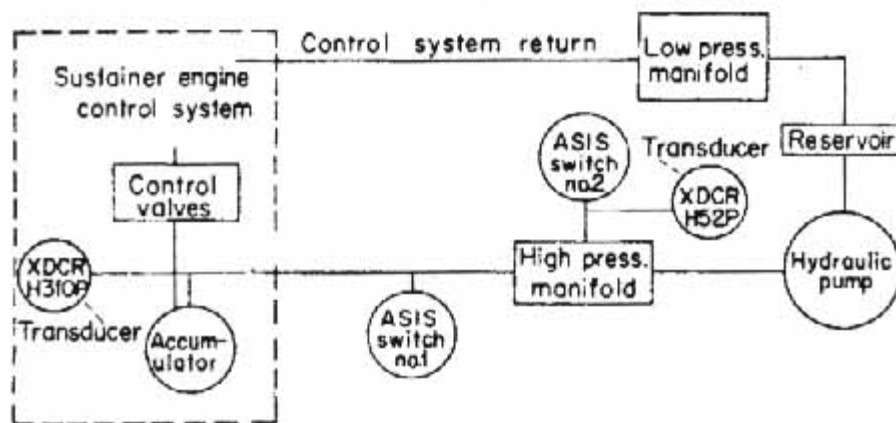
[14] Figure 1-14. Launch vehicle hydraulic diagram.

Although the abort sensing and implementation system (ASIS) performed satisfactorily during the flight, hydraulic switch no.2 for the sustainer engine actuated to the abort position at 4:25 minutes after liftoff. This switch and the pressure transducer H52P for the sustainer hydraulic accumulator are connected to a common pressure-sensing line as shown in [figure 1-14](#). For an unknown reason this transducer was apparently faulty and showed a gradual...

....decrease in pressure from 2,940 psia to 0 between 190 seconds and 312 seconds after liftoff Another transducer located in the sustainer control circuit indicated that pressure had remained at proper levels throughout powered flight; therefore, this pressure switch did not actuate until the normal time after SECO. Since both of these switches must be activated to initiate an abort, the signal which would have unnecessarily terminated the flight was not generated.
