APOLLO PROGRAM

D2-117017-7

FINAL FLIGHT EVALUATION REPORT APOLLO 10 MISSION

AUGUST 1969

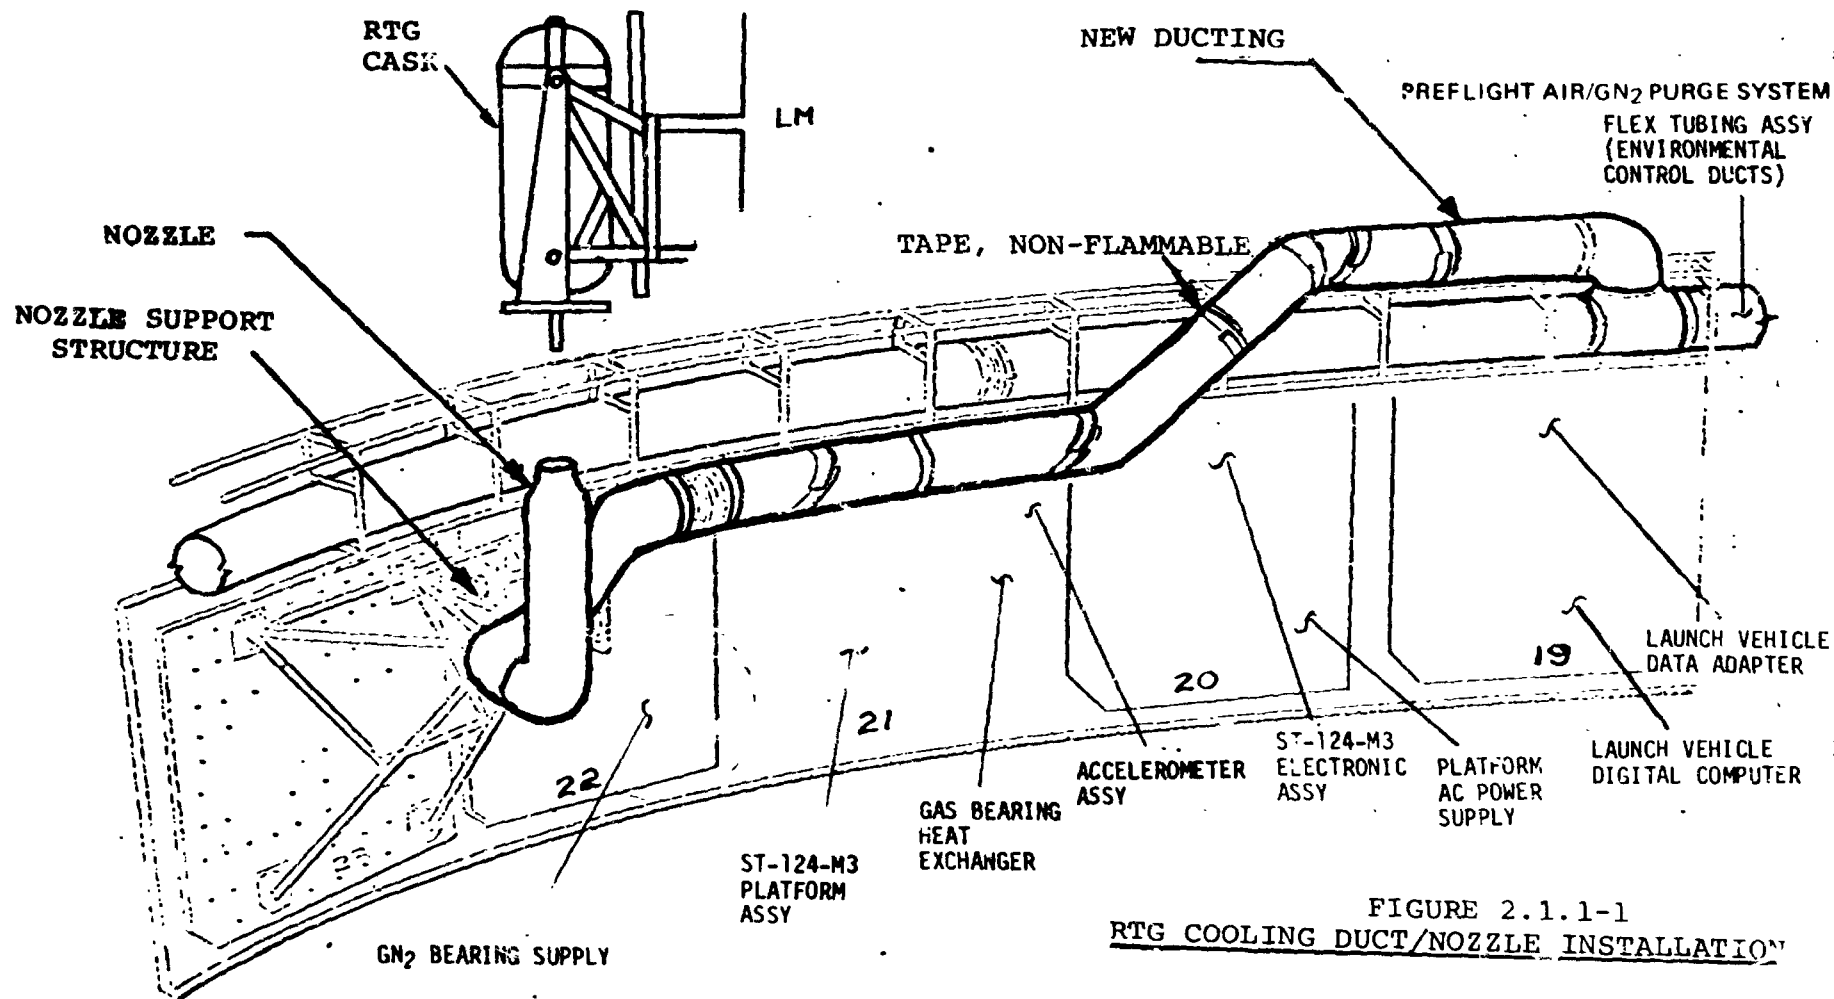
FIGURE 2.1.1-1
RTG COOLING DUCT/NOZZLE INSTALLATION

PROBLEM: AFTER SWITCHOVER FROM AIR TO GN₂, A REDUCTION WAS OBSERVED IN PRESSURE IN THE IU/S-IVB PURGE GASES. THE PRESSURE TRANSDUCER READING ON THE RTG COOLING NOZZLE DECREASED FROM 0.37 PSIG AT T-9:00 TO ALMOST ZERO GAGE PRESSURE AT T-8:30. THE CORRESPONDING GROUND SUPPORT EQUIPMENT (GSE) FLOWRATE INCREASED FROM AN INITIAL VALUE OF 200 LB/MIN TO AN OFF-SCALE VALUE OF MORE THAN 225 LB/MIN. THE UPSTREAM INLET PRESSURE DECREASED FROM 2.15 PSIG TO 1.66 PSIG. THE LOW PRESSURE AT THE INLET TO THE RTG NOZZLE INDICATED LOSS OF FLOW THROUGH THE NOZZLE. THE INCREASE IN FLOWRATE FROM THE GSE WITH A CORRESPONDING DECREASE IN INLET PRESSURE INDICATED THAT AN OPENING HAD OCCURRED SOMEWHERE IN THE PURGE DUCTING. THE ECS PURGE SYSTEM CONTINUED TO FUNCTION ADEQUATELY AS INDICATED BY A STABLE COMPARTMENT TEMPERATURE; THE DUCT FAILURE WAS ASSESSED AS NON-CRITICAL FOR THE APOLLO 10 LAUNCH, AND THE COUNTDOWN PROCEEDED.

MSFC TESTS INDICATE THE ECS AIR/GN₂ PURGE DUCT HAD A MASSIVE GAS LEAK AT THE DUCT JOINT APPROXIMATELY 4 INCHES INSIDE THE STAGE SKIN. THIS JOINT CONSISTED OF A FIBERGLASS DUCT WHICH FIT OVER A SHORT METAL DUCT STUB ATTACHED TO THE IU SKIN. THE FIBERGLASS DUCT WAS RETAINED BY A MARMAN CLAMP, WHICH WAS TORQUED TO 7+1 INCH-POUNDS.

ACTION: AS A RESULT OF THE MSFC TESTS, A SECOND MARMAN CLAMP WILL BE ADDED, AND BOTH CLAMPS WILL BE TORQUED TO 20+2 INCH-POUNDS. THIS CONFIGURATION HAS BEEN TESTED TO 9 TIMES THE NORMAL OPERATING PRESSURE WITH NO FAILURES. THIS CHANGE (IBM ECP 1905) HAS BEEN COMPLETED ON APOLLO 11, AND IT WILL BE ACCOMPLISHED ON ALL SUBSEQUENT LAUNCH VEHICLES.

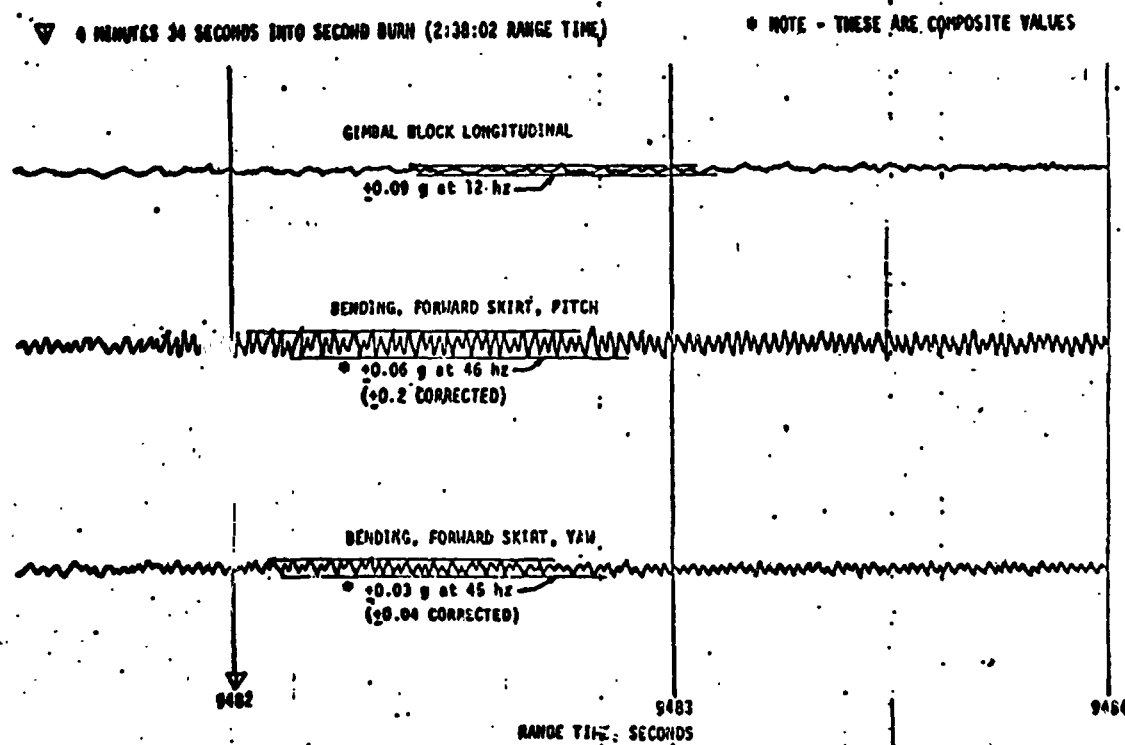
FIGURE 2.1.2-1 S-IVB SECOND BURN LONGITUDINAL AND LATERAL OSCILLATIONS

PROBLEM: DURING THE FIRST S-IVB BURN, 19 HERTZ LONGITUDINAL OSCILLATIONS OF APPROXIMATELY +0.25 G WERE OBSERVED AT THE ENGINE GIMBAL BLOCK. A SLIGHT CHANGE IN OSCILLATORY THRUST, DERIVED FROM CHAMBER PRESSURE, WAS ALSO EVIDENT DURING THIS TIME PERIOD. A REVIEW OF THE APOLLO 8 FLIGHT DATA SHOWED SIMILAR THRUST OSCILLATIONS AS ON APOLLO 10, BUT AT APPROXIMATELY 1/2 THE G LEVEL. THIS ACTIVITY IS WITHIN THE NORMAL J-2 ENGINE UNCOUPLED THRUST LEVEL, AND IT DOES NOT REPRESENT CONCERN FOR FUTURE APOLLO MISSIONS.

LOW FREQUENCY, LOW AMPLITUDE VIBRATION WAS ALSO PRESENT THROUGHOUT THE SECOND BURN. SHORTLY AFTER STEP PRESSURIZATION, A PREDOMINANT HIGH FREQUENCY OSCILLATION OF 46 HERTZ OCCURRED AND REMAINED UNTIL CUTOFF. THE MOST PROBABLE CAUSE WAS SEQUENTIAL VENTING OF THE DUAL VENT VALVES IN THE FORWARD SKIRT AREA, WHICH TENDS TO EXCITE THE FORWARD SKIRT RING MODE. TESTS WERE RUN AT AEDC TO ATTEMPT TO DUPLICATE THE FLIGHT DATA. APOLLO 11 WAS NOT CONSTRAINED BECAUSE THERE WAS NO ADVERSE EFFECT ON EITHER THE STRUCTURE OR THE VENTING SYSTEM DURING THE APOLLO 10 MISSION.

THE CREW REPORTED A LOW FREQUENCY LATERAL AND LONGITUDINAL OSCILLATION DURING BOTH S-IVB BURNS, WITH A HIGHER FREQUENCY VIBRATION SUPERIMPOSED ON IT BEGINNING 4 MINUTES AND 40 SECONDS INTO THE SECOND BURN. LONGITUDINAL 19 HZ OSCILLATIONS WERE EXPERIENCED DURING THE FIRST BURN AT A MAXIMUM AMPLITUDE OF +0.25 G ON THE LONGITUDINAL GIMBAL BLOCK ACCELEROMETER. A FREQUENCY ANALYSIS OF THE CHAMBER PRESSURE (Pc) SHOWS A CHANGE IN THE THRUST OSCILLATIONS DURING THE SAME TIME OF FLIGHT. THE AS-503 S-IVB DATA SHOWED 19 HZ LONGITUDINAL OSCILLATIONS SIMILAR TO AS-505 AT ABOUT ONE-HALF THE AMPLITUDE. S-IVB-201 AND S-IVB-204 THRUST DATA SHOWED 18-19 HZ OSCILLATIONS EQUAL IN AMPLITUDE TO AS-505. LONGITUDINAL VIBRATIONS WHICH ARE RESPONSES TO UNCOUPLED THRUST OSCILLATIONS ALSO OCCURRED DURING S-IC AND S-II MAINSTAGE BURNS. THE AMPLITUDE OF THE 19 HZ THRUST OSCILLATIONS CALCULATED FROM Pc IS WITHIN THE NORMAL J-2 UNCOUPLED THRUST LEVELS (NOISE LEVEL THRUST OSCILLATIONS). THE OSCILLATIONS ARE CONSISTENT WITH THE ENGINE NOISE LEVEL THRUST OSCILLATIONS AND THEY ARE OF NO CONCERN FROM STABILITY CONSIDERATIONS. SIMILAR VIBRATION LEVELS WERE ALSO PRESENT THROUGHOUT THE SECOND BURN. AN INCREASE IN THE PITCH & YAW VIBRATION LEVEL OCCURRED DURING THE SECOND BURN 4 SECONDS BEFORE THE ASTRONAUT COMMENT. THE PREDOMINANT FREQUENCY WAS 46 HZ WHICH REMAINED UNTIL ENGINE CUTOFF. THE FUEL STEP PRESSURIZATION AND VENT SEQUENCE OCCURRED 3 SECONDS BEFORE THIS VIBRATION LEVEL INCREASE. THE PROBABLE CAUSE IS THE PROXIMITY (0.1 PSI) OF THE DUAL VENT VALVE SETTINGS.

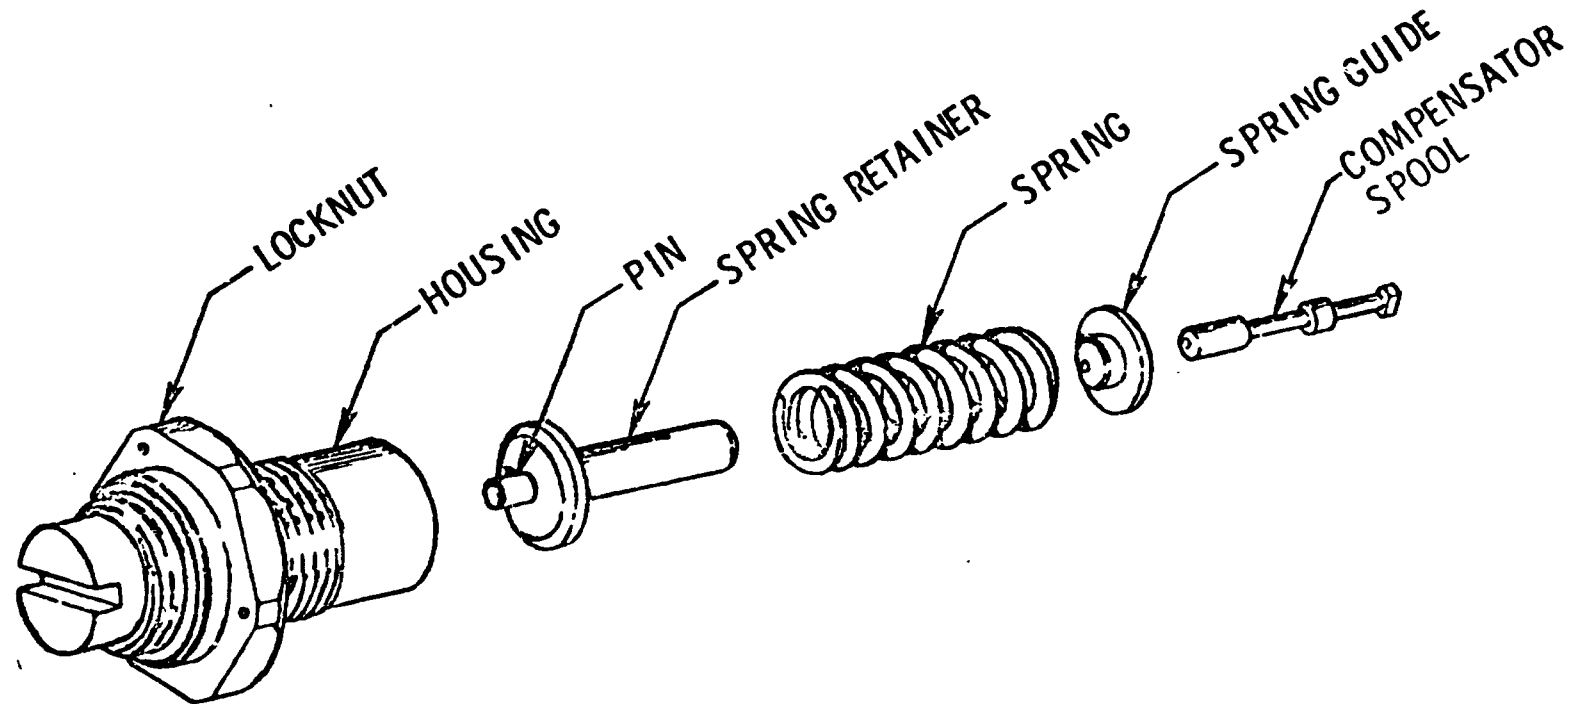
FIGURE 2.1.3-2 PRESSURE COMPENSATOR ASSEMBLY

AN AUXILIARY PUMP GROUND TEST WAS RUN IN AN ATTEMPT TO DUPLICATE THE FLIGHT DATA BY INTRODUCING KNOWN FAILURES. THE PRIME SUSPECT, STRUCTURAL FAILURE OF THE COMPENSATOR SPRING GUIDE, DID PRODUCE SIMILAR DATA. ADDITIONAL FAILURE TESTS (COMPENSATOR SPRING BREAKAGE, VALVE PLATE TORSION SPRING FRACTURE, AND STOP PIN FAILURE) DID NOT DUPLICATE FLIGHT DATA.

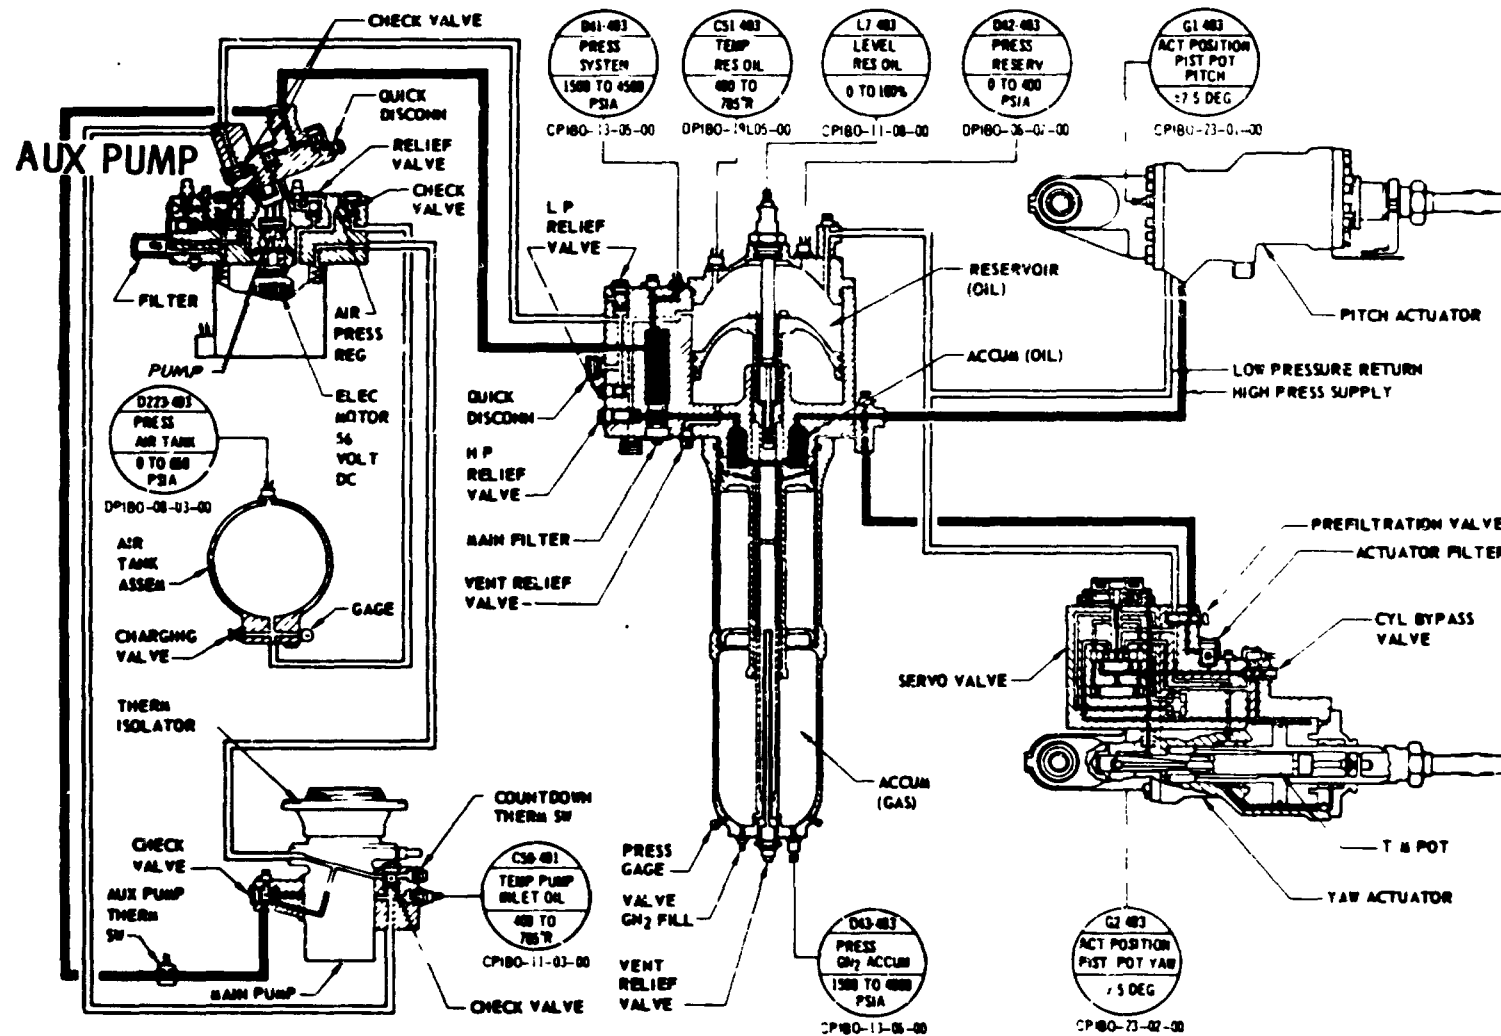
FIGURE 2.1.3-1. S-IVB HYDRAULIC SYSTEM

NO. 2.1.3	TITLE: S-IVB AUXILIARY HYDRAULIC PUMP ABNORMAL OPERATION	
SYSTEM: S-IVB	MISSION: APOLLO 10	
SUBSYSTEM: HYDRAULIC	EVENT TIME: 2:37	
PROBLEM:	<p>DURING THE TLI BURN AND THE PROPELLANT DUMP, THE AUXILIARY HYDRAULIC PUMP OPERATED ABNORMALLY. THE PUMP WAS CAVITATING, HEATING UP, PRESSURIZING THE SYSTEM TOO SLOWLY, AND DRAWING 19 AMPS INSTEAD OF THE EXPECTED 40 AMPS. DURING THE PRESSURIZATION CYCLE AFTER SECOND BURN AND DURING THE PROPELLANT DUMP, THE PUMP CURRENT WAS 15 TO 16 AMPERES AND THE SYSTEM PRESSURE WAS LESS THAN THE 1500 PSI LOWER LIMIT OF THE MEASURING SYSTEM. THERE WAS ENOUGH PRESSURE AVAILABLE, HOWEVER, TO CENTER THE J-2 ENGINE DURING THESE PERIODS.</p>	
ACTION:	<p>TESTS WITH A FAILED COMPENSATOR SPRING GUIDE REPRODUCED THE FLIGHT DATA. THE SPRING GUIDES WERE REDESIGNED SOME TIME AGO, BUT IT IS SUSPECTED THE OLD DESIGN FLEW ON AS-505 THE COMPENSATOR SPRING GUIDE ON S-IVB-506 WAS REPLACED BEFORE CDDT TO INSURE ADEQUATE PERFORMANCE DURING THE APOLLO 11 MISSION.</p>

THE AUXILIARY HYDRAULIC PUMP WAS TURNED ON 6 MINUTES PRIOR TO SECOND BURN. THE ACTUATORS CENTERED THE J-2 ENGINE IN RESPONSE TO THE 3635 PSIA SYSTEM PRESSURE. AT ENGINE IGNITION, THE ACTUATORS RESPONDED NORMALLY TO THE APPLIED GUIDANCE SIGNALS. THE AUXILIARY PUMP RESPONDED BRIEFLY WITH HIGH FLOW TO MEET THIS DEMAND WHILE THE ENGINE DRIVEN PUMP WAS BROUGHT UP TO SPEED. SHORTLY AFTER ENGINE IGNITION, THE ENGINE DRIVEN PUMP OUTPUT PRESSURE EXCEEDED THE NORMAL 3635 PSIA BY 3 PERCENT. THE AUXILIARY PUMP RESPONDED TO THIS EXCESS PRESSURE BY FEATHERING TO THE NO-FLOW CONDITION WITH A CORRESPONDING DROP TO A CONTINUOUS 21 AMPERE DEMAND. AT ABOUT 2:37 GET, THE AUXILIARY PUMP CURRENT DECREASED UNEXPECTEDLY TO 19 AMPERES. THE CURRENT REMAINED AT THIS LEVEL DURING THE 4.1 SECOND INTERVAL FOLLOWING ENGINE CUTOFF INSTEAD OF RISING TO THE NORMAL 40 TO 70 AMPERES.

ONE PRESSURIZATION WAS PROGRAMMED BETWEEN SECOND BURN AND THE CHILL DOWN EXPERIMENT/PASSIVATION EVENT. NO MEASURABLE SYSTEM PRESSURE WAS OBSERVED (TRANSDUCER RANGE AND SYSTEM CHARACTERISTICS DO NOT ALLOW DETECTION BELOW 1500 PSI). HOWEVER, THE ACTUATORS CENTERED THE ENGINE WHICH INDICATES THAT THE AUXILIARY PUMP PRODUCED SOME PRESSURE AND FLOW.

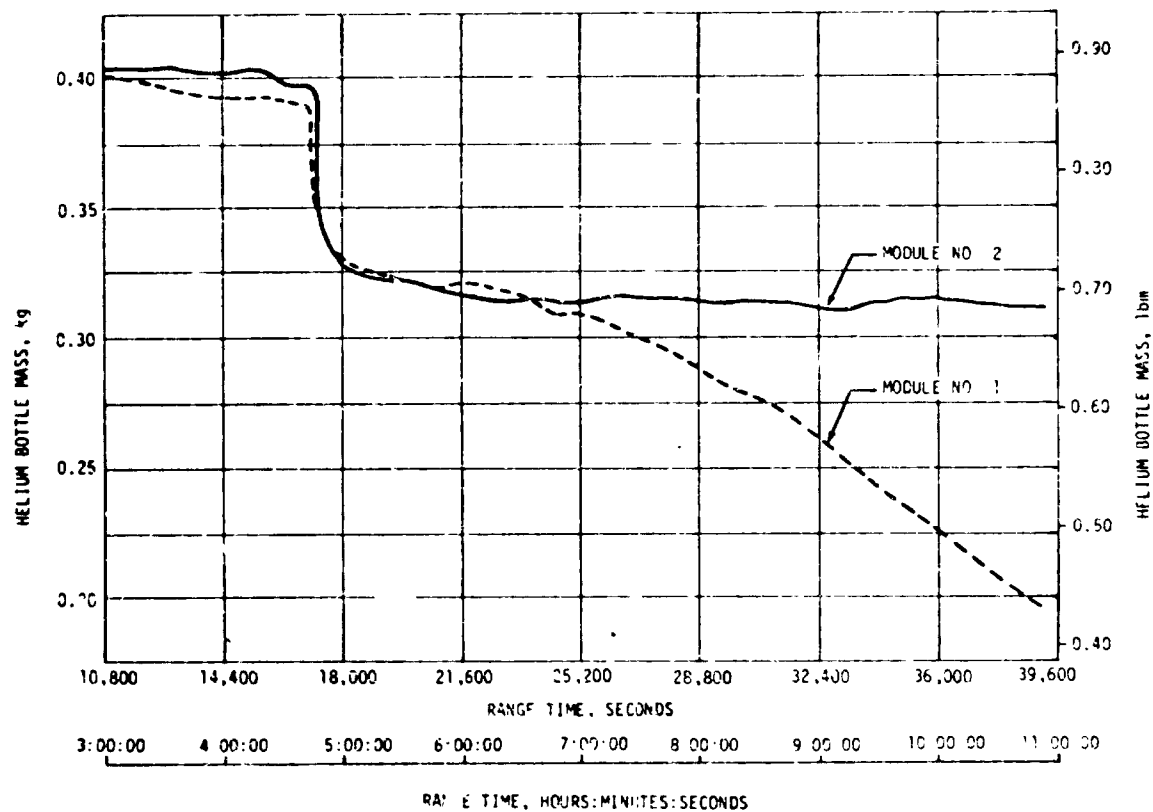
FIG. 2.1.4 S-IVB APS HELIUM BOTTLE MASS

PROBLEM: THE OPERATIONS OF THE APS PRESSURIZATION SYSTEM WAS SATISFACTORY WITH THE EXCEPTION OF A HELIUM LEAK IN MODULE NO. 1. THE LEAK STARTED APPROXIMATELY 6.5 HOURS AFTER LIFTOFF AND EXTENDED THROUGH LOSS OF DATA (10:54:00). THE LEAK RATE AT LOSS OF DATA WAS APPROXIMATELY 3278 SCCM (200 SCIM).

ACTION: AS A RESULT OF A SIMILAR LEAK WHICH OCCURRED ON AS-504 (APOLLO 9), FIVE "O" RINGS IN THE HIGH-PRESSURE HELIUM PLUMBING WERE CHANGED ON APOLLO 10 AND SUBSEQUENT. THE LEAKAGE RATES EXPERIENCED ON APOLLO 9 AND APOLLO 10 WOULD NOT IMPAIR THE ACCOMPLISHMENT OF THE S-IVB PORTION OF THE APOLLO 11 MISSION.

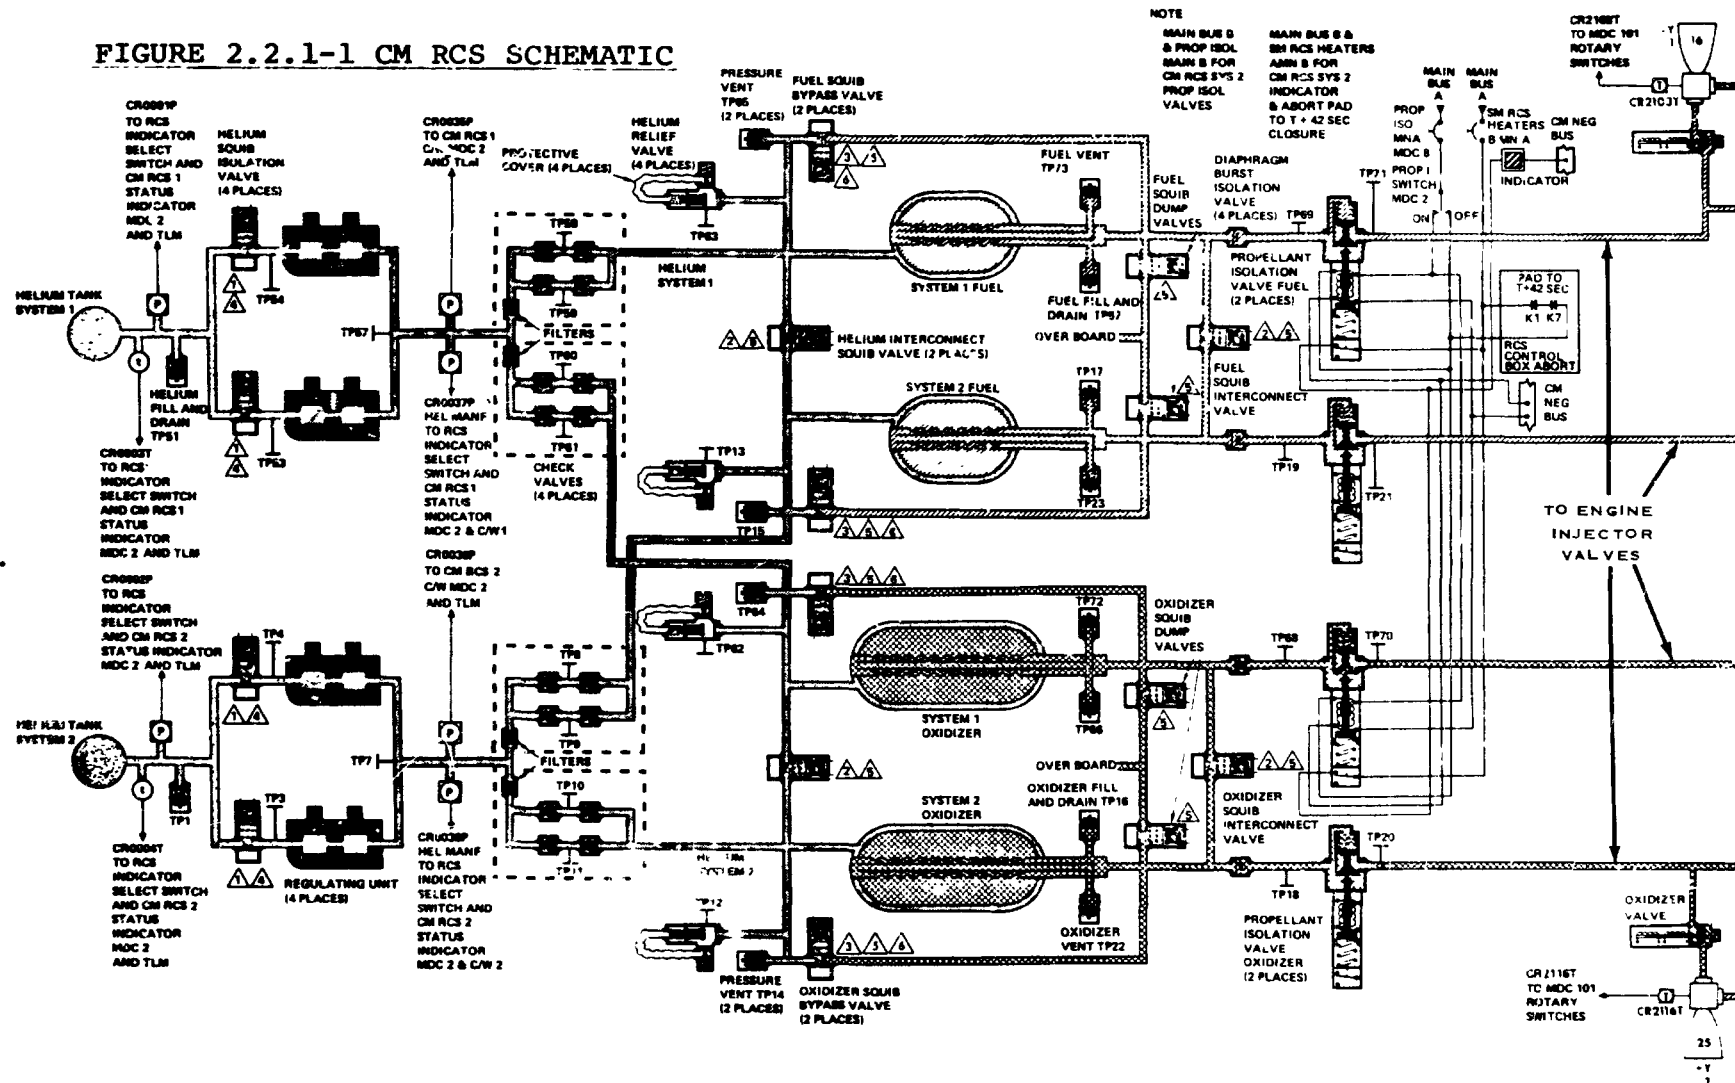
FIGURE 2.2.1-1 CM RCS SCHEMATIC

PROBLEM 1: THE HELIUM MANIFOLD PRESSURE IN CM RCS SYSTEM 1 BEGAN TO DECAY AT A RATE OF 0.13 PSIA/HR FOLLOWING HELIUM SERVICING 3.5 DAYS PRIOR TO LAUNCH. AFTER 2.5 DAYS, THE PRESSURE HAD DROPPED FROM 45 TO 37 PSIA. THE PRESSURE IN THE HELIUM MANIFOLDS BETWEEN THE PROPELLANT TANKS AND THE CHECK VALVES WAS CHECKED; THE OXIDIZER SIDE WAS AT THE INITIAL PRESSURE, BUT THE FUEL SIDE WAS LOW. NEITHER A HELIUM LEAK NOR A FUEL LEAK COULD BE DETECTED; HOWEVER, A FUEL LEAK OF SUFFICIENT MAGNITUDE TO CAUSE THE PRESSURE DROP DEFINITELY WOULD HAVE BEEN DISCOVERED. THE CONCLUSION WAS THAT THE LOW PRESSURE HELIUM MANIFOLD IN THE FUEL LEG WAS LEAKING SLIGHTLY BUT AT A RATE ACCEPTABLE FOR THE MISSION. THE SYSTEM WAS THEN REPRESSURIZED TO 49 PSIA. THE LEAK RATE DECREASED AS THE MISSION PROGRESSED, REACHING 0.04 PSIA/HR BY THE END OF THE MISSION. ONLY PART OF THIS DECREASE RESULTED FROM THE REDUCED SYSTEM PRESSURE; THUS, THE LEAK CORRECTED ITSELF TO SOME EXTENT AND/OR THE CHARACTERISTICS OF THE HELIUM CHANGED AS IT BECAME DILUTED BY PROPELLANT PERMEATING THE BLADDER.

ACTION: POSTFLIGHT TESTING OF THE COMMAND MODULE INCLUDED A VERY THOROUGH MASS SPECTROMETER LEAK CHECK ON SYSTEM 1, AT BOTH 50 AND 285 PSIG. NO LEAKS WERE DETECTED; HOWEVER, DURING THE POSTFLIGHT DECONTAMINATION PROCEDURES, CERTAIN TYPES OF LEAKS COULD BE ELIMINATED.

FOR FUTURE MISSIONS, THE SYSTEM WILL BE PRESSURIZED TO 100 PSIA ABOUT 30 DAYS PRIOR TO FLIGHT TO INSURE THAT ANY LEAKS CAN BE DETECTED AND APPROPRIATE CORRECTIVE ACTION TAKEN PRIOR TO START OF THE LAUNCH COUNTDOWN.

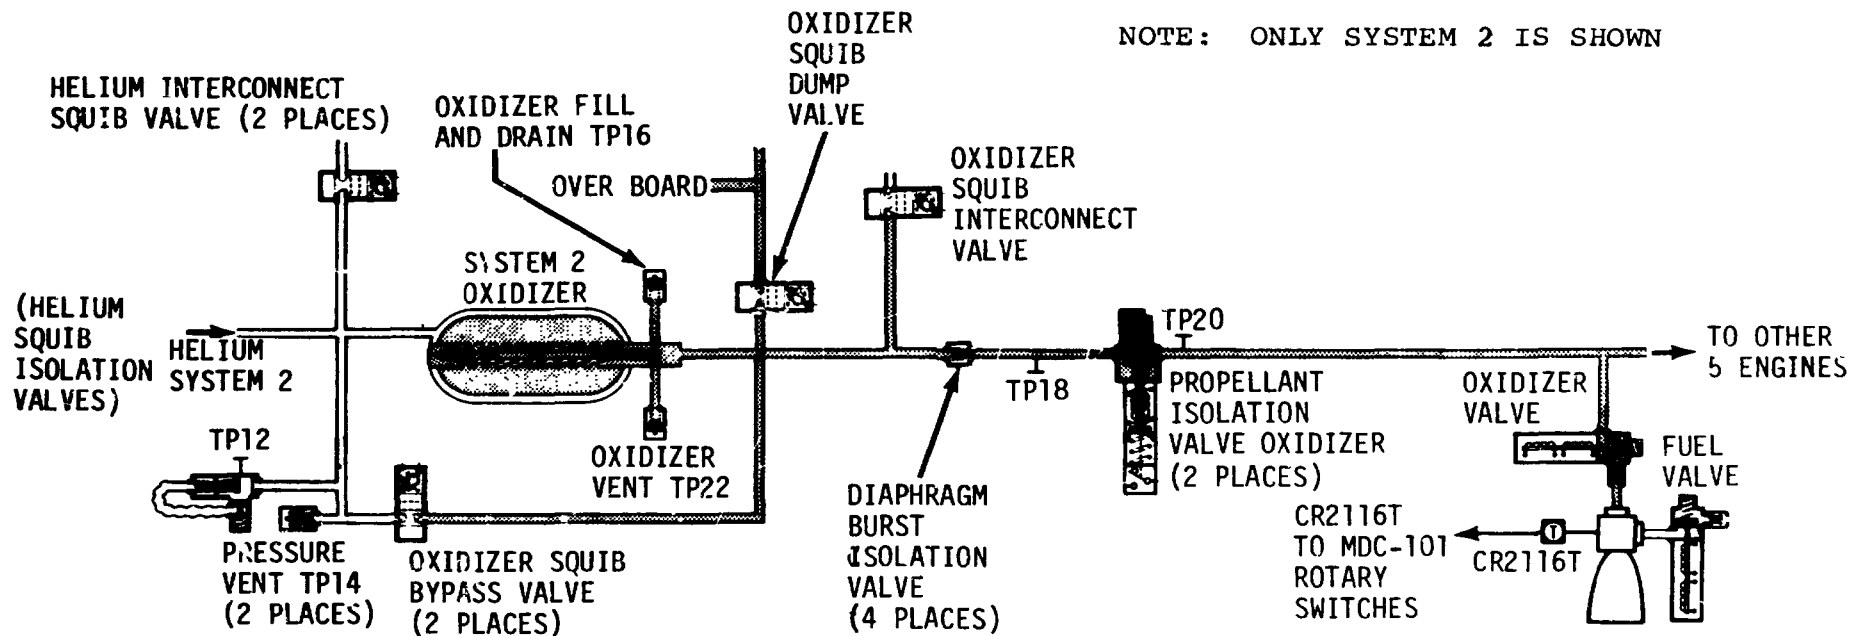
Figure 2.2.2-1. CM RCS OXIDIZER SUPPLY

PROBLEM: DURING THE FINAL SWITCH LIST VERIFICATION, WHEN THE PROPELLANT ISOLATION VALVES OF THE COMMAND MODULE RCS SYSTEM WERE OPENED, THE PRESSURE IN THE CM RCS HELIUM SYSTEM 2 DROPPED FROM 44 PSIA TO 37 PSIA. THIS INDICATED THAT THE OXIDIZER PROPELLANT BURST DIAPHRAGM WAS RUPTURED, ALLOWING OXIDIZER TO FLOW FROM THE TANK INTO THE MANIFOLD WHEN THE ISOLATION VALVE WAS OPENED. THE OXIDIZER ISOLATION VALVE BACKED UP BY THE ENGINE VALVES PREVENTED LOSS OF OXIDIZER, AND THE SYSTEM WAS VISUALLY VERIFIED TO BE LEAK-TIGHT; THEREFORE, IT WAS DECIDED THAT THE SYSTEM WAS ACCEPTABLE FOR FLIGHT. THE ISOLATION VALVES WERE CLOSED AFTER ORBITAL INSERTION. THE ENGINE VALVES WERE THEN OPENED BY MEANS OF THE REACTION CONTROL HEATER CIRCUITS, AND THE OXIDIZER WAS VENTED FROM THE MANIFOLD FOR 25 MINUTES. FOUR PERCENT OF THE OXIDIZER IN SYSTEM 2 WAS LOST, HOWEVER, THE MAXIMUM PREVIOUS PROPELLANT USAGE DURING A MISSION WAS 35% OF ONE SYSTEM. AFTER THE MISSION, THE OXIDIZER AND FUEL BURST DISCS WERE SIMILAR IN PHYSICAL APPEARANCE, INDICATING THAT THE OXIDIZER BURST DISC HAD FAILED BECAUSE OF PRESSURE.

ACTION: CAUTION NOTES HAVE BEEN ADDED TO THE PRELAUNCH CHECKOUT PROCEDURES IN THE PLACES WHERE THE ALLOWABLE LIMITS ON THE BURST DISC (241 +16 PSID IN THE FLOW DIRECTION AND 10 PSID IN THE REVERSE DIRECTION) COULD BE EXCEEDED. TO ALLOW EARLY DETECTION OF ANY SIMILAR PROBLEM IN THE FUTURE, A LEAK CHECK OF THE BURST DISC HAS BEEN ADDED AFTER REACTION CONTROL SYSTEM PROPELLANT SERVICING.

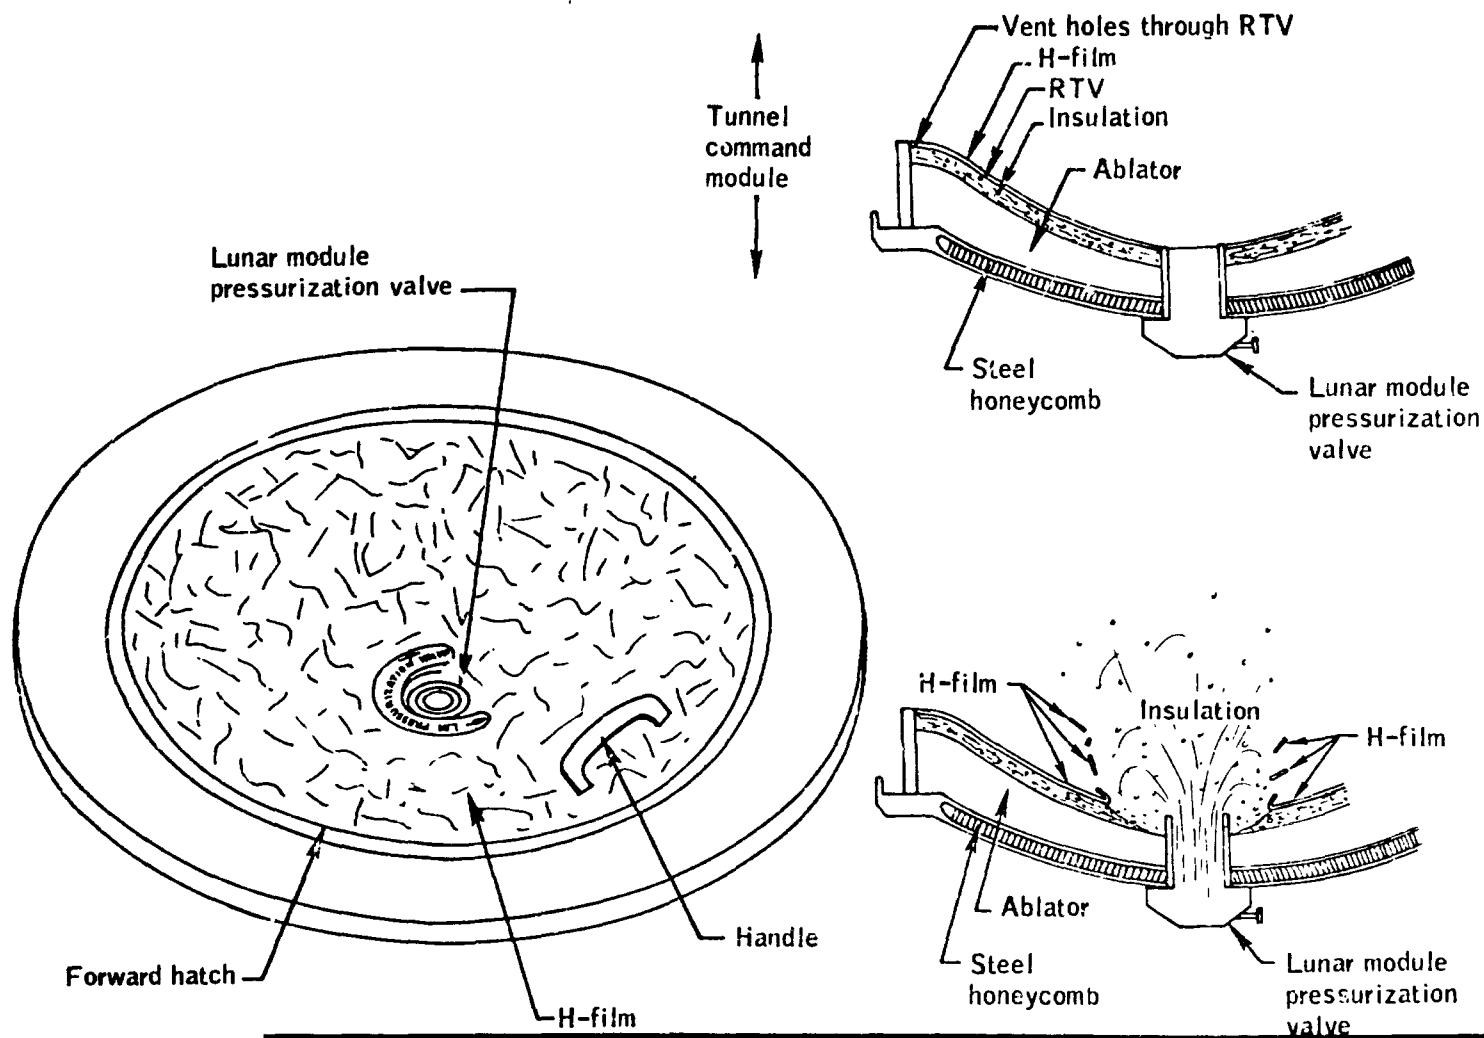
FIG. 2.2.6-1 FORWARD HATCH THERMAL COATING.

PROBLEM: WHEN THE LUNAR MODULE CABIN WAS FIRST PRESSURIZED THE THERMAL COATING ON THE COMMAND MODULE HATCH CAME OFF IN PIECES. THE INSULATION BLANKET VENT HOLES WERE PLUGGED, PRODUCING THE DAMAGE. ONE POSSIBILITY IS THAT THE PREFLIGHT BAKING OF THE HATCH AT 900°F FOR 15 HOURS WEAKENED THE INSULATION TO THE EXTENT THAT INTERNAL PIECES OF INSULATION BROKE LOOSE AND PLUGGED THE HOLES DURING TUNNEL DEPRESSURIZATION. ANOTHER POSSIBILITY IS THAT THE VENT HOLES WERE INADVERTENTLY SEALED WHEN THE INSULATION BLANKET WAS POTTED WITH RTV OR WHEN THE H-FILM TAPE WAS INSTALLED ON THE HATCH SURFACE.

ACTION: ON THE APOLLO 11 COMMAND MODULE, THE INSULATION HAS BEEN DELETED BECAUSE OF THE EFFECTS NOTED AND BECAUSE A REEVALUATION OF THERMAL CONDITIONS HAS SHOWN THAT THE INSULATION IS NOT NECESSARY. HOWEVER, TO MINIMIZE CONDENSATION, A SINGLE LAYER OF H-FILM TAPE HAS BEEN APPLIED OVER THE EXTERIOR SURFACE OF THE HATCH ABLATOR. SOME WATER AND ICE CAN BE EXPECTED ON APOLLO 11 BUT TO A LESSER DEGREE THAN OBSERVED ON APOLLO 10.

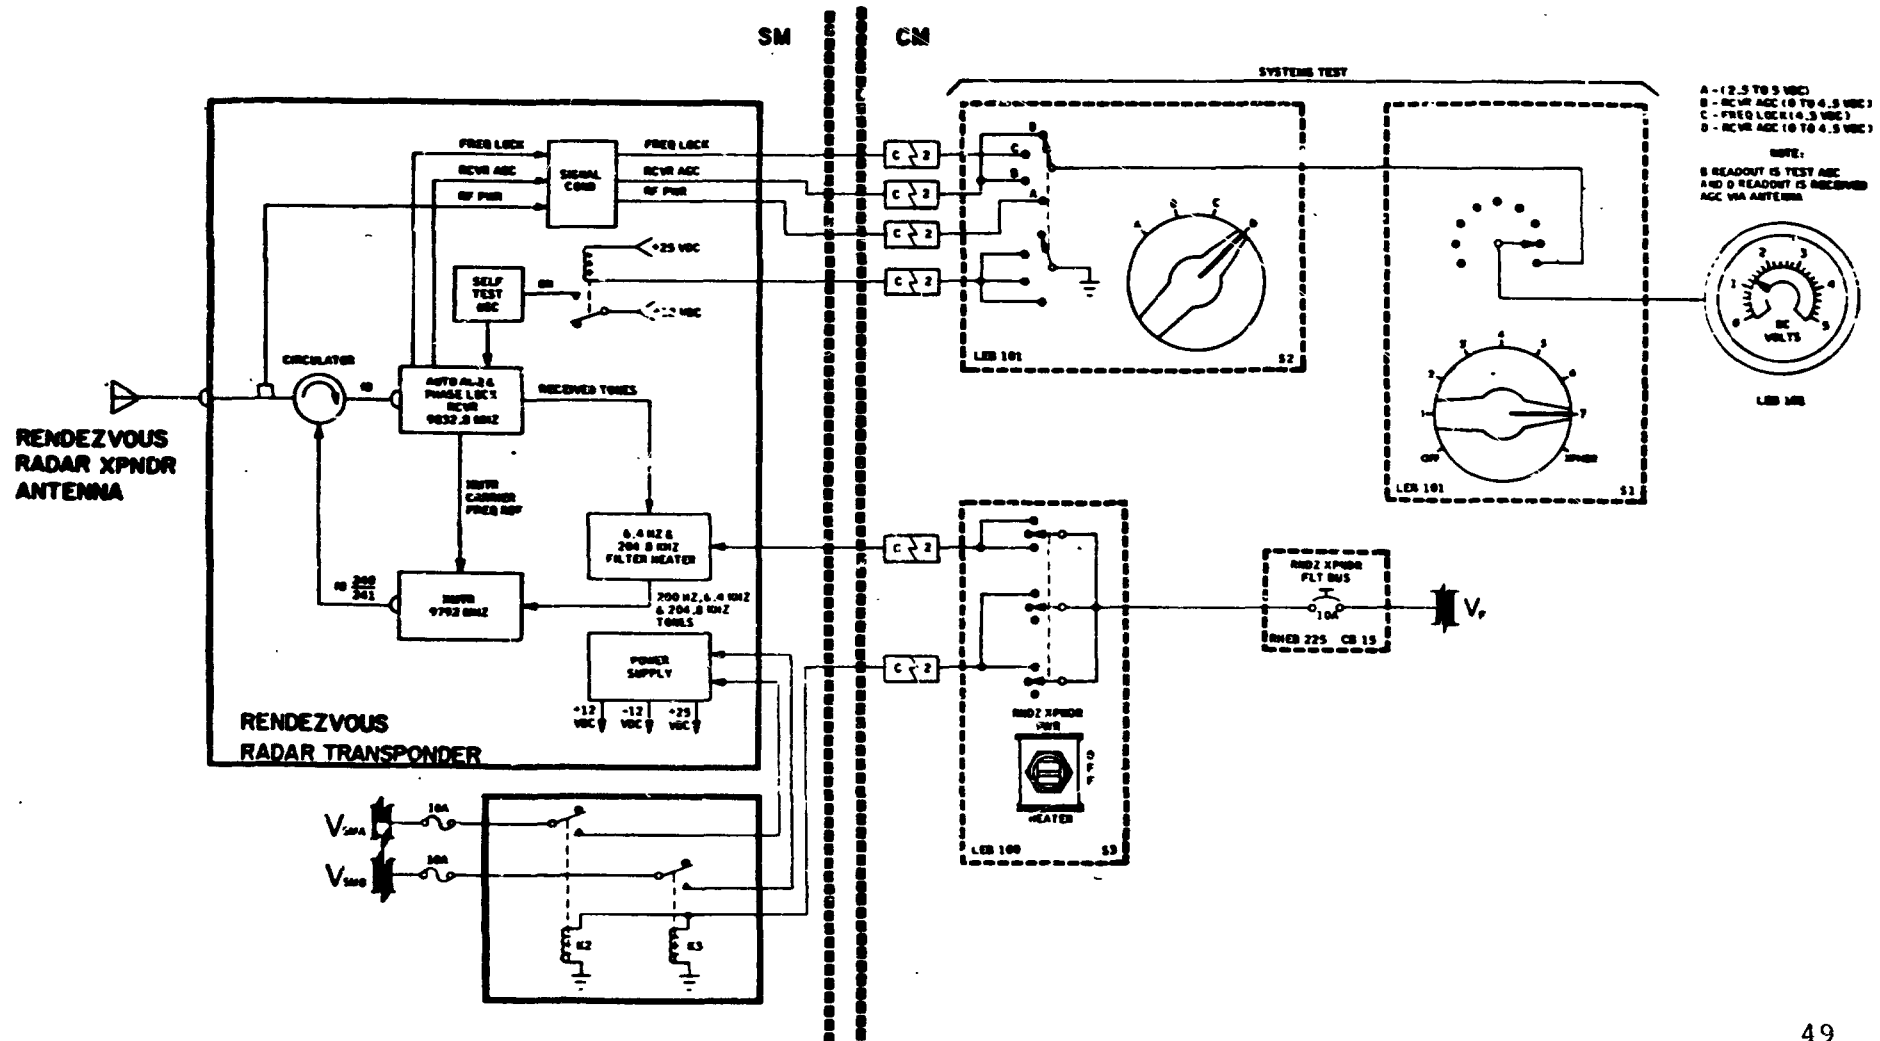
FIGURE 2.2.9-1 RENDEZVOUS RADAR TRANSPONDER CONTROL CIRCUITRY

ACTION: DURING POSTFLIGHT TESTS OF THE SWITCH AND WIRING, NO DEFECTS WERE FOUND, AND THE ANOMALY CANNOT BE ATTRIBUTED TO ANY CM HARDWARE.

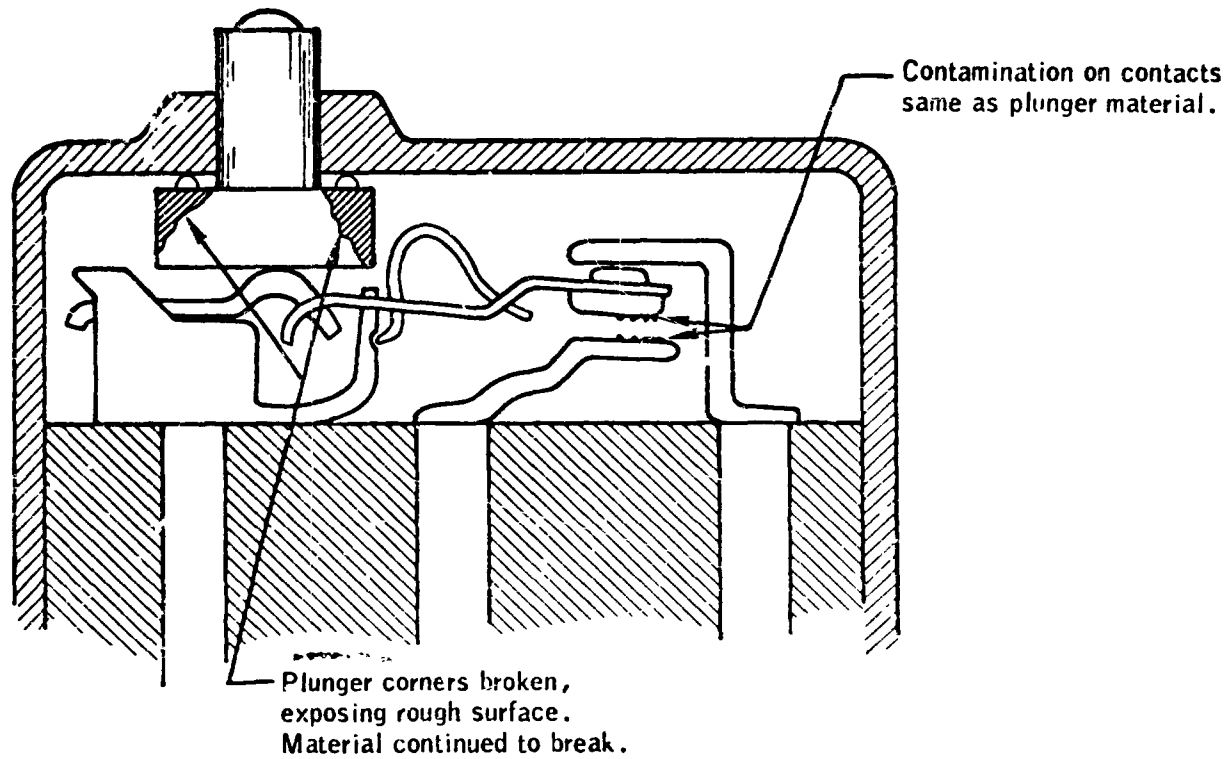
FIG. 2.2.10-1 MAGAZINE INTERLOCK SWITCH.

PROBLEM: AT APPROXIMATELY 173 HOURS, DURING TRANSEARTH COAST, THE COMMAND MODULE 16-MM CAMERA CEASED TO OPERATE IN THE PULSE MODE BECAUSE THE MAGAZINE INTERLOCK MICROSWITCH FAILED. THE SWITCH WAS NOT A HIGH RELIABILITY ITEM AND FAILED BECAUSE OF INTERNAL CONTAMINATION AND A FAULTY PLUNGER.
