APOLLO 11 MISSION REPORT

MANNED SPACECRAFT CENTER  
HOUSTON, TEXAS  
NOVEMBER 1969

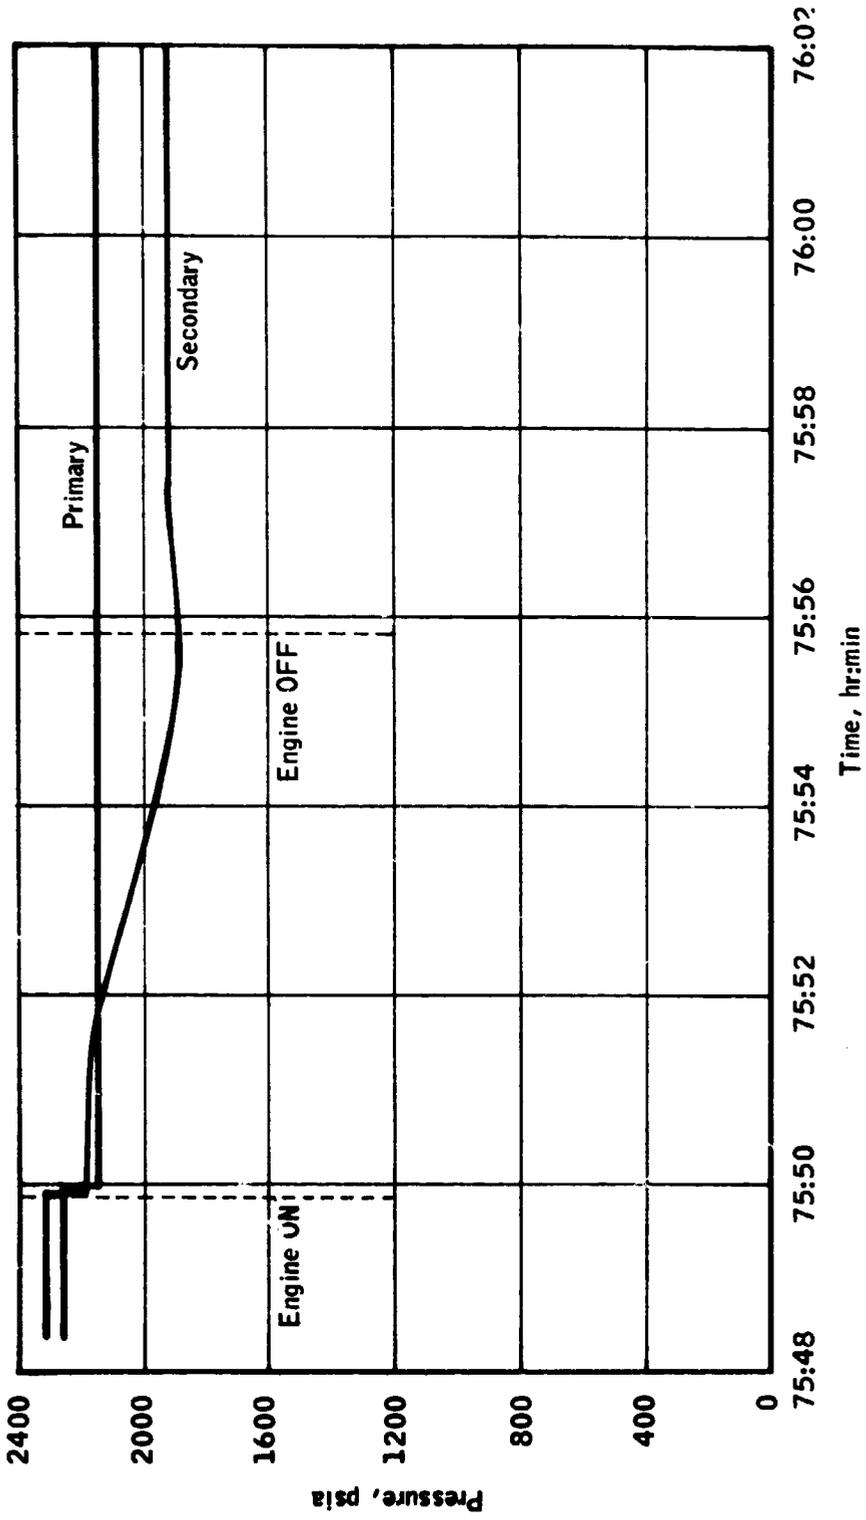
Figure 16-1.- Nitrogen pressure during initial lunar orbit insertion firing.

An abnormal decay in the secondary (system B) nitrogen pressure was observed during the lunar orbit insertion service propulsion firing, indicating a leak in the system which operates the engine upper bipropellant valve bank. No further leakage was indicated during the remainder of the mission. This anomaly is discussed in greater detail in section 16.1.1.
