MSC-05101

APOLLO 14 MISSION  
ANOMALY REPORT NO. 1

FAILURE TO ACHIEVE DOCKING PROBE  
CAPTURE LATCH ENGAGEMENT

OCTOBER 1971

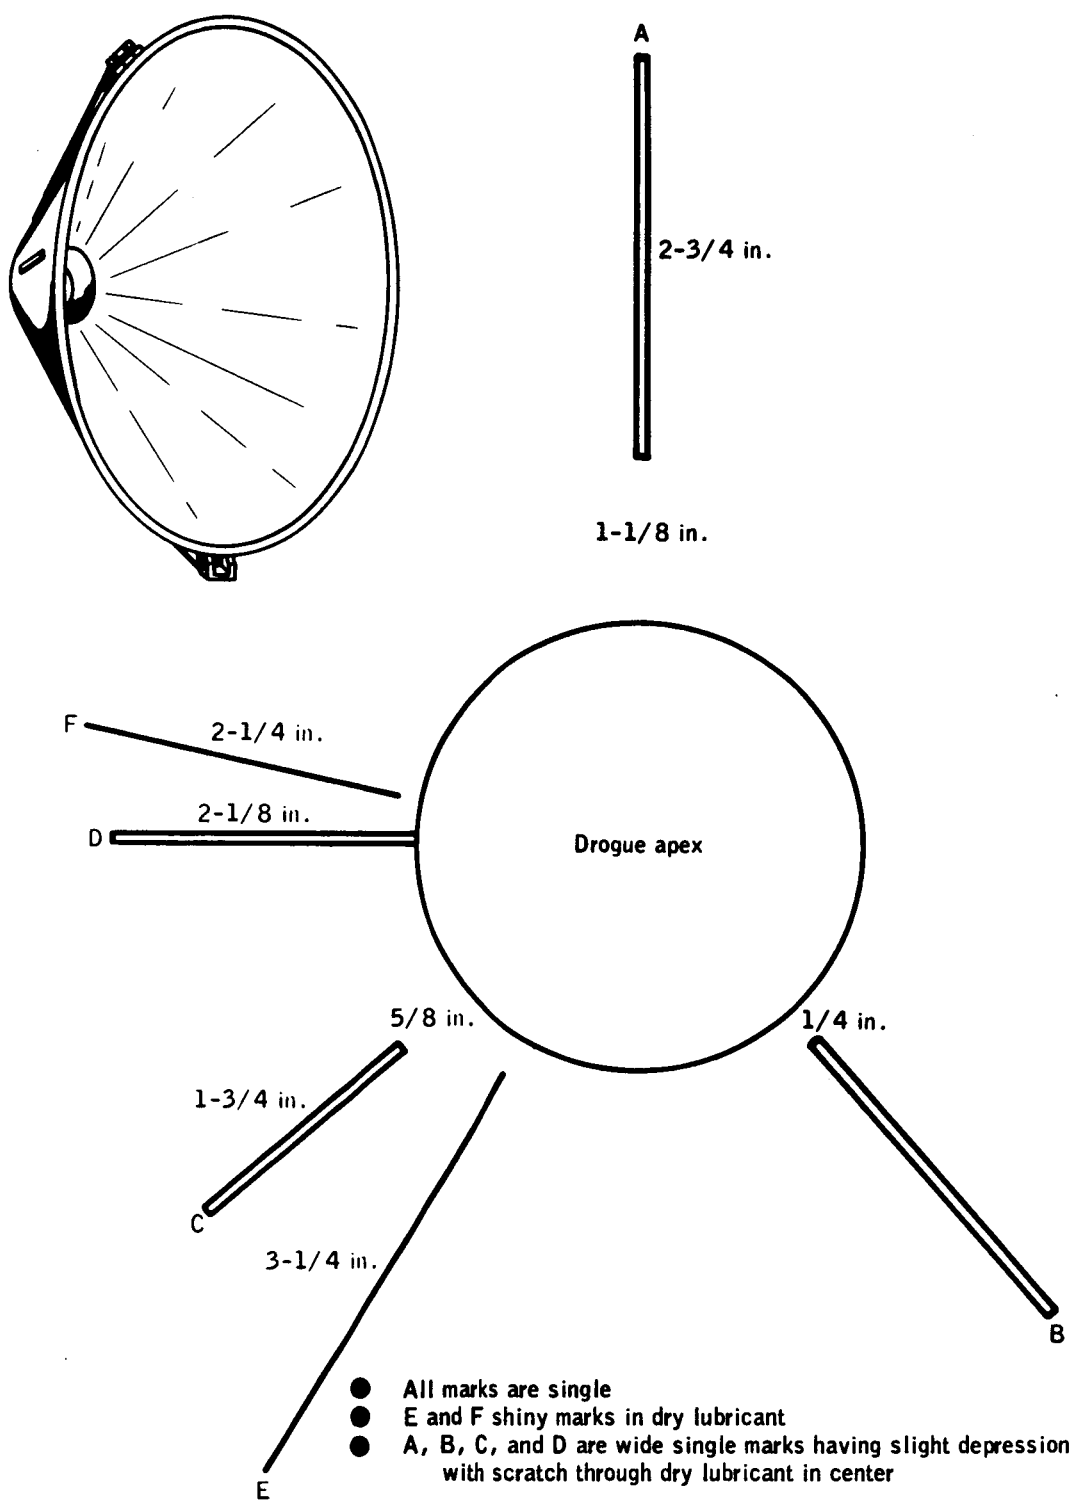
Figure 2.- Drogue assembly and location of radial marks.

2. The marks on the drogue noticed by the crew (fig. 2) indicate that capture latch hooks were cocked as they should have been during the docking attempts. This confirms the talkback indications at the time of the docking maneuver. Also, after the flight, a drogue that had been used in dynamic testing with multiple marks, scratches, dents, and tears in the face sheet skin was examined by the Command Module Pilot. The marks chosen by him to be most like those on the Apollo 14 drogue were caused by the capture latch hooks while operating normally (cocked position).

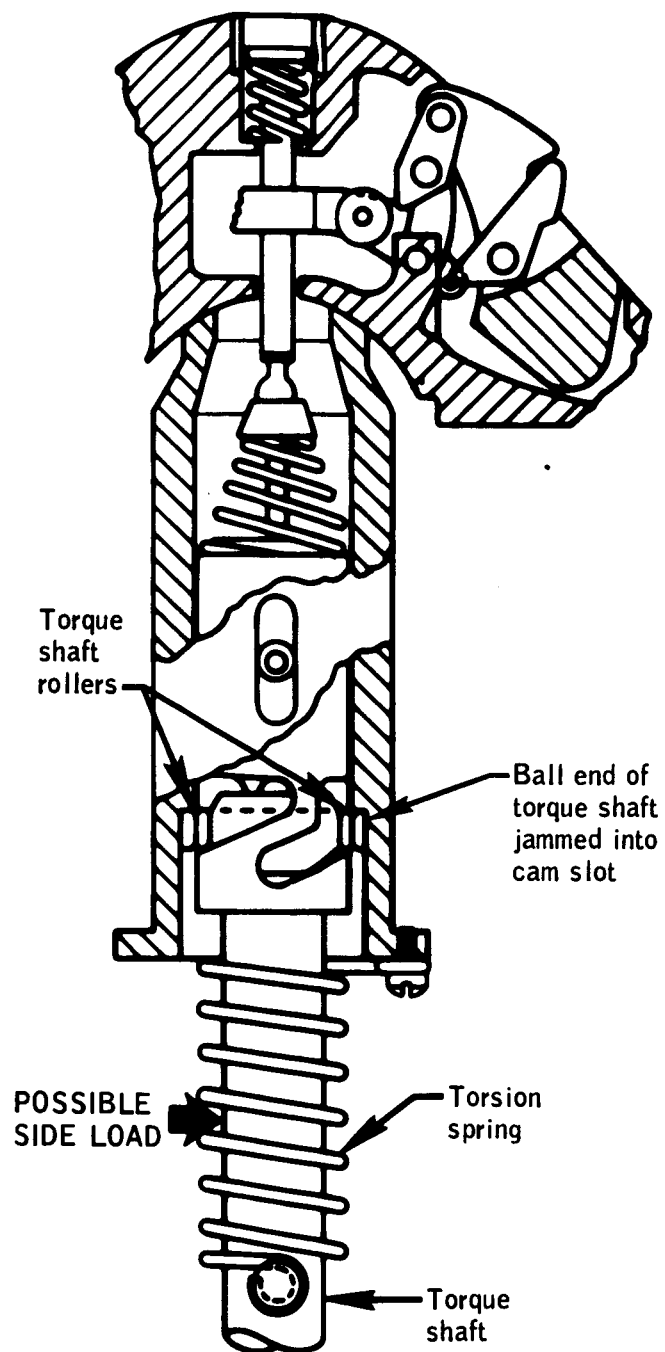
Figure 12.- Side load reaction on torque shaft operation.

The first possibility is that of a side load being introduced into the torque shaft (fig. 12) by the torsion spring or by other means; this may cause the ball end of the torque shaft to bind against the cam. This failure occurred on another probe during acceptance tests and it was possible to demonstrate this same failure on the Apollo 14 probe by applying a side load, but the failure did not occur consistently.

1. The probe translation-cam assembly (fig. 15) was modified to eliminate possible binding of the cam and spider.
  - a. The diameter of the ball machined on the forward end of the torque shaft was reduced.
  - b. The roller pin surface was machined to allow a rocking motion between the roller pin and hole in torque shaft.
  - c. A spherical surface was provided on the roller ends and roller pin ends for improved clearance.
  - d. An alignment bushing was added to insure proper torque shaft alignment.
2. A requirement was added to test the probe in the horizontal as well as vertical position during the capture latch timing test of the acceptance testing.
3. Capture latch timing tests were added just prior to the countdown demonstration test for the latest possible verification of latch operation in the spacecraft checkout flow.

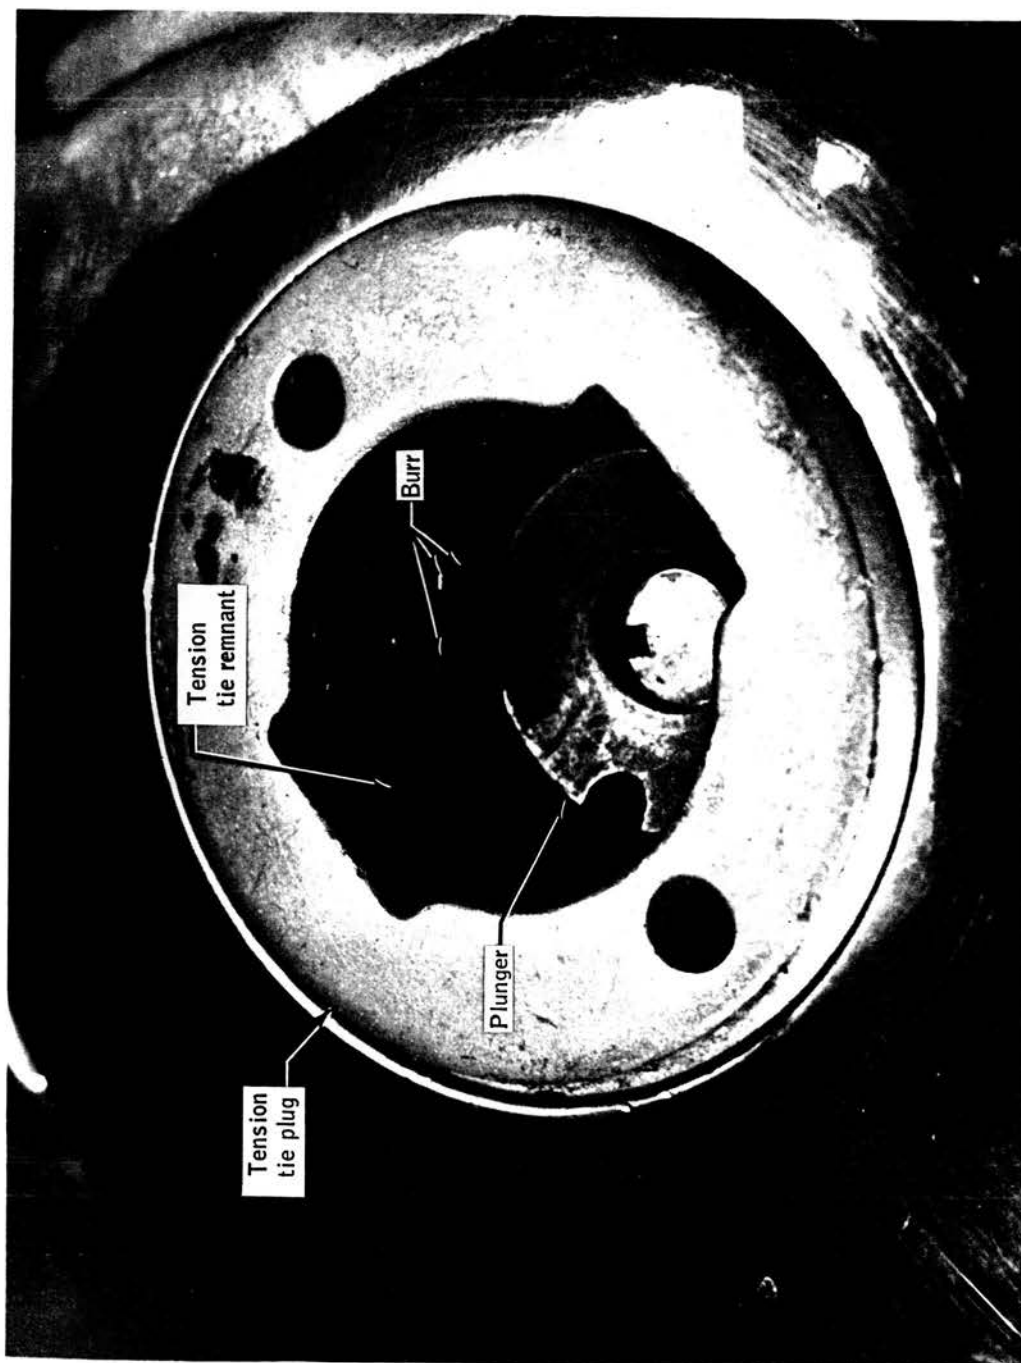
Figure 13.- Scratches and burrs adjacent to capture latch plunger.

The second possibility is that some small foreign material may have been lodged in the probe in a manner that prevented operation of the mechanism. Burrs from an unknown source were discovered in the bore of the tension-tie plug (fig. 13). A foreign particle might have been lodged between the plunger and the plug and may have caused the problem.

During disassembly of the probe, 12 contaminant particles were found. Three materials foreign to the probe were: Iron oxide, double-back tape, and cadmium particles. The largest of the 12 particles was 0.060-inch long. Of the particles which were large enough to cause mechanical interference none were strong enough to restrict the operations of the mechanism.

1. A removable cover was provided for the probe head. The cover will be installed at the completion of acceptance testing and remain in place until the tension-tie assembly is installed at the launch complex. It will be removed only when the probe is being tested.
2. Cleanliness requirements for all ground support equipment mating with the probe have been implemented.
3. Use of cleaners or primers when potting the tension tie nut during installation has been prohibited.
4. Shear pin remnants in the tension tie have been safety wired, and the potting holding the shear pins in place has been removed (fig. 14).
