## APOLLO 15 MAIN-PARACHUTE FAILURE

By Donald D. Arabian and Joseph E. Mechelay\*

### ABSTRACT

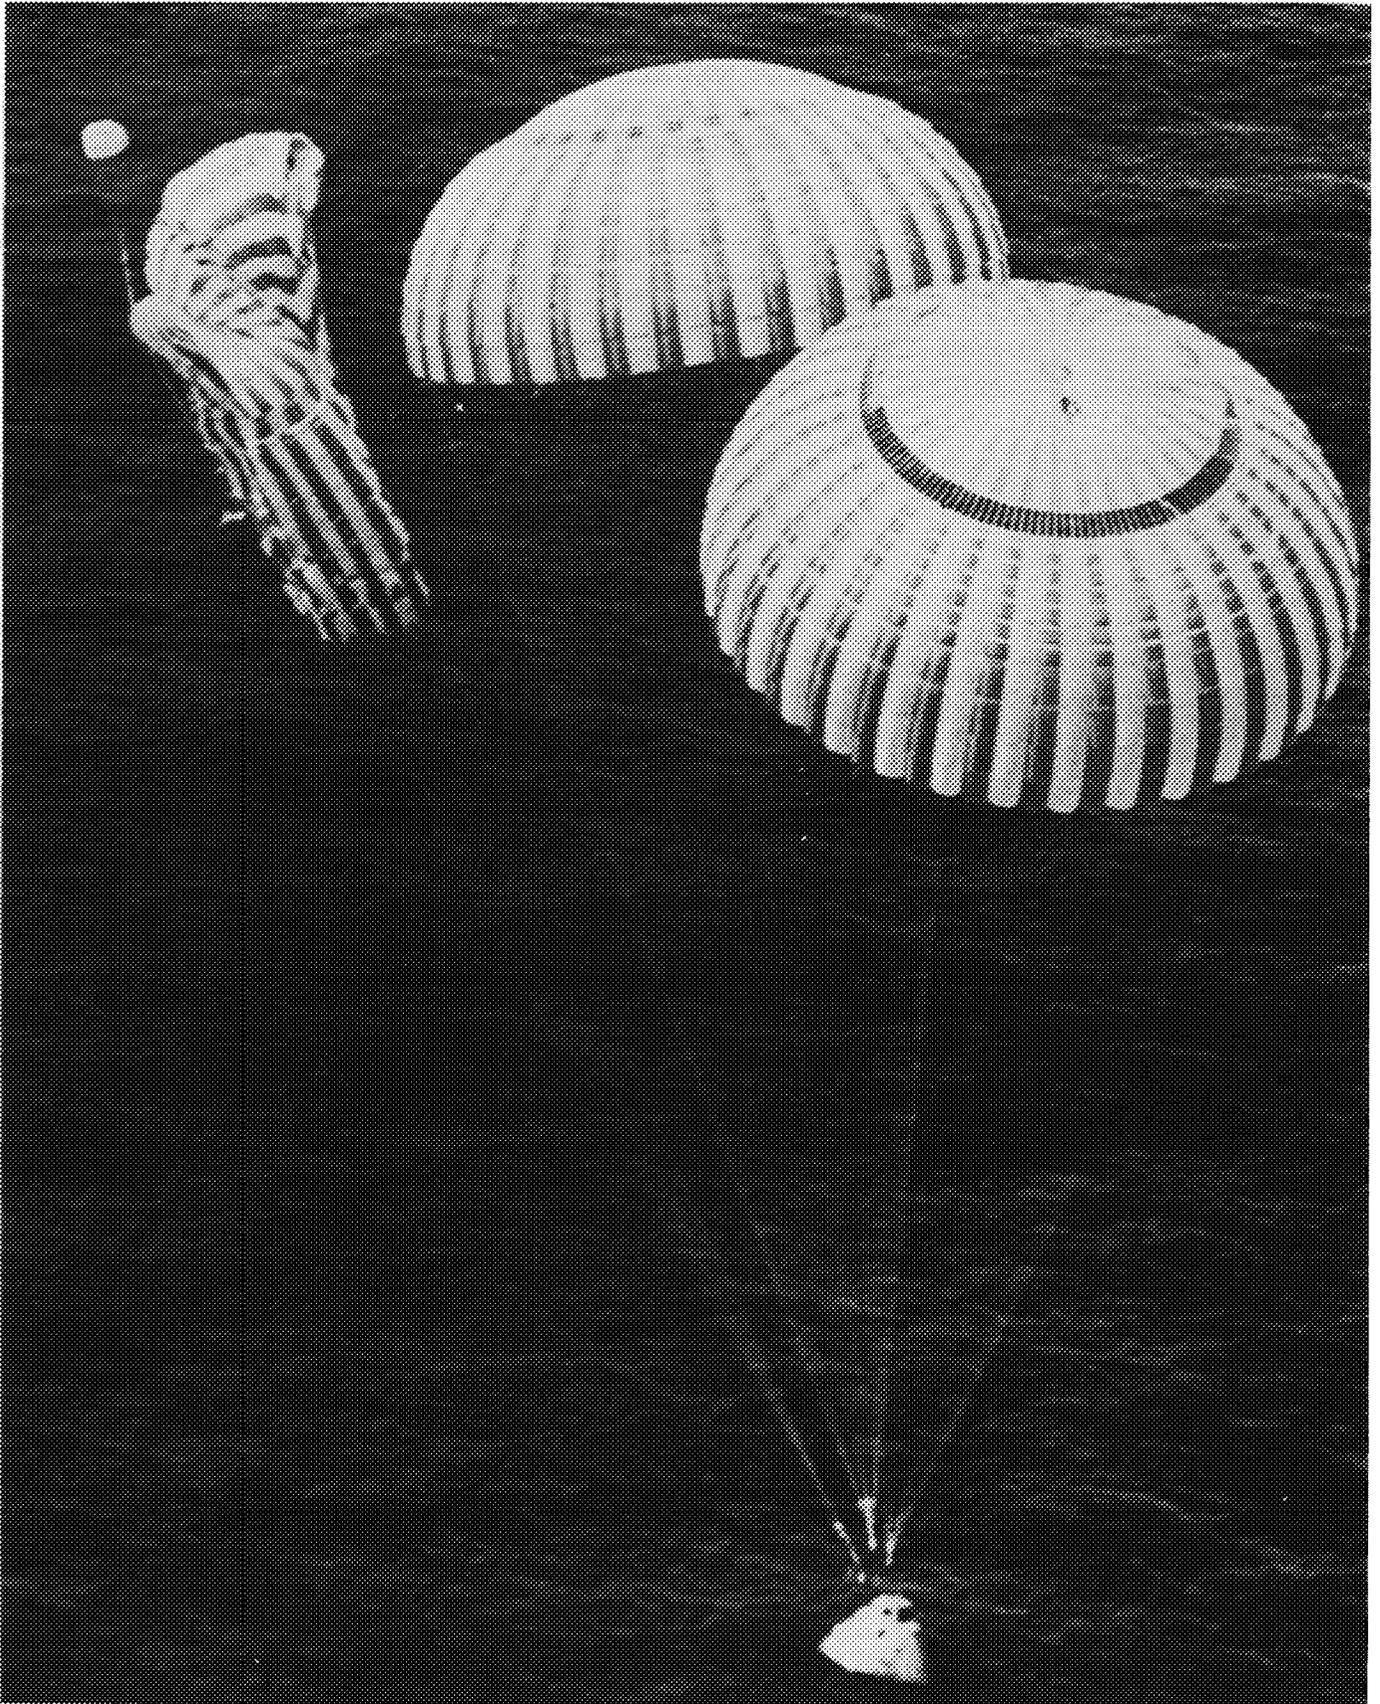
The three main parachutes of the Apollo 15 spacecraft deployed and inflated properly at approximately 3050 meters altitude. Films show that all three parachutes disreefed and opened fully in the proper sequence. The spacecraft and its parachutes were obscured by clouds at approximately 2135 meters altitude. On emerging from the clouds at approximately 1825 meters altitude, one of the three main parachutes was deflated,

as shown in figure 1. The spacecraft and parachute system descended in this configuration to water landing. The three parachutes were disconnected and one of the good main parachutes was recovered.

1. Three of the risers are taking the load.
2. There is no evidence of flailing suspension lines.
3. Two of the damaged riser lines appear to be full length.
4. Approximately two-thirds of the suspension system appears to be missing.
5. No significant canopy damage is visible.

Figure 1. - Spacecraft descending with one main parachute failed.

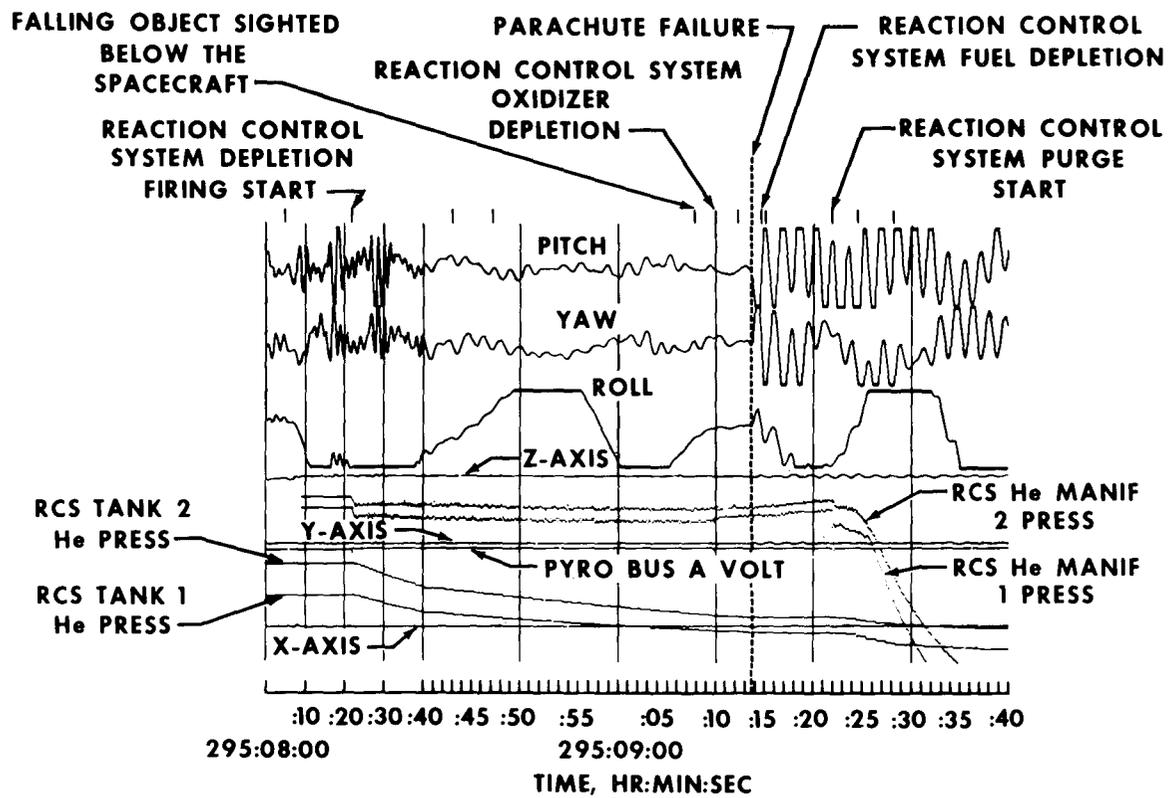
The initial efforts of the investigation team were concentrated on accumulating and assessing the spacecraft data, evaluating the photographic and television coverage, and inspecting the recovered parachute and the forward heat shield. The spacecraft data and the associated events are shown in figure 2. The time of the anomaly was determined from the X, Y, and Z accelerometer data and the associated rapid rate changes. The data show that the command module reaction control system depletion firing was completed approximately 3.5 seconds before the anomaly, as determined from an abrupt rise in the reaction control system manifold pressure. This change occurs when the pressure regulators abruptly close, as a result of the reaction control system tank bladders being collapsed. The completion time of the fuel (monomethyl hydrazine) dump that follows the depletion firing was determined by calculating the amount of fuel remaining at the end of the depletion firing (approximately 2.72 kilograms, using the known flow rate of the fuel through the engines). The 4.7-second duration of the fuel dump overlaps the time of the anomaly occurrence. The start of the reaction control system purge occurred 8.3 seconds after the anomaly, as determined from the spike in the pyrotechnic bus voltage and the immediate decreases in the reaction control system pressures.

According to these results, two connector links must fail simultaneously to satisfy the abrupt load change calculated from the data of figure 2. It is highly unlikely that this situation occurred because of the low-load condition at the time of failure (35 percent of the opening shock load). Assuming that the collapsed parachute did have two failed links, load still would have been carried by the fractured links. This fact was demonstrated by testing of the recovered failed link in which the link withstood two complete mission load cycles.

Figure 2. - Sequence of events during descent on the main parachutes.

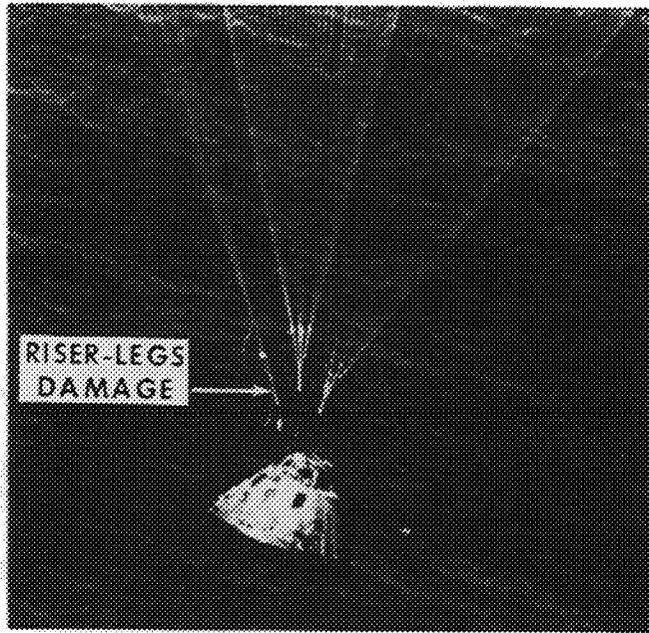
The two most significant items of photographic data obtained were the television tape, which indicated that the forward heat shield was in the vicinity of the spacecraft at the time of the anomaly, and the photographs shown in figures 1 and 3, which show the spacecraft parachute system damage when the spacecraft was relatively close to landing. The photographs show that

Figure 3. - Parachute-riser damage during final descent.

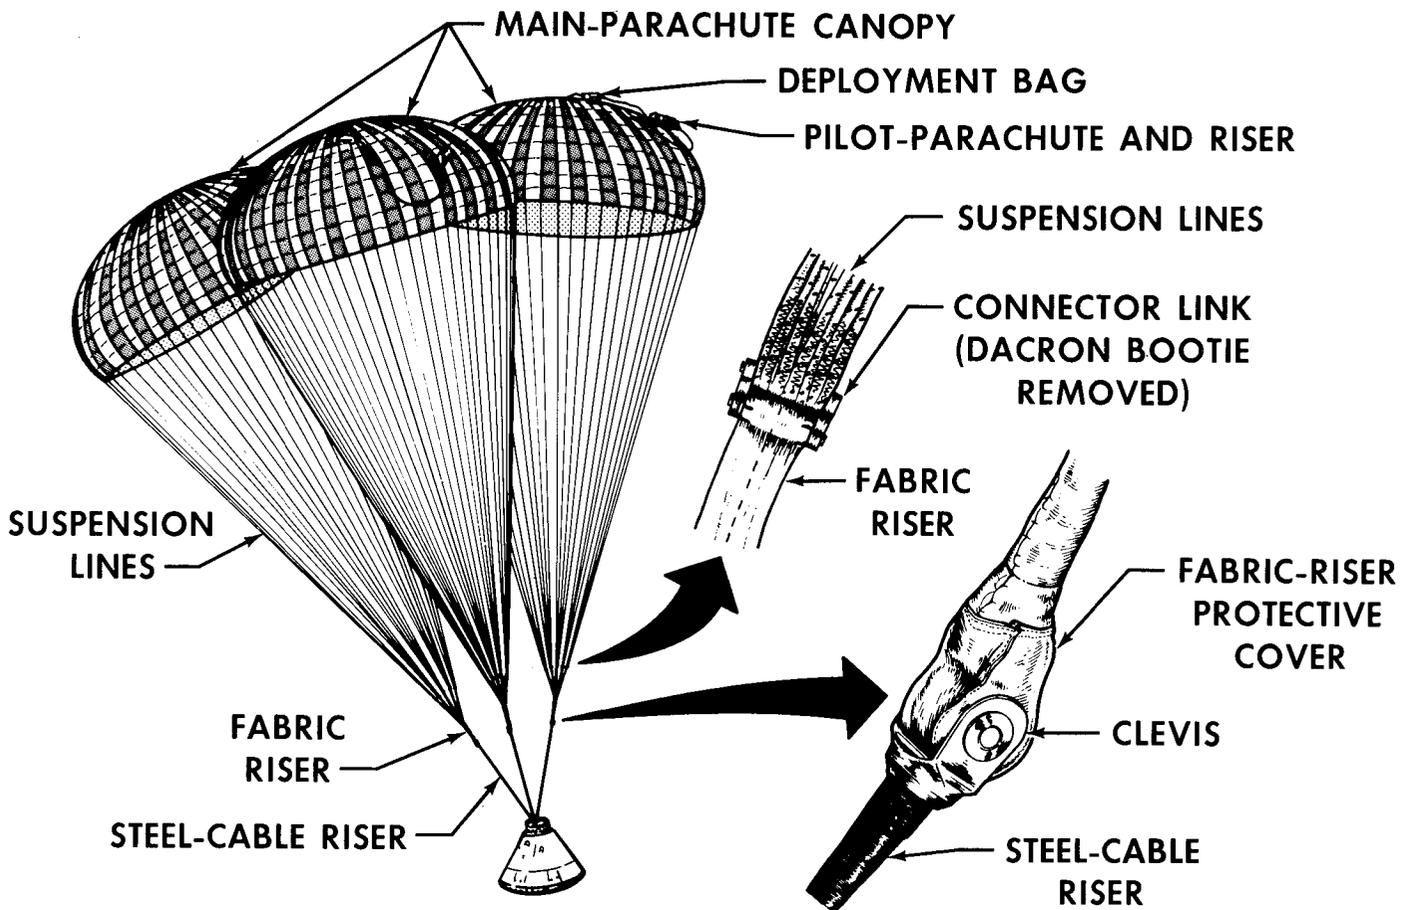
the recovered parachute showed only that it was not the one that had collapsed. Approximately 1 week after the first inspection, a second inspection was conducted, and a broken riser/suspension-line connector link was found after the Dacron bootie that protected it had been removed. Two to 3 weeks later, a closer examination of the Dacron riser protective cover (fig. 4) and the Dacron connector-link booties showed evidence of heat.

Figure 4. - Parachute system configuration.

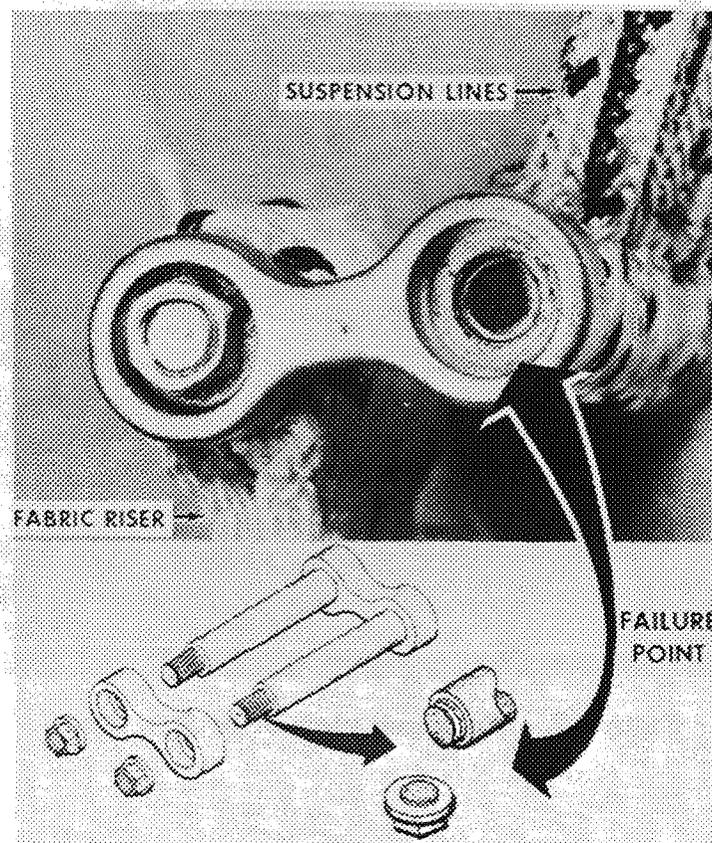
The discovery of the failed link on the recovered parachute (fig. 6) resulted in an extension of the investigation in order to identify the process that caused the connector link to fail and to determine if such a failure could have occurred and resulted in the parachute failure observed during the Apollo 15 landing. Microscopic inspection of the broken stud (fig. 7) indicated that stress corrosion or hydrogen embrittlement may have caused the link failure, or that it may have been caused by some other indeterminate means. The material used in the studs (4130 steel alloy) is susceptible to cracking when it is highly stressed and immersed in salt water. This process can cause stress corrosion. Hydrogen embrittlement can occur in the plating operation during the manufacturing process. The plating produces hydrogen that causes the embrittlement if the subsequent heat treating is improper.

Tests were performed on the connector links in an attempt to determine if either stress corrosion or hydrogen embrittlement was the process that caused the link failure. These tests included sustained-load tests to determine if hydrogen embrittlement was present; stress-corrosion tests to determine if salt-water corrosion could have induced the failure; over-torque tests of the studs to determine if tolerance buildup of stresses could have caused the problem; and hypergolic propellant exposure to determine if propellant exposure could have caused the observed flaws. The results of the tests and the metallurgical examinations performed were inconclusive in isolating the failure mechanism.

The failure of a single connector link has little effect on the load-carrying capability of a parachute and was not the cause of the parachute collapse.

Figure 6. - Main-parachute connector-link failure.

Corrective actions for the reaction control system include landing with the propellants on board for a normal landing and biasing the propellant load to provide a slight excess of oxidizer. Thus, for the low-altitude abort land landing, burning the propellants when the parachutes are deployed will subject the parachutes to some acceptable oxidizer damage but will eliminate the dangerous burning-fuel conditions. The suspension-line connector-link material has been changed to Inconel 718 to eliminate the requirement for plating, and the link-stud threads are rolled rather than machined to improve the metallurgical properties of the material.

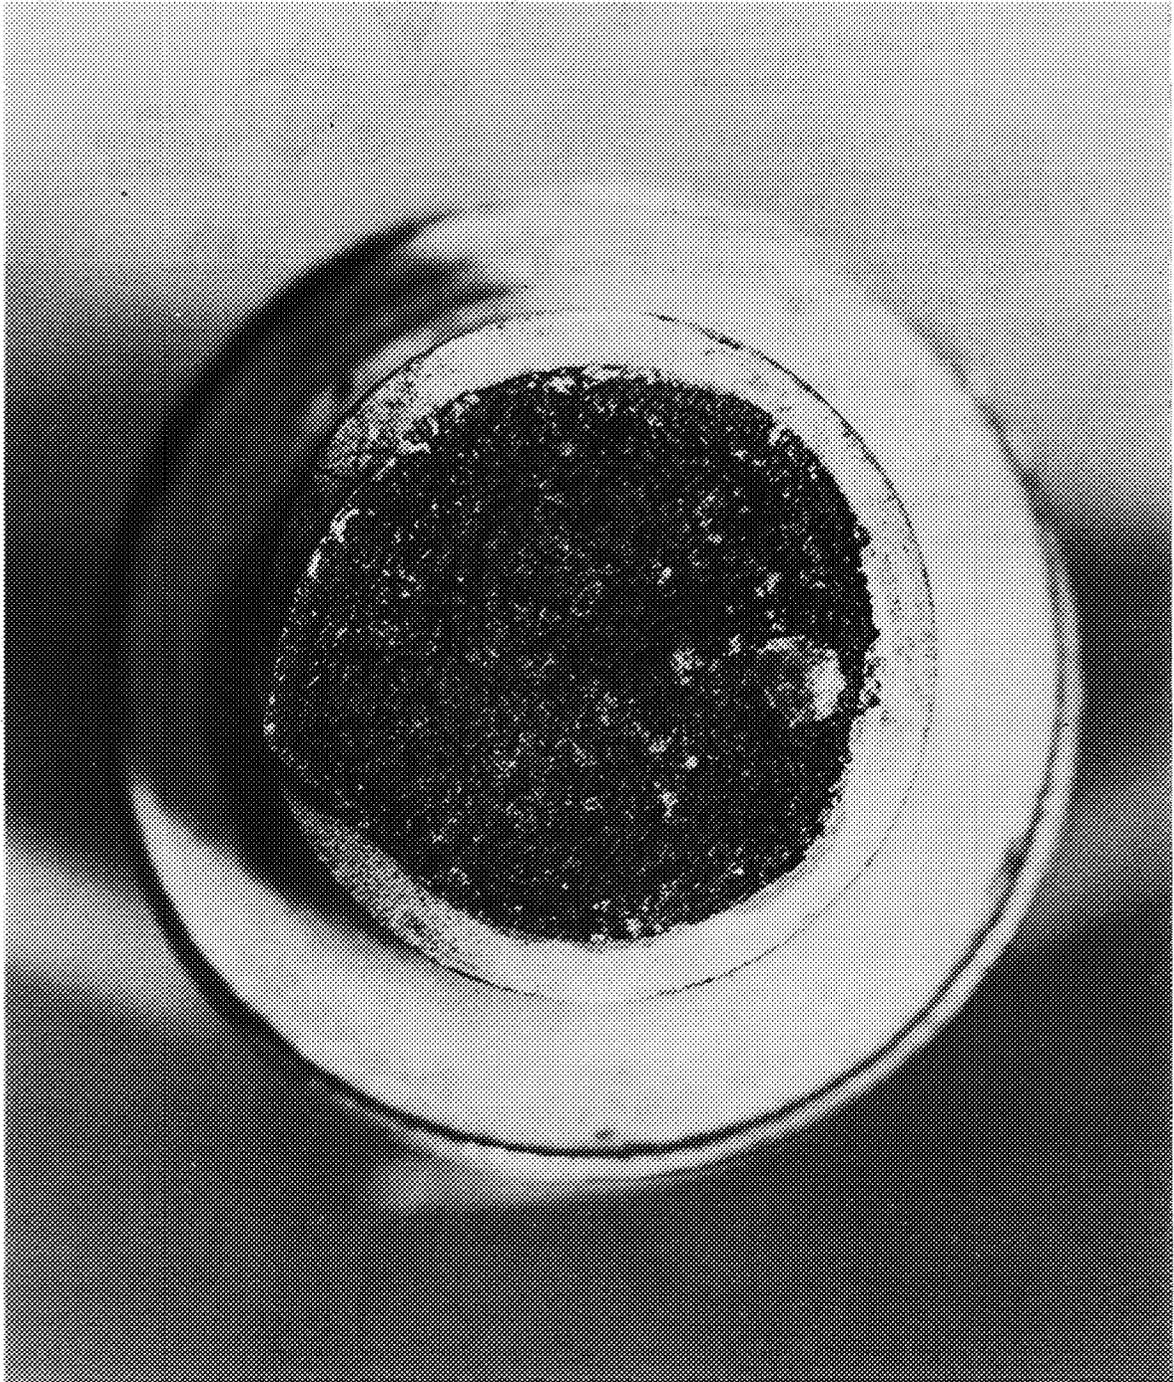
Figure 7. - Enlarged view of broken stud.
