**APOLLO 15 MISSION  
ANOMALY REPORT NO. 1  
MAIN PARACHUTE FAILURE**

(NASA-TM-X-6835C) APOLLO 15 MISSION MAIN  
PARACHUTE FAILURE Anomaly Report no. 1  
(NASA) Dec. 1971 32 p CSCL 22C

**MANNED SPACECRAFT CENTER  
HOUSTON, TEXAS  
DECEMBER 1971**

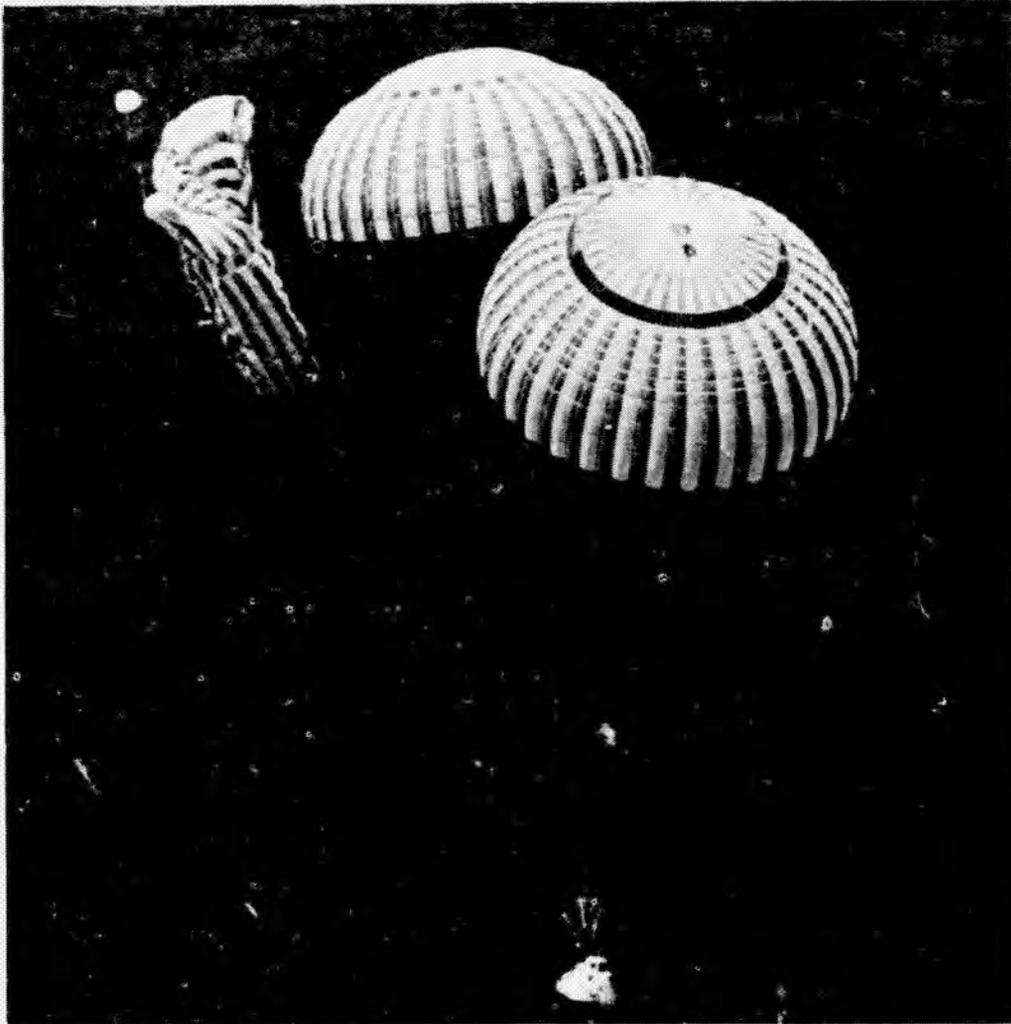
Figure 1.- Spacecraft descending with one main parachute failed.

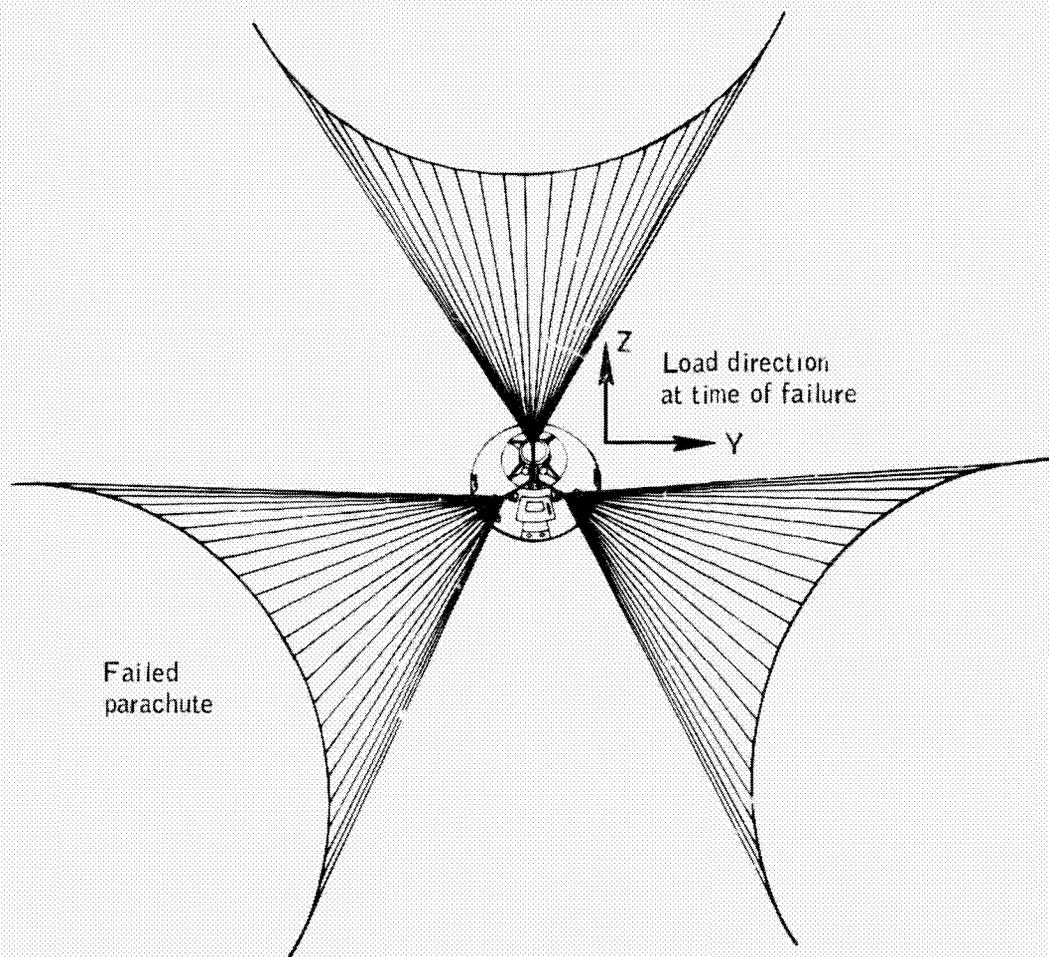
This resultant vector locates the failed parachute as shown in figure 4. The computed force vector was substantiated by body-mounted rate gyro data.

Figure 4.- Parachute location at time of failure.

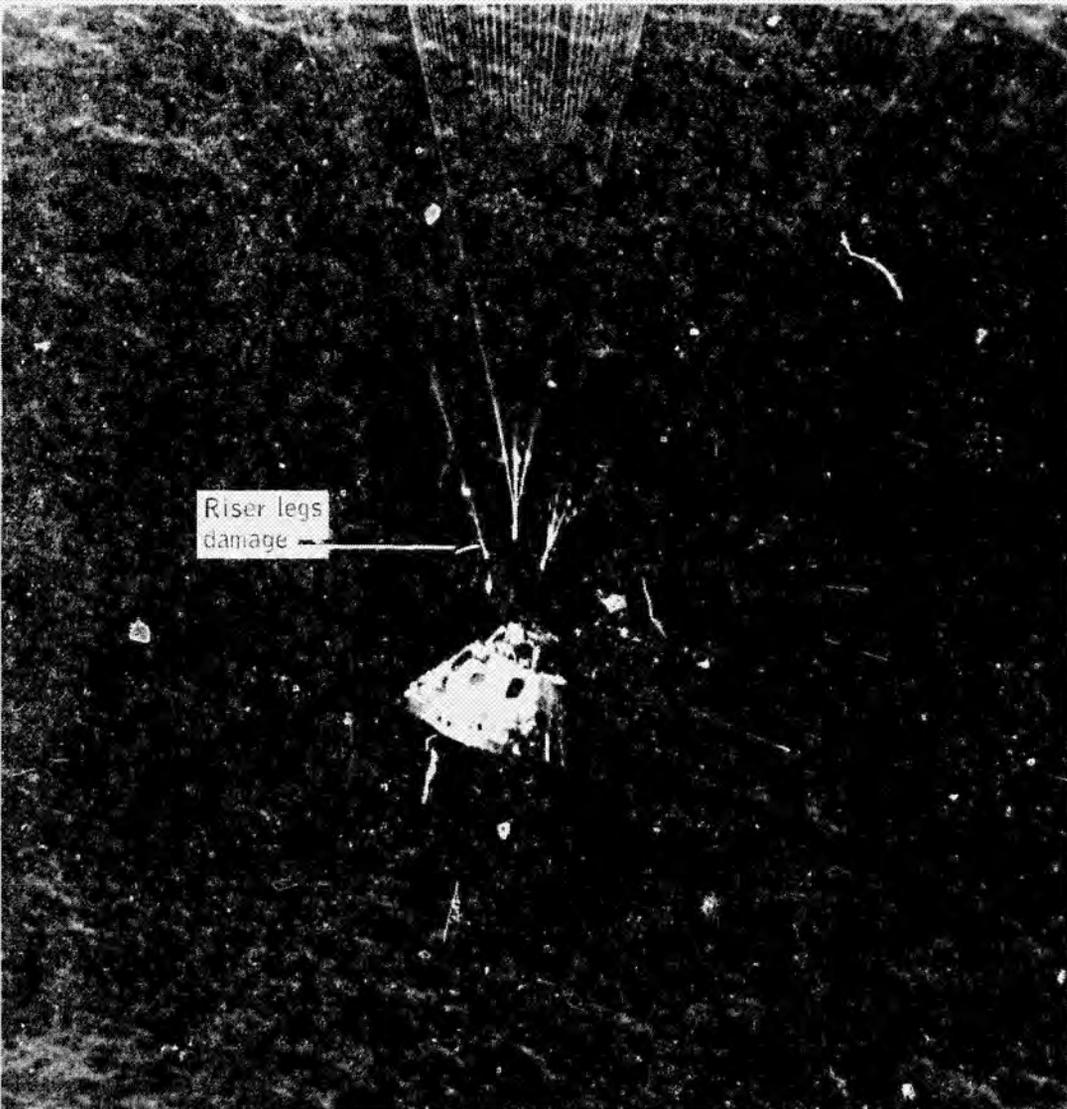
Figure 5.- Parachute riser damage during final descent.

- a. Apparently three of the six legs of the fabric riser were taking the load.
- b. There was no significant canopy damage observed.
- c. About two-thirds of the suspension lines appeared to be missing.

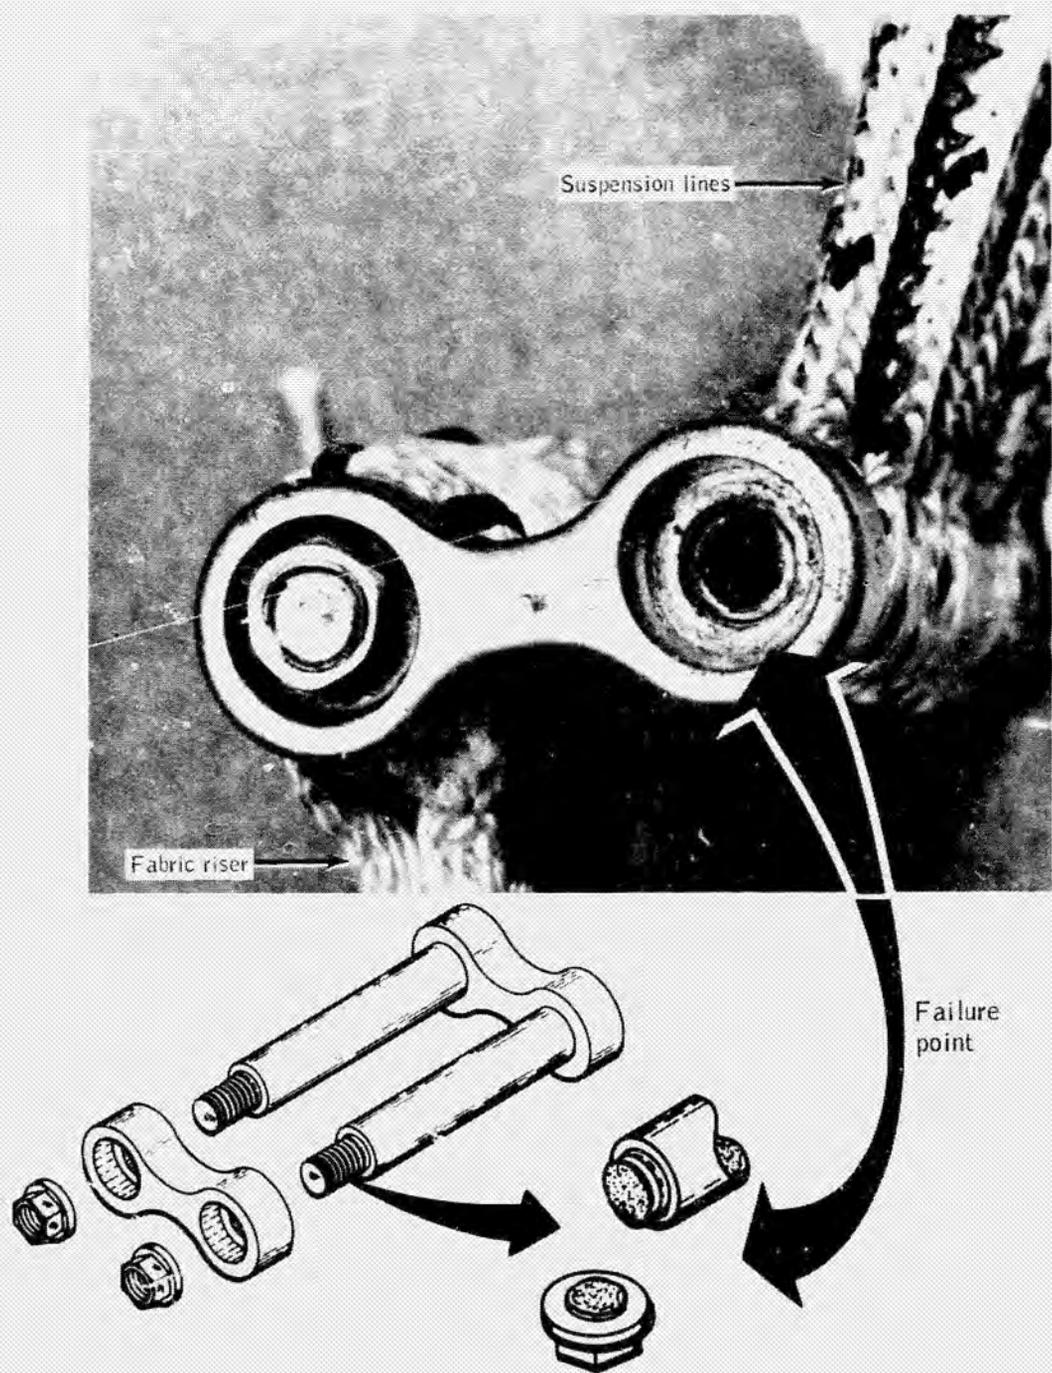
g. A broken riser/suspension-line connector link was found after the protective Dacron bootie had been removed (fig. 7).

Figure 7.- Main parachute connector link failure.

One stud in a connector link assembly on the Apollo 15 recovered parachute failed. The failure was caused by stress corrosion cracking, hydrogen embrittlement, or some unknown mechanism. Stress corrosion is a possible cause because the high-strength steel (4130) used in the links is susceptible at high stress levels to cracking in salt water. Hydrogen embrittlement is a possibility because of the susceptibility of the high-strength steel to cracking from dissolved hydrogen. Earlier in the Apollo program, studs which were not properly processed after plating failed because of hydrogen embrittlement.

e. The flaw observed in the recovered parachute connector link probably occurred after the plating operation, and could be due either to salt-water-induced stress corrosion or hydrogen embrittlement.

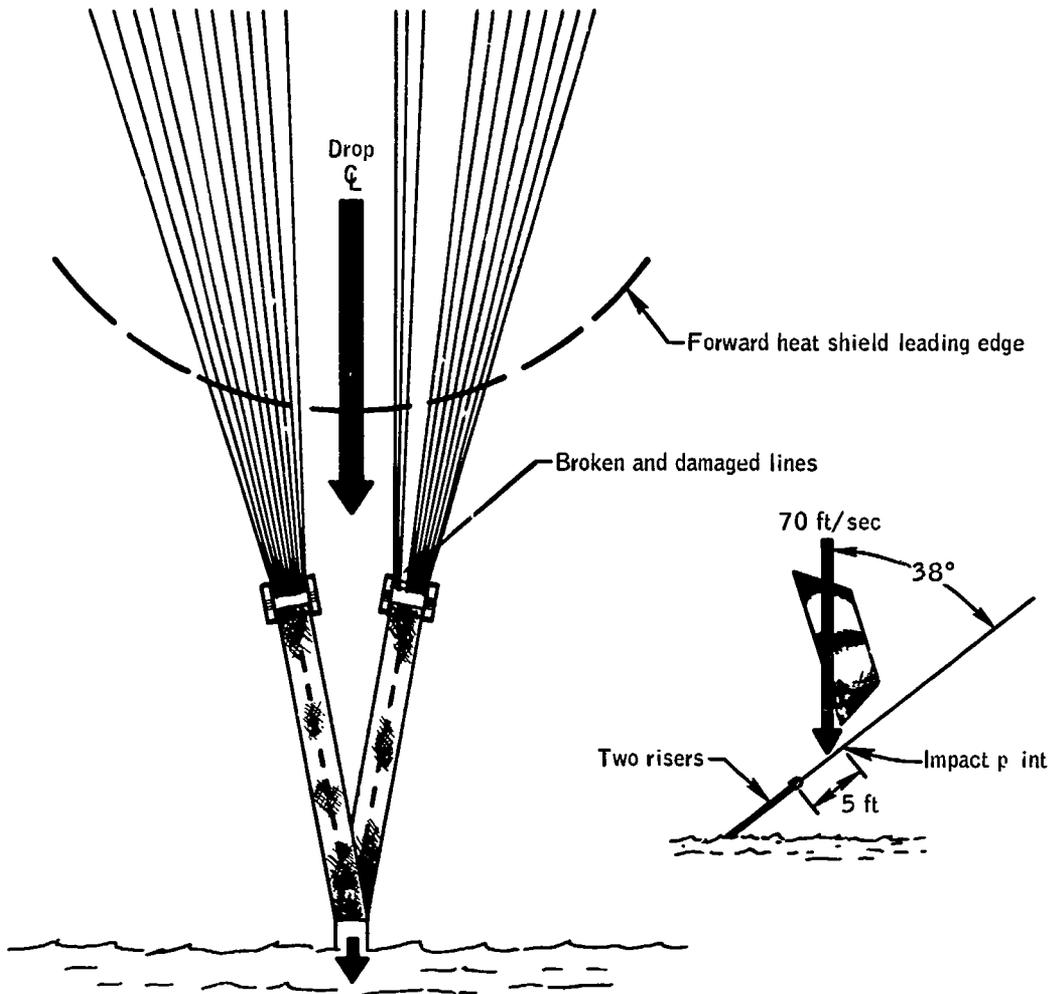
Forward heat shield/parachute suspension system impact tests.- Drop tests were conducted to determine the nature and extent of the damage to the main parachute suspension lines and fabric risers when impacted by a forward heat shield at simulated flight conditions. In tests of the parachute components, the risers and associated lines were mounted at the flight angle (38 degrees from vertical), with the lines correctly fanned and pre-tensioned (fig. 11). In the suspension line test, the forward heat shield impacted 5 feet above the connector links, striking all 22 of the lines used, breaking four, and damaging 10 others (fig. 11). The room-temperature vulcanizing material on the forward heat shield edge was cut and gouged where it struck the suspension lines.

Figure 11.- Results of forward heat shield/suspension system impact test.

These tests showed that the forward heat shield contacting the parachute could damage some of the suspension lines, but would probably not cause a loss of riser legs.

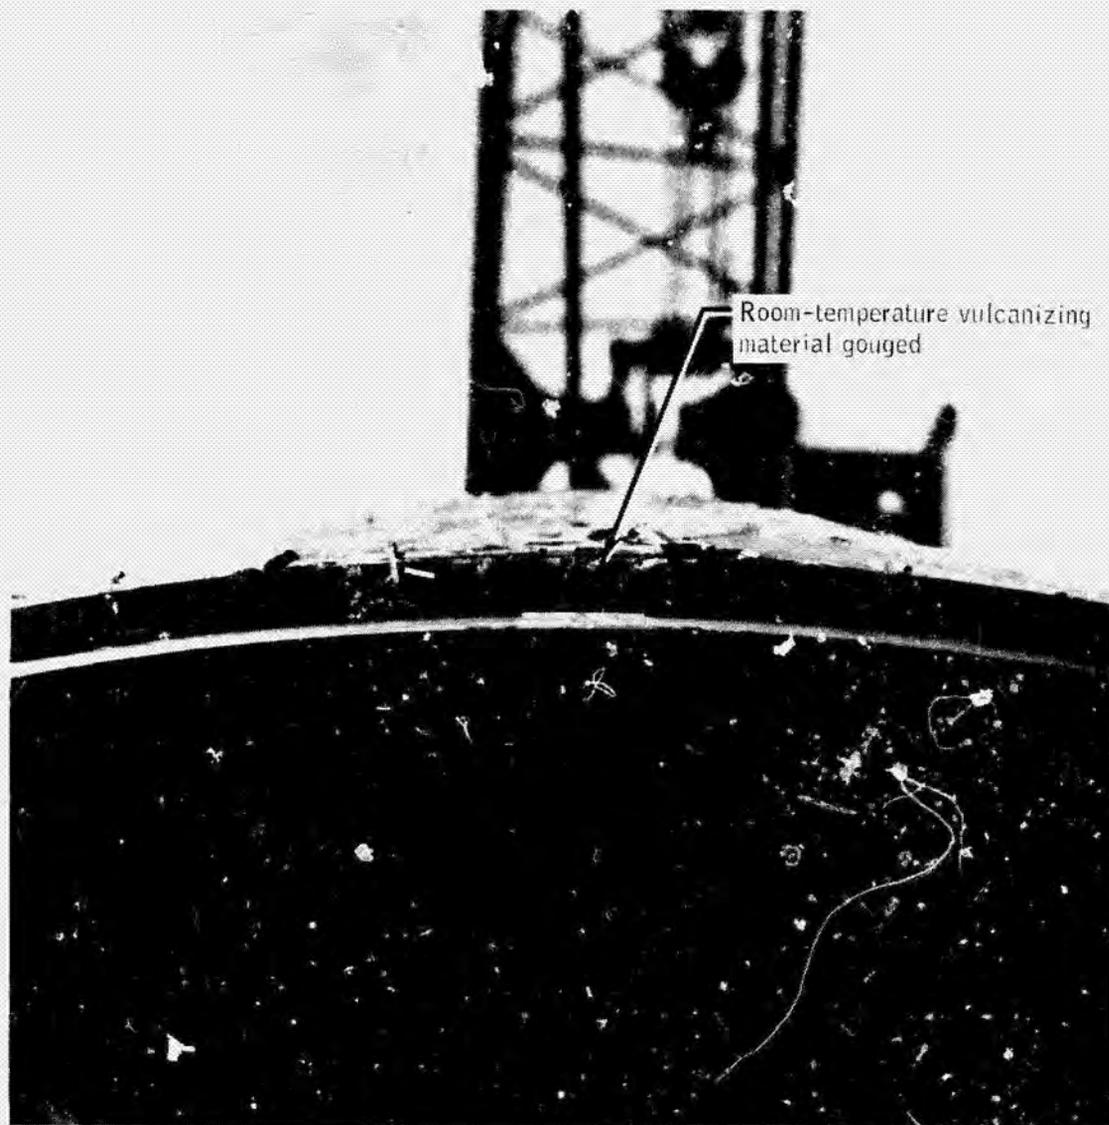
Two riser tests were made. In the first, the forward heat shield impacted 1-3/4 inches above the fabric confluence point, and in the second, the forward heat shield impacted near the center of the 42-inch riser legs. In both cases, the forward heat shield bounced off without damaging the risers. However, the room-temperature vulcanizing material on the leading edge of the forward heat shield was gouged (fig. 12).

Figure 12.- Forward heat shield damage.
