APOLLO 15 MISSION REPORT

MANNED SPACECRAFT CENTER  
HOUSTON, TEXAS  
DECEMBER 1971

Mission Evaluation Team

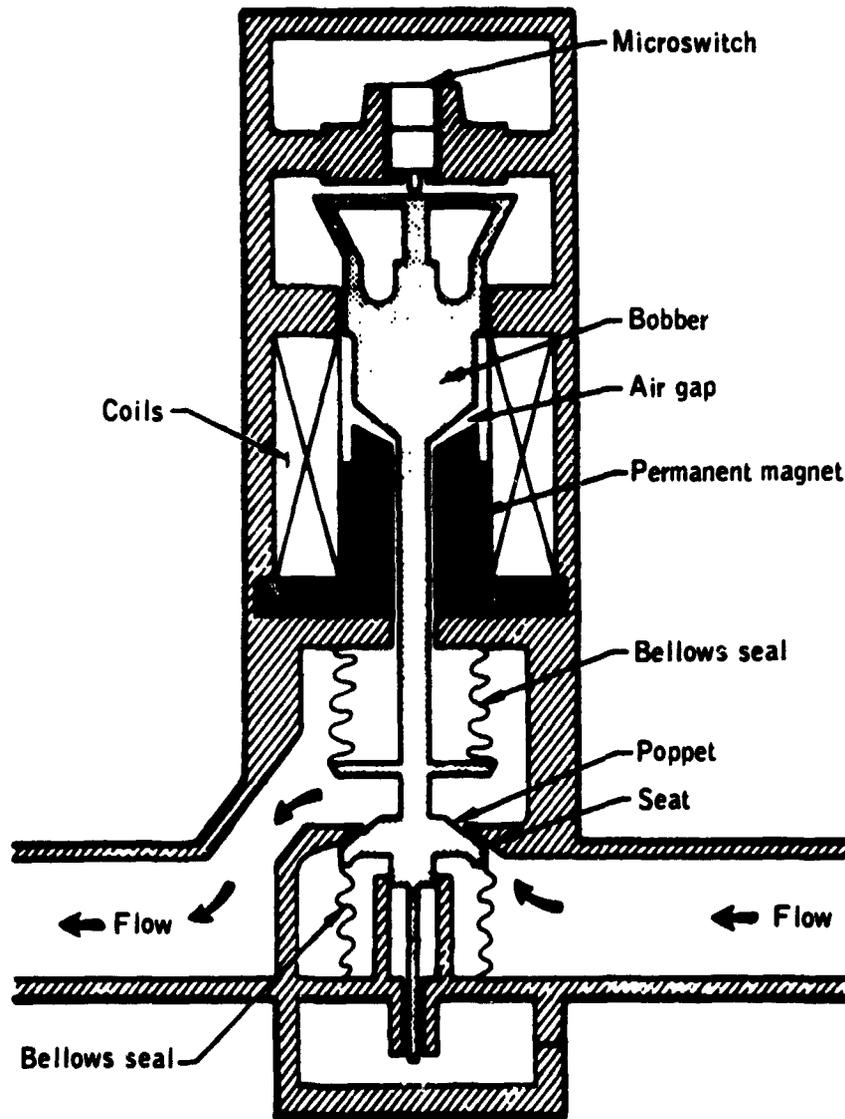
During acceptance testing of one valve for command and service module 117, the latching voltage had changed from approximately 13 volts to 3 volts. Additional testing of the spacecraft 117 valve verified the low voltage condition. Additionally, the valve stroke was proper, thereby eliminating contamination as a possible cause of the problem. During the test, the valve was disconnected from spacecraft power (28 volts) and was being supplied power through a variable power supply (approximately 20 volts, maximum, applied to the valve). The valve was most likely subjected to a reversed

Figure 14-1.- Cross section of reaction control system isolation valve.

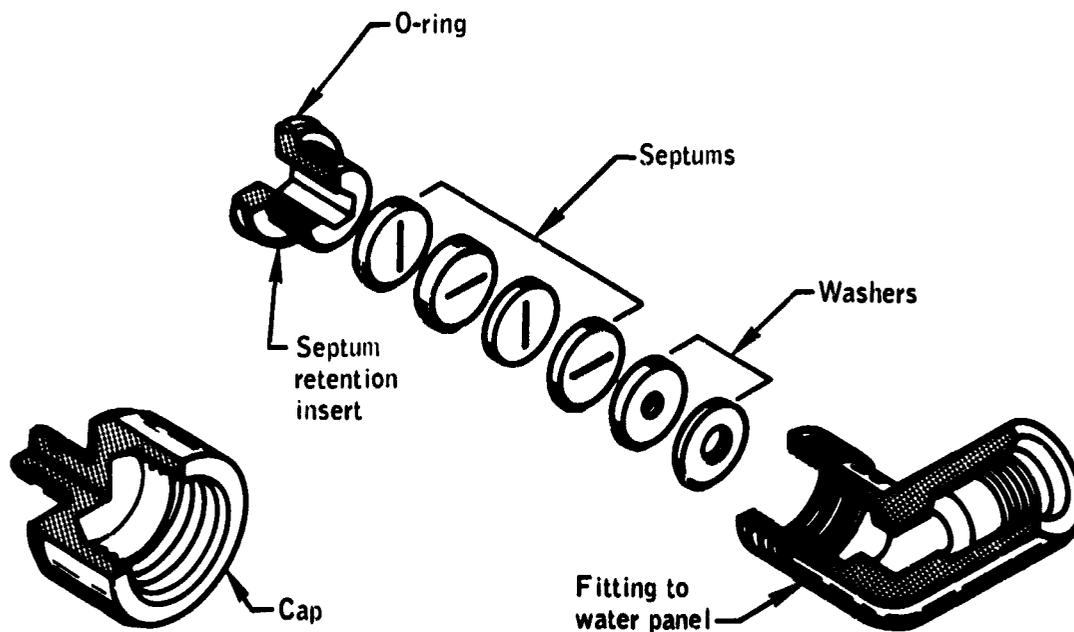
Postflight inspection and dimensional checks of the injection port assembly showed that all components were within established tolerances.

Figure 14-2.- Water panel chlorine injection port.

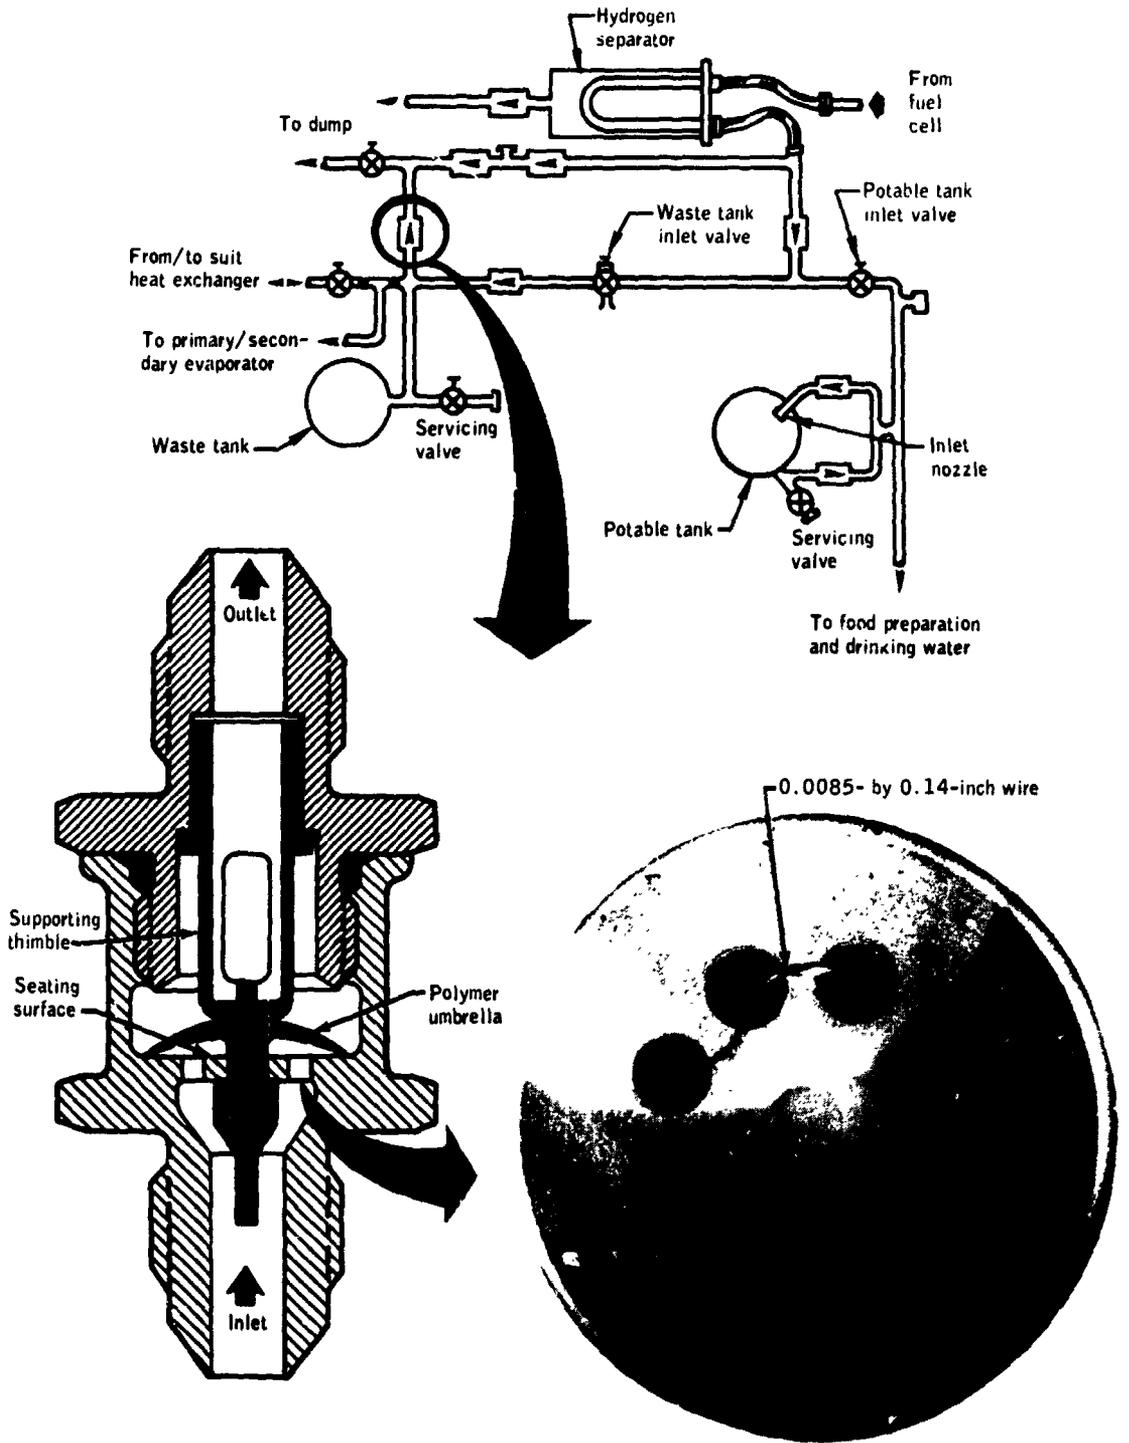
Figure 14-9.- Water management system and failed check valve details.

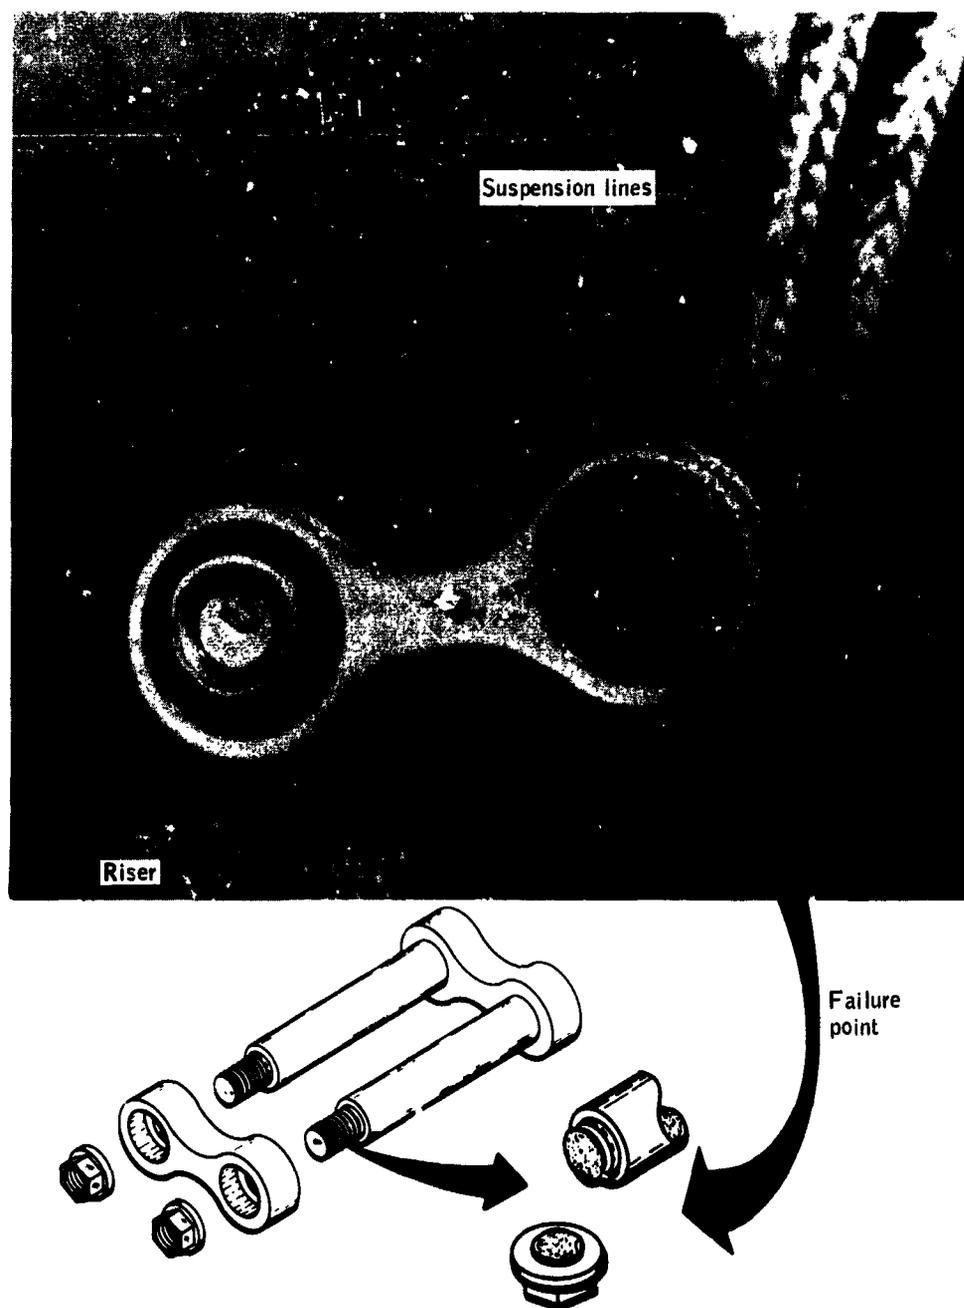
Figure 14-12.- Main parachute connector link failure.

In order to eliminate critical processing operations from manufacture of the connector links, the material was changed from 4130 to Inconel 718.

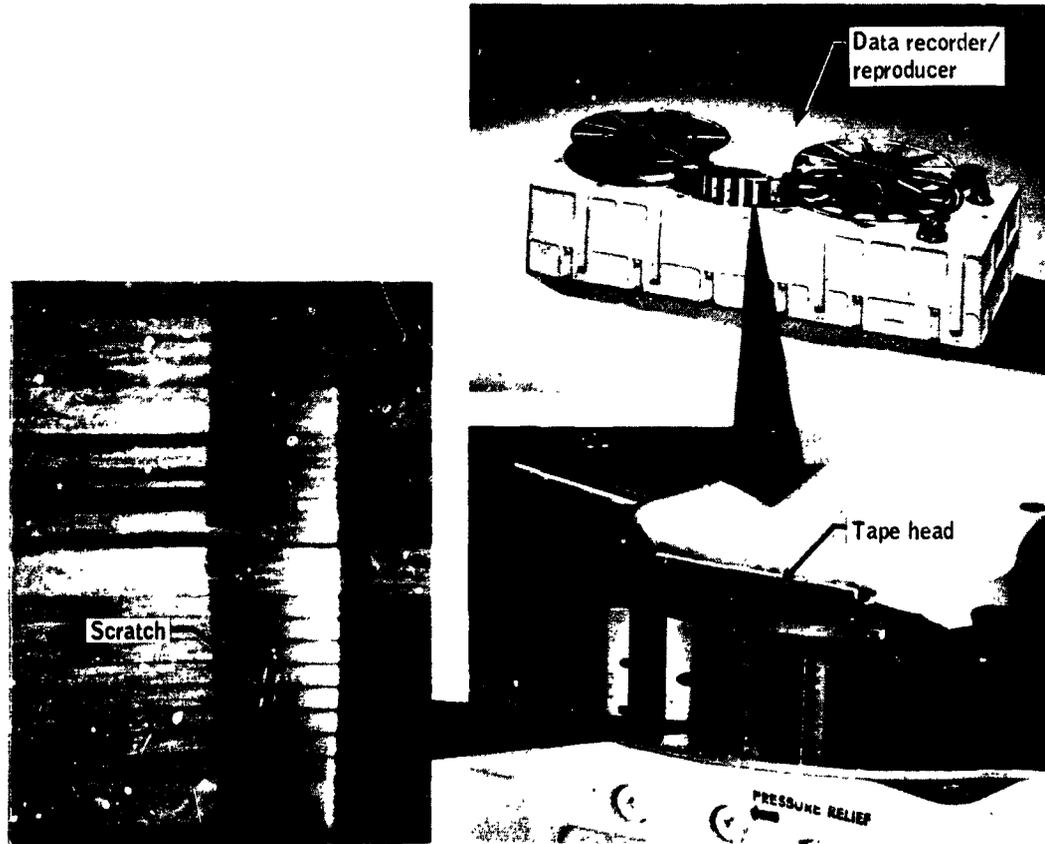
Figure 14-15.- Data recorder/reproducer and scratches on head.

Removable head covers have been provided to protect the heads from handling damage when the recorder covers are not installed. These covers have been used since early in the buildup cycle of the Apollo 16 and 17

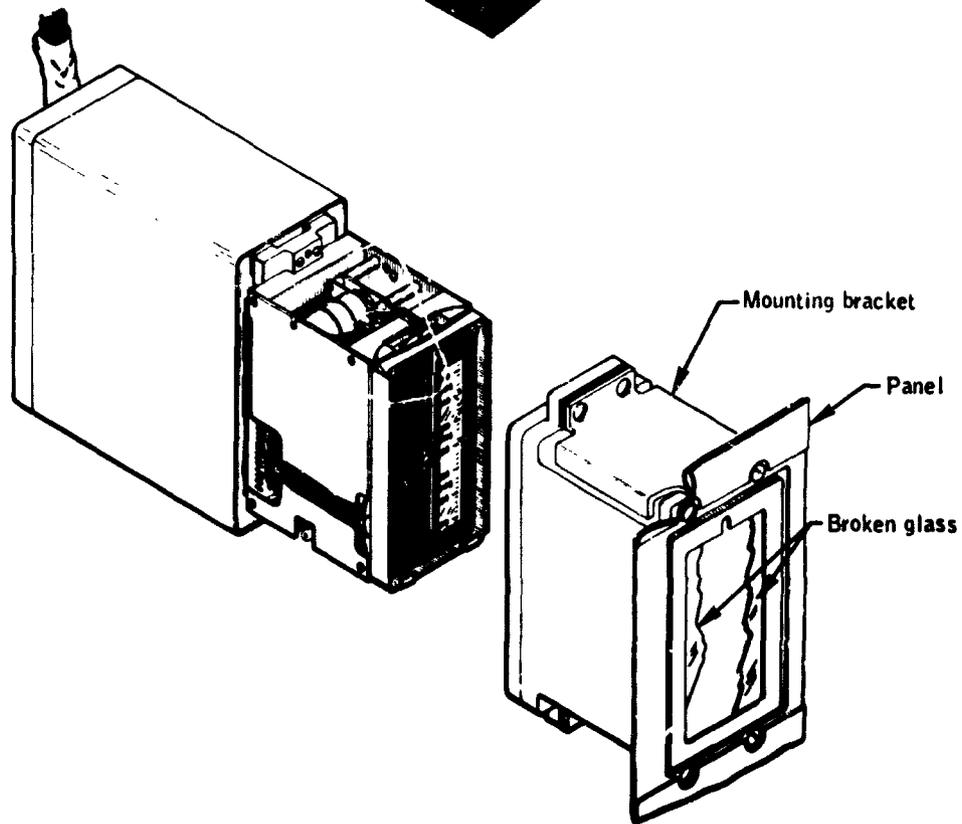
Figure 14-34.- Range/range rate meter mounting.

For future missions, an exterior glass doubler will be added to the window to reduce the maximum operating stress to less than 2000 psi. This will increase the threshold flaw depth to 0.0036 inch and the critical flaw depth to 0.032 inch. This should prevent future fatigue failures since there are no reported fatigue failures in soda-lime glass at stresses below 2000 psi. In addition, all similar glass applications in the lunar

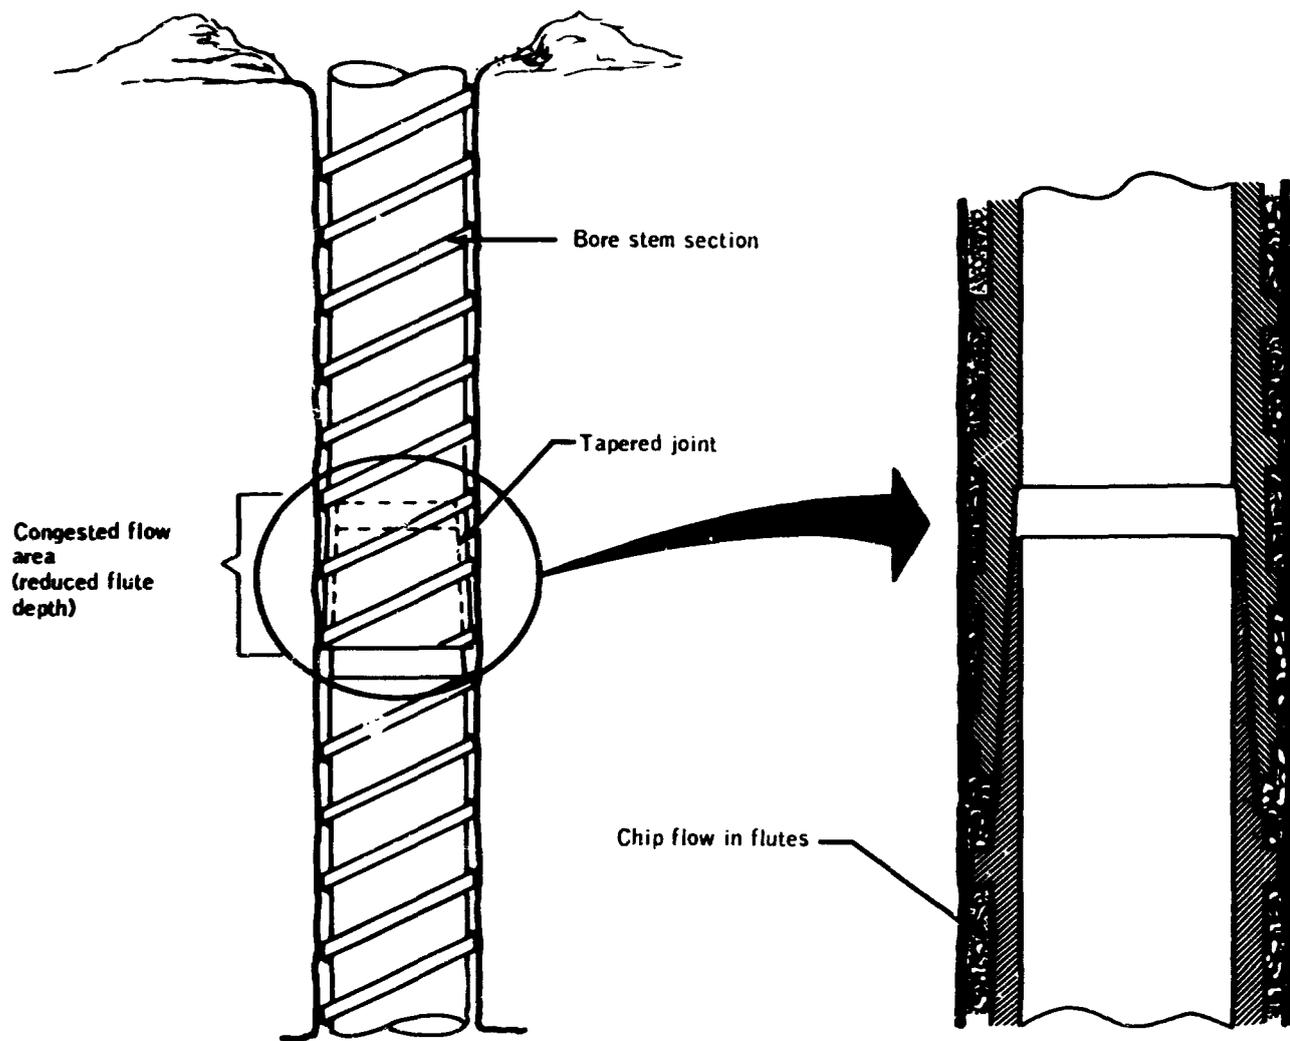
Figure 14-41.- Congestion at bore stem joints.

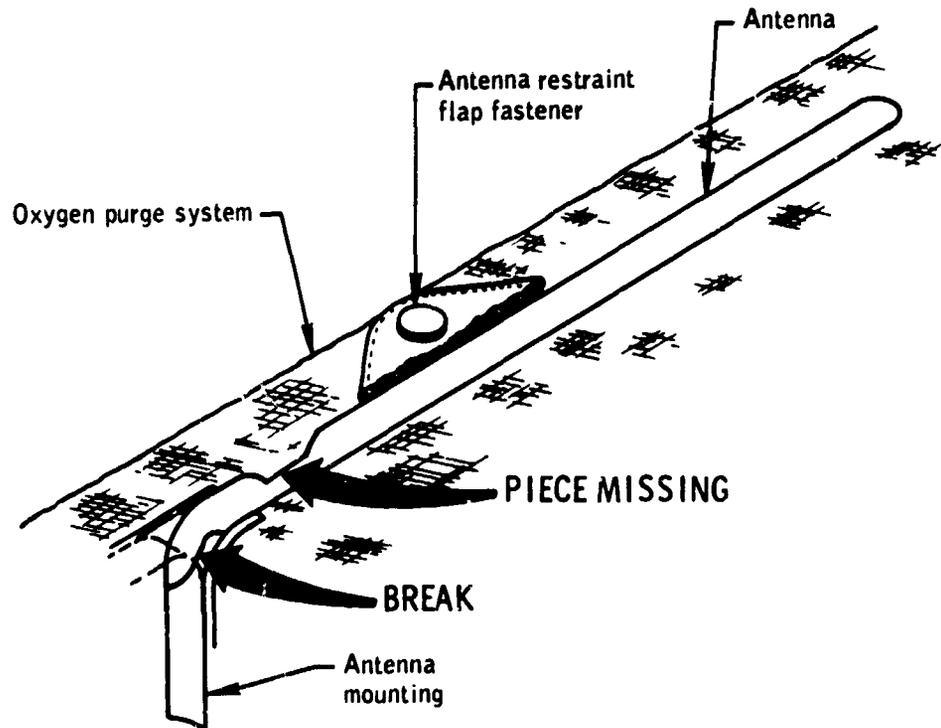
The communications check at the beginning of the second extravehicular activity was initially unsuccessful for the Lunar Module Pilot because his antenna was broken (sec. 14.5.6). The crewmen taped the antenna to the

Figure 14-51.- Damaged antenna stowed on oxygen purge system.
