## SYSTEM FAILURE CASE STUDIES

SEPTEMBER 2010 VOLUME 4 ISSUE 9

# Descent into the Void

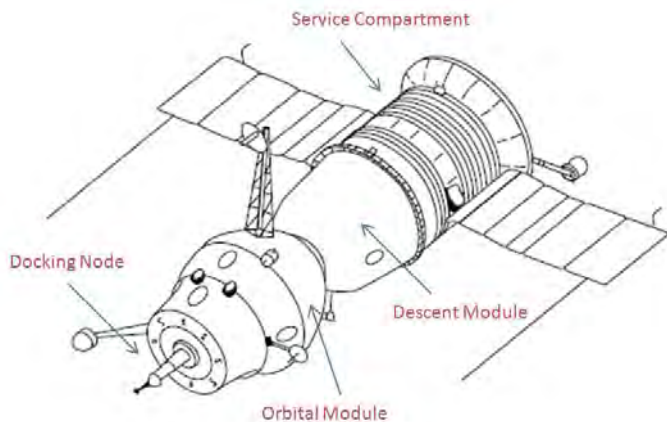
seal of the cabin. Pressure tests of the cabin show a slight loss, but it took 1.5 hours for the cabin to fully depressurize with the valve closed. What had forced the valve to open too soon? At approximately 723 seconds after retrofire, the descent module separated from the service compartment and orbital module. This orbital/descent module separation exposed the ventilation/equalization valves and the pressure relief valve to vacuum. Then, contrary to design intent, the 6 pyrotechnic-cartridges and the 6 pyrotechnic bolts used to separate the orbital module from the descent module fired simultaneously instead of sequentially with a delay between the bolts and cartridges. The resulting off-nominal separation shock to the descent module opened one of the two ventilation/equalization valve and pressure regulator outlets to vacuum.

**Figure 3: The descent module nominally separated from the other compartments when 12 explosive bolts fired sequentially.**

Pressure inside the descent module leaked into the vacuum of space when a pyrotechnic ventilation/equalization valve designed to open when the vehicle reached an altitude of 2.5 miles (4 km) instead opened at a height of 105 miles (170 km). In an effort to determine what caused the valve to open early, engineers simulated varying loads on the valve, and deduced that the pyrotechnic fasteners that should have fired sequentially during capsule separation from the orbital module and descent module fired simultaneously instead. The resultant force jarred a ball joint in the pyrotechnic valve mechanism loose. This forced the valve open and depressurized *Soyuz-11*. Other pyrotechnics blew a valve seal clear at about 4 km altitude per design intent to equalize cabin pressure with the atmosphere—but the prematurely open valve had already done so in vacuum. Analysis of automatic attitude control system thruster firings made to counter the force of escaping cabin pressure, along with the pyrotechnic powder traces found in the throat of the valve determined when the valve had malfunctioned, causing the depressurization.

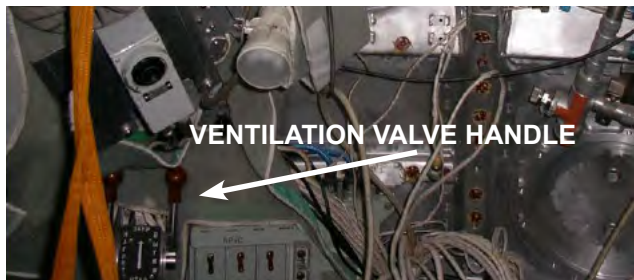
**Figure 4: Manual ventilation valve handles were added to the Soyuz spacecraft.**

spacecraft was redesigned with increased valve reliability versus shock loads. Emergency pressurization equipment was added to the spacecraft. A manually operated valve, accessible to the crew, was placed in series with the pyrotechnic valves in both the ventilation inlet and outlet (Figure 4). Cosmonauts were issued and required to wear pressure suits for launch and landing; *Soyuz* crews were reduced to two to account for the additional equipment volume. Later, redesigned space suits occupied less space and allowed a *Soyuz* to be flown with three suited crewmembers. In October of 1971, *Salyut* was no more; its on-board supplies expired, the first human space station was commanded to a destructive re-entry over the Pacific Ocean.
