System Failure Case Studies

FEBRUARY 2008

Volume 2 Issue 2

FIRE IN THE COCKPIT

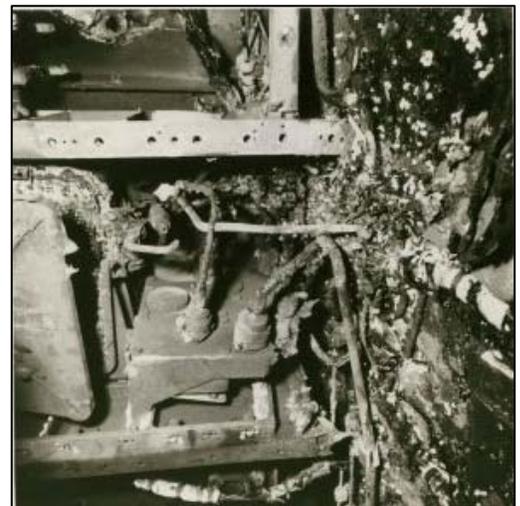
Electric Arcs: Teflon has excellent fire resistance, but low resistance to cold flow (see “Cold Flow” inset). The Teflon covering on the wire used in Apollo 204 could also be damaged easily or penetrated by abrasion. In addition, the Board

found numerous examples in the wiring of poor installation, design, and workmanship. If a power conducting wire experiences penetration of its insulation by the metal structure of the spacecraft or

Figure 2: Wires where the fire was suspected to have started.

short to ground is created at the point of conductor contact. An arc or a series of arcs between conductor and structure will result. Circuit breakers and other practical circuit interrupting devices cannot act rapidly enough to prevent an arc. Thus, arcs cannot be eliminated as a potential source of ignition energy. As noted previously, there were strong data indications of an abrupt, short-duration voltage decrease. This is consistent with a quickly terminated arc.

Both wiring and plumbing installation designs were faulted by the accident Review Board – “unprotected vulnerable wiring carrying spacecraft power and vulnerable plumbing carrying a combustible and corrosive coolant.” The choice of Teflon as the wire coating may have been a good choice from the standpoint of fire resistance but the wrong choice for wires that were directly exposed to the cabin environment.

NASA aggressively responded to implement the Board’s suggestions, switching to “Block II” (upgraded) spacecraft already in development, which included many of the recommendations of the Board, such as better hatch design which would open outwards and be operable in less than 10 seconds. Better fire resistant materials were developed for spacesuits, concerns about a pure oxygen environment for ground tests were addressed, higher quality wiring with abrasion protection and fireproof coatings was used, new emergency procedures and equipment were added, and almost all flammable materials inside the spacecraft were removed. In all, about 1500 changes were made, resulting in a more secure and safer vehicle. In addition, NASA implemented management changes moving astronauts into more management positions and creating an independent flight program office at Headquarters. Additionally, space flight centers were tasked to review all aspects of design, manufacturing, test, and flight from a safety standpoint.
