## SYSTEM FAILURE CASE STUDIES

NOVEMBER 2010 VOLUME 4 ISSUE 11

# Spektr of Failure

### Automated supply vehicle collides with Space Station Mir

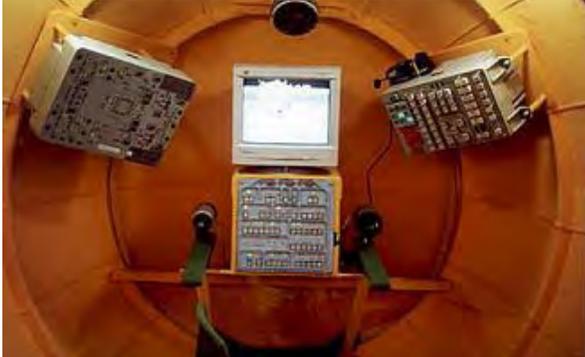
parently, RF radiation emitted through the antenna interfered with the camera signal. TsUP addressed this issue simply by turning off the emitter. This left Tsibliyev without telemetry of speed, range and range rate data. Ground control instructed astronaut Michael Foale and cosmonaut Aleksandr Lazutkin to manually calculate the speed, range and range rate using a handheld laser rangefinder and a stopwatch. American engineers were not consulted or informed of this fallback measure until after the mishap.

Figure 2: The TORU Docking System.

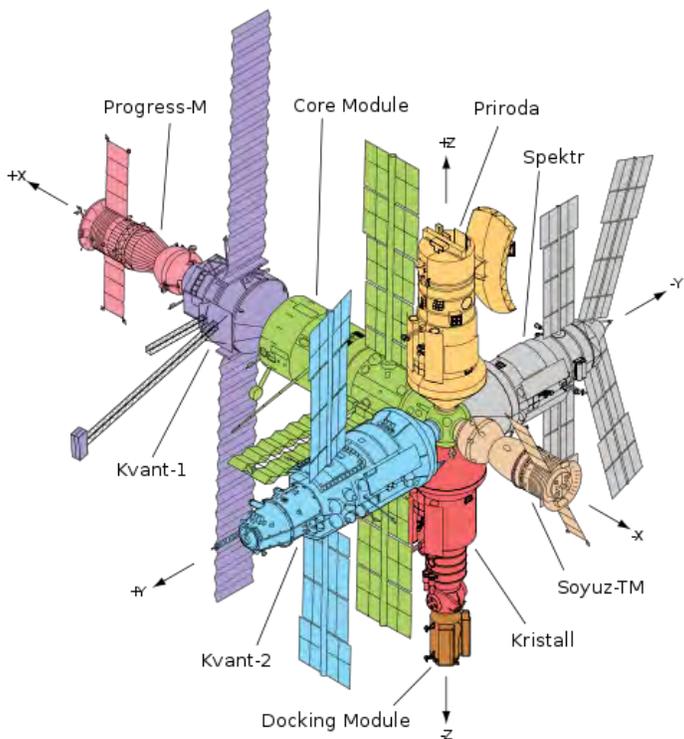
Ninety seconds remained before the final docking time when Lazutkin saw the Progress emerge suddenly, looming from behind one of *Mir*'s solar arrays. Urgently, he commanded Foale to flee to the *Soyuz* and prepare for evacuation. Suddenly learning of Progress' proximity, Tsibliyev clamped down the braking lever, but despite his commands, Progress coasted past the docking node over Base Block at high relative speed (three meters per second). *Mir*'s hull now filled Tsibliyev's entire screen. Then, Progress slammed into a solar array and ricocheted into the *Spektr* module, rocking the entire station (Figure 4). The crew felt the pressure change in their ears almost immediately and heard a loud hissing noise. Progress had punctured the hull somewhere on *Spektr*. If the crew did not act quickly, they would suffocate.

**Figure 3: Core Module (Base Block) is shaded in green. Progress should have docked to Kvant-1. Instead, it collided with Spektr.**

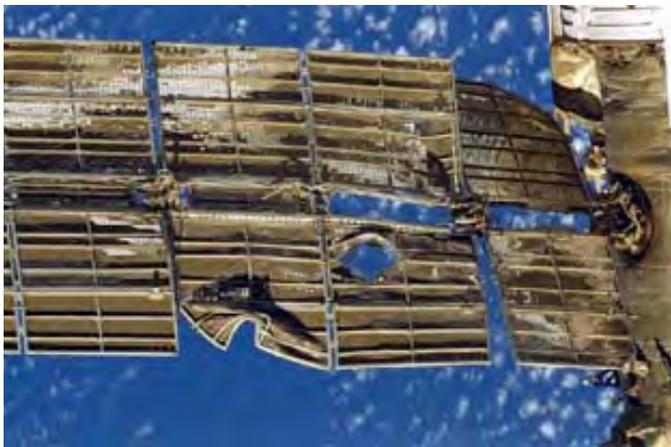
**Figure 4: *Mir* solar array with collision-induced damage**
