## Soyuz investigation findings backed by nominal Soyuz TMA-13 return

April 8, 2009 by Chris Bergin

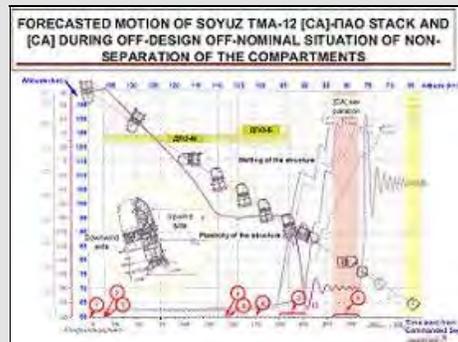
“Hatch forward” is undesirable for long periods of time during re-entry, due to the obvious risk of excessive heating causing a breach, which would result in the loss of the Soyuz crew.

“Worst Case Assumption for Mechanism Penetration Insulation,” explained one slide on the presentation. “Hatch failure assumed when temperature of hatch aluminum structure reaches point where internal pressure causes failure, around 750 degrees F.”

However, a Russian slide (see left) added to the investigation document appears to show the period of time Soyuz TMA-12 was in the “hatch forward” position was relatively short, with post landing photography backing up the slide, showing most of the vehicle’s TPS (Thermal Protection System) was in reasonably good shape, with only the antenna melted away.

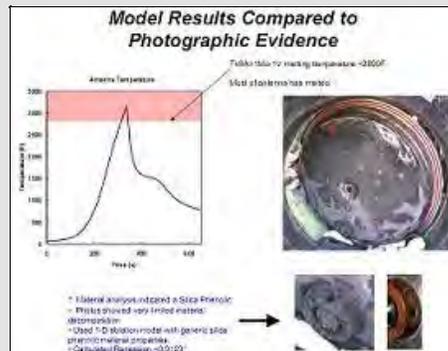
NASA’s highly regarded thermal modelling capability, used mainly on shuttle analysis, is put to work on several slides relating to heating loads on the Soyuz – mainly used on working out when the separation of the modules would occur, in the event of a nominal separation failure.

Included in the findings are notes that the crew on Soyuz TMA-11 suffered from almost 8.5G during part of their re-entry, and that there is a serious risk – albeit under worst case scenarios – that the hatch could fail, or the parachute cover could incur damage – both hold the serious threat of LOV/C

“Analysis Summary: Notional trajectory (15S) had truss failure at 67.85 km altitude. Max g = 8.42 gees, consistent with crew experience. Comparable trends with Russian telemetry data.

“Notional truss failure at 70.44 km (conservative), an acceleration of 2.6 km in altitude or 12.91 sec. Russians’ range of separation altitudes with software patch is within the bounds of our calculations. Russians’ range is 77 – 83 km. Our range is 68 – 89 km

“If separation did not occur and the spacecraft continued in the hatch-forward orientation. With worst case assumptions, the hatch would fail: Failure altitude = 55.95 km (11.9 km from notional truss failure). Failure time = 400 sec (59.49 sec from notional truss failure)

“With more realistic design assumptions, the hatch frame survives with a margin of around 100 degrees F from burst temperature. With conservative assumptions, the chute cover would fail: Failure altitude = 35.9 km (31.95 km from notional truss failure). Failure time = 487 sec (146.5 sec from notional truss failure).”
