# Extravehicular Mobility Unit (EMU) / International Space Station (ISS) Coolant Loop Failure and Recovery

**John F. Lewis**  
JSC NASA

## ABSTRACT

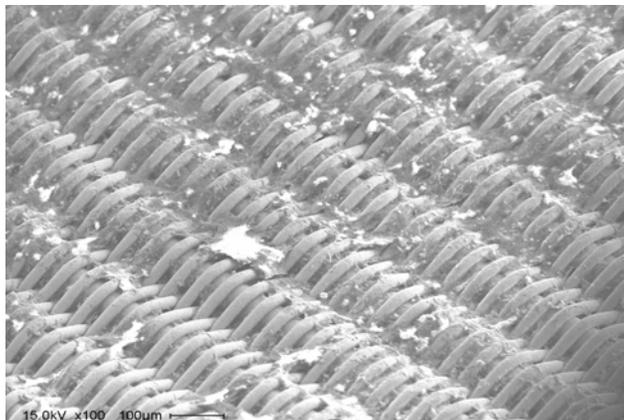
FIGURE 3: Outer Surface of EMU 3013 Gas Trap (100X)

Item-141 Gas Trap - The EMU 3013 Item-141 Gas Trap influent and effluent surface high magnification images (Figure 3) showed the presence of significant agglomerations of organic material mixed with inorganic precipitates (nickel, silicon and aluminum), a number of which exceeded 100-microns in size. It is important to note that these agglomerations appeared to be made up of particulates that were significantly less than the 20-micron screen rating of the Gas Trap, but when joined together as agglomerations, exceeded 100-microns in size. Importantly, these agglomerations were in a size range that could cause a decoupling of the Item-123 Pump Rotor if they became dislodged, then re-deposited between the Item-141 Rotor and Rotor Cup. (1)

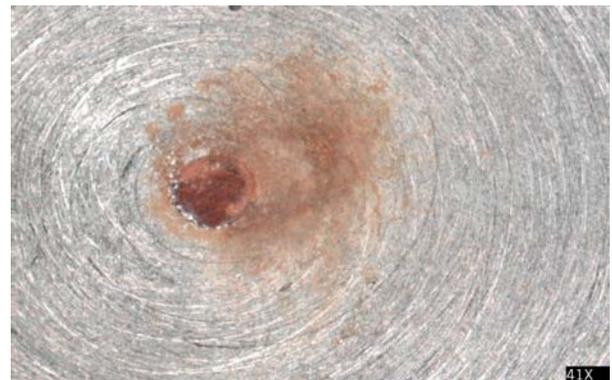
#### FIGURE 4: EMU 3005 Item-141 Gas Trap Cover Blocked Hole

The EMU 3005 Item-141 Gas Trap was not functioning on-orbit. In that respect, the failure signature of EMU 3005 and EMU 3013 diverged. It was determined through examination that the center 0.155 in. diameter hole in the Gas Trap Cover of the EMU 3005 Item-141 Gas Trap was completely plugged. This prevented flow of water to the Water Separator. The contaminant blocking this hole was identified as primarily iron oxide,

with lesser amounts of non-volatile organic material. (Figure 4)

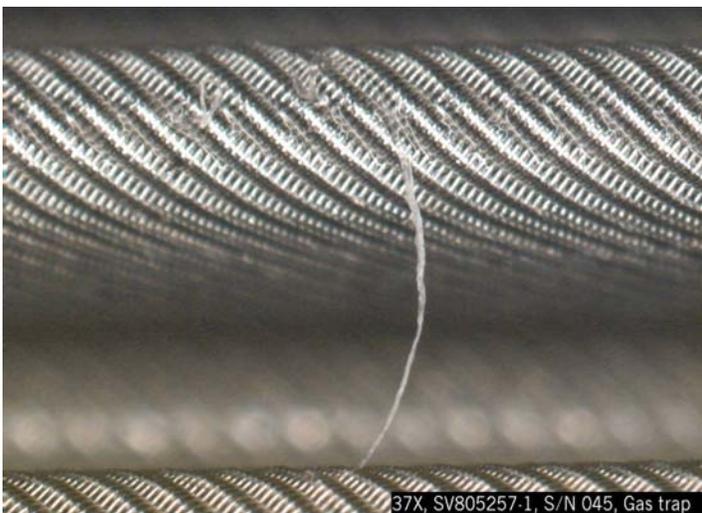
FIGURE 5: EMU 3013 Gas Trap OD (~ 40X)

The OD screen material of the EMU 3005 Item-141 Gas Trap appeared to be covered with a clear, wet gelatinous material initially thought to be moisture. A higher magnification examination of this material revealed "stringers" that bridged the gap between the OD screen convolutions. A microbial count and speciation of this material collected on swabs, and the finding of high levels of protein, indicated the presence of biofilm and biofilm forming microorganisms. This is similar to what was observed with the EMU 3013 Gas Trap as well. (Figure 5)

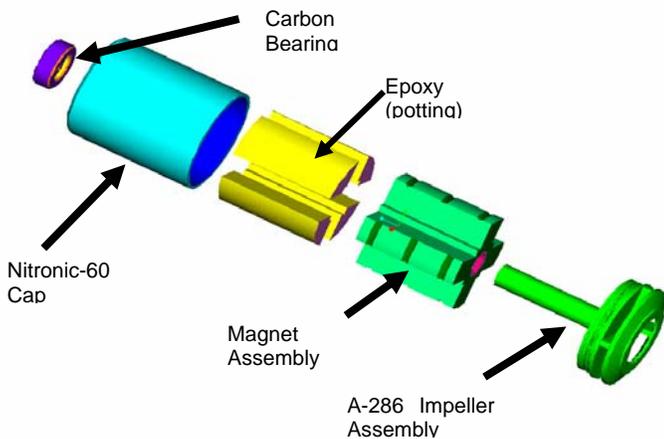
FIGURE 6: Item-123 Rotor Schematic

The initial examination of the EMU 3013 Pump Impeller Rotor indicated that it had increased by .003-.004 inches in length. The increase in length had occurred as a result of a widening in the gap between the Nitronic -60 cap and the impeller assembly (Figure 6). The impeller appeared to have de-bonded from the corroded steel core and appeared to be lifting out of the cap. The rotor is encased within a seal cup cavity and any increase in length would be expected to make the rotor more susceptible to fouling from contaminants. The chemical analyses of the contamination on and within the EMU 3013 Item-123 was consistent with the organic contaminants and nickel, silicon and iron corrosion products previously observed in the coolant and on the Item-141 Gas Trap. Observed rust colored deposits were rich in iron and oxygen, indicating the presence of iron oxide corrosion products.

The EMU 3011 rotor exhibited no growth in length in the gap between the Nitronic-60 cap and impeller assembly (Figure 6). No evidence of de-bonding was observed. It is theorized that the increased gap between the Nitronic-60 cap and the impeller assembly for the EMU 3005 and 3013 Item-123 rotors are the reasons this hardware experienced coolant flow disruptions before EMU 3011. It should be noted that the occurrence of a rotor growth in length is not necessary for an eventual disruption of Item-123 rotor functionality. Coolant quality remains as the primary reason for EMU coolant flow disruption, and rotor growth a significant other finding.

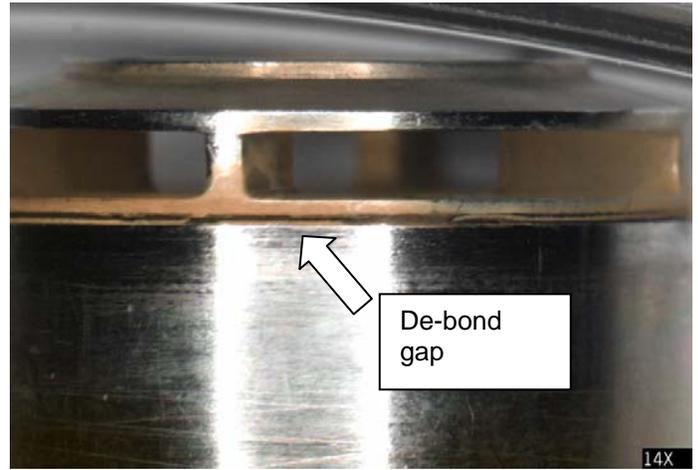
FIGURE 7: EMU 3005 Item-123 Rotor De-bond Gap

The EMU 3005 Item-123 Fan/Pump/Separator Pump Impeller Rotor exhibited more rust colored contamination than EMU 3013. This rotor showed a growth in length of approximately 0.005 inches. (Figure 7) This is slightly greater than the 0.003-0.004 inches growth seen in EMU 3013. Again, since the rotor is incased within a seal cup cavity, this growth in length would be expected to make the rotor more susceptible to fouling from contaminants.

Because the EMU 3005 rotor displayed the more pronounced case of de-bonding and contamination, it was selected for further examination. The rotor was cross-sectioned in an attempt to gain information on the condition of the bond joints within the rotor. The impeller shaft appeared to have de-bonded from the cold rolled steel core. The epoxy bond to the cap remained intact. The growth in rotor length was attributed to the de-bonding of the Impeller. The Impeller was no longer seated in the cap and had risen out of the cap slightly.
