# USS IWO JIMA Mishap

## A Set-up for Failure

**Bryan O'Connor**  
Chief,  
Office of Safety and Mission Assurance  
NASA Headquarters, Washington, DC  
OSMA POC, Brian Hughitt (202) 358-1572

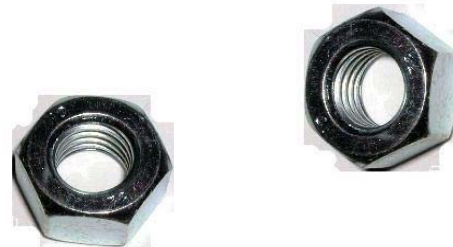
**Unauthorized substitution of black oxide coated brass fasteners (BOCBF) for high strength steel fasteners in the valve**

Alloy Steel Nuts

Black Oxide Coated Nuts

(not actual BOCBF)

- Identified all BOCBF substitution hazards on Navy ships
- Mass inspection of in-service fasteners (scrape or magnet)
- Purged stocks & replaced with shiny brass or monel fasteners
- Revise parts lists to flag Level I fasteners and include warning notes
- Training curricula modified to include Level I awareness (engineers and mechanics)
- Fastener Selection training video disseminated Navy-wide
