# System Failure Case Studies

JANUARY 2008

## REFINERY ABLAZE – 15 DEAD

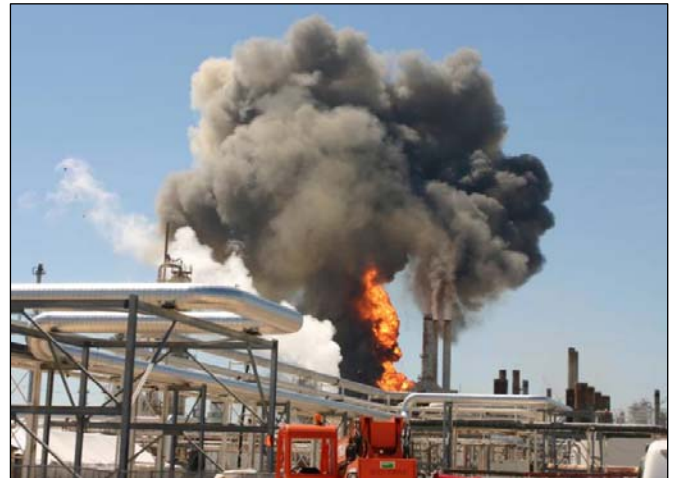
**Blowdown stack emitting flames after explosion.**

ing the adjacent blowdown unit. At 1:20 PM, a “geyser-like release” of highly flammable liquid and vapor emerged from the blowdown stack, with distillate running down the outside of the stack and pooling around the base. Heavier-than-air hydrocarbon vapors came into contact with an ignition source, exploding in a fireball that killed 15 workers, injured 170 others, and damaged office trailers at distances up to 600 feet.

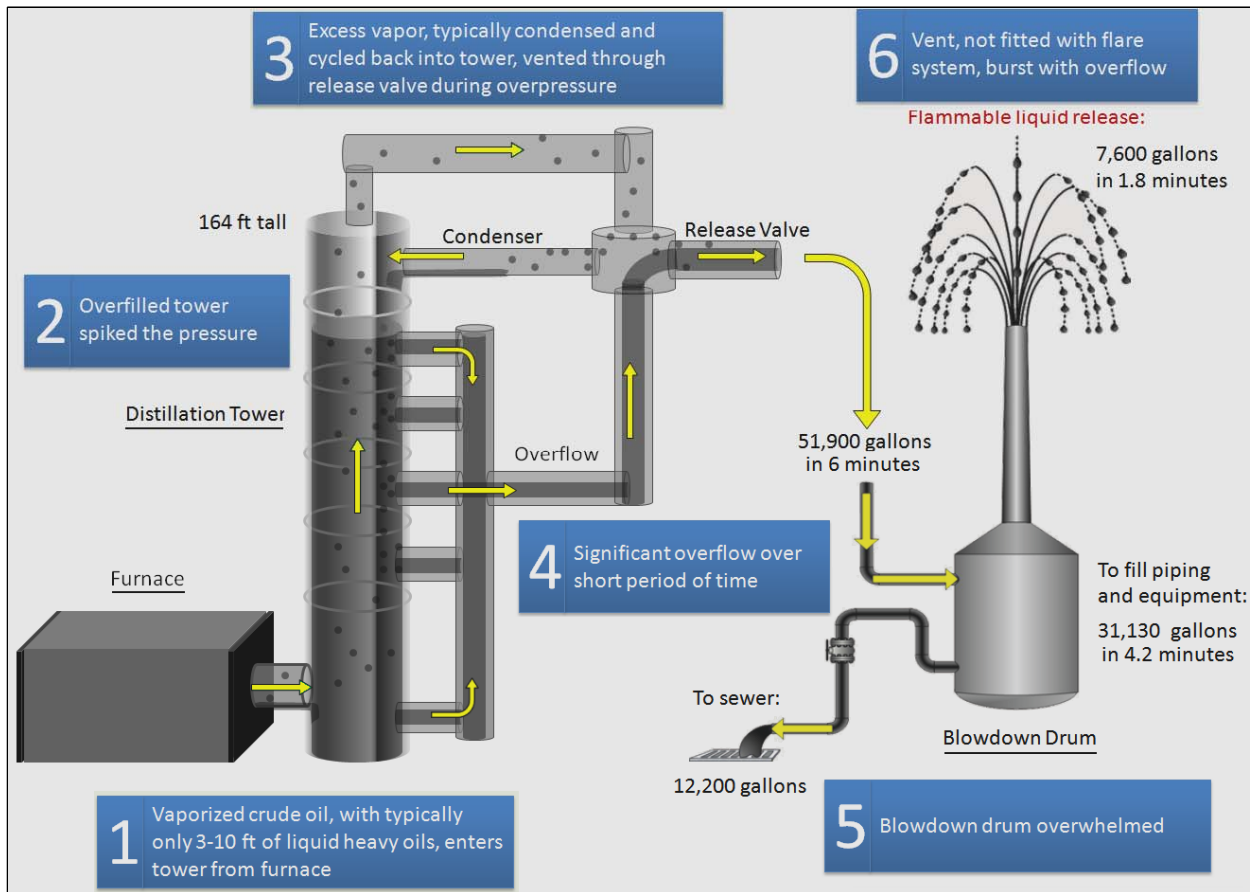
**The sequence of events that resulted in explosion, ignited by a nearby truck.**

Personnel responsible for startup greatly overfilled the tower and overheated its contents, which resulted in an over-pressurization condition. Liquid was pumped into the tower for almost three hours without any liquid being removed or any action taken to achieve the lower liquid level mandated by the startup procedure.

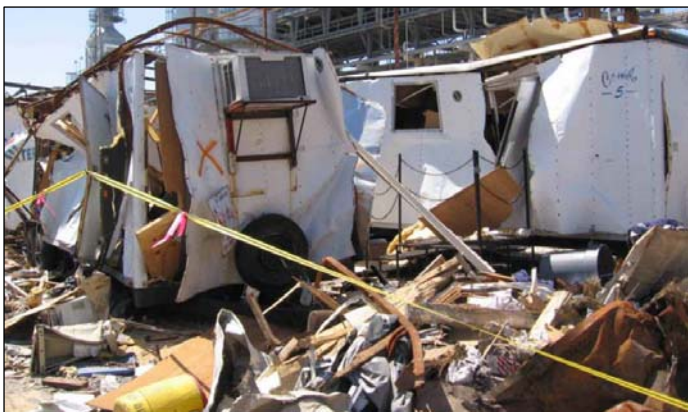
Most of the fatalities occurred in or around trailers that were susceptible to blast damage and were located within 150 feet of the blowdown drum and vent stack. These trailers were placed in close proximity to the distillation unit in violation of facility sitting policy. This unit had experienced hydrocarbon releases, fires, and other process safety incidents over the past two decades. There was no blast wall or sufficient separation to protect the trailers from an explosion, deflagration, or detonation event.

**Remains of trailers after destruction.**

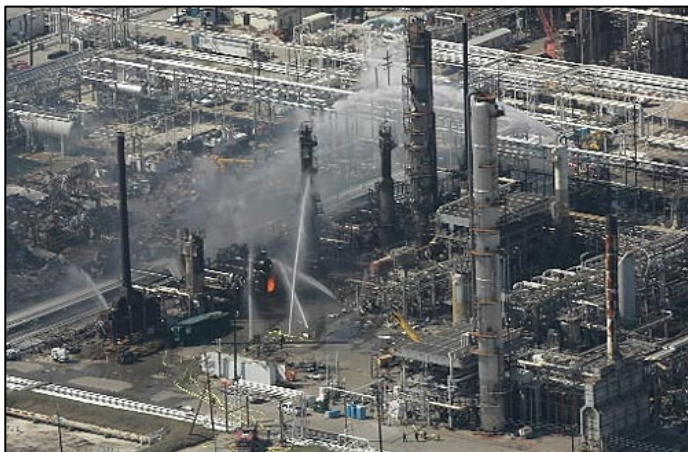
**View of damaged equipment post accident.**
