Mishap at an Explosives R&D Laboratory

Mishap with an Energetic Material at an R&D Laboratory

At 10:45 pm on February 14, 2005, an explosion and fire occurred in the R&D laboratory building M-590 at the ATK Thiokol Promontory campus.

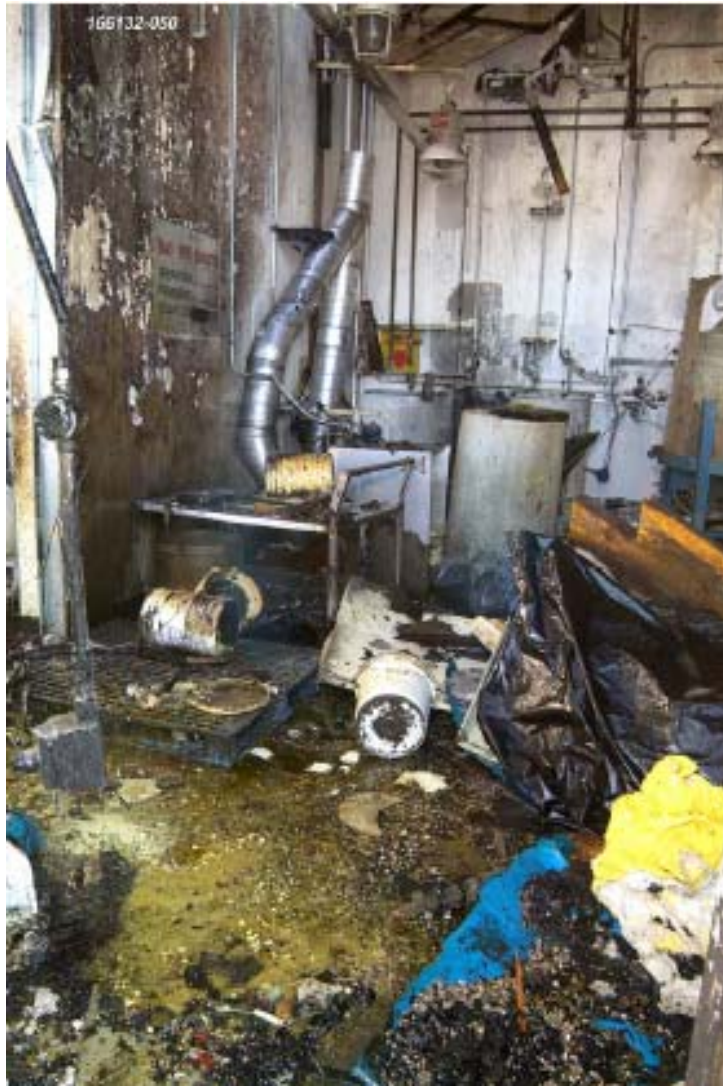
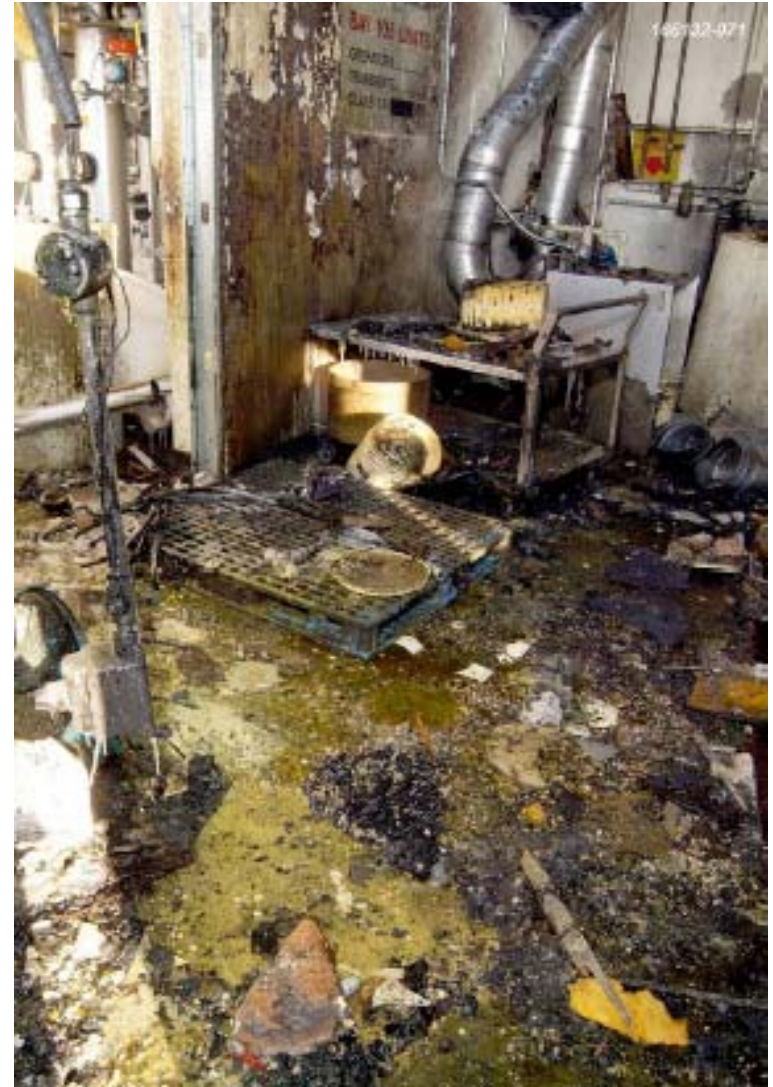
Views inside Building M-590, Bay 105

- Two laboratory technicians were transferring a chemical compound known as TETNB from a filter tray into 5-gallon plastic buckets.
- One of the technicians was killed, the other severely burned.

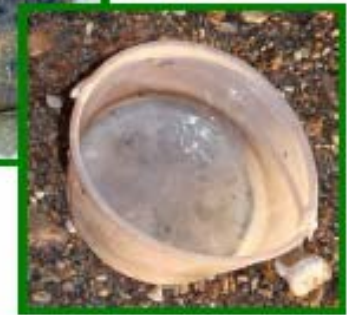
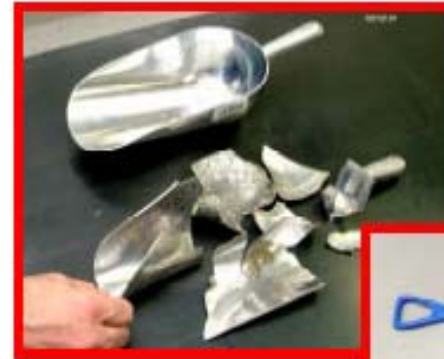
Authorized
Tools

- While sensitive material in the receiver was not specifically anticipated, the process design included considerable margin to mitigate the risk of off-nominal conditions (plastic squeegee specified).

- Plastic tools were specified in the planning documents and only plastic tools had been used in prior transfers of TETNB.
 - There was no apparent schedule pressure or management direction to remove the unusual and unanticipated caked material.

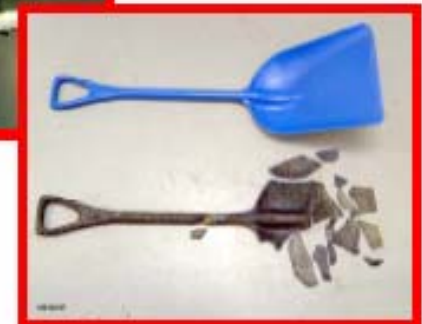
Unauthorized
Tools

- A metal scoop is never the type of tool to be used in operations with explosive materials.
- The technicians were well trained, involved personally in the Hazards Analyses and table-top reviews, and experienced in handling energetic materials.

3. Lab technicians improvised on their own, and used unauthorized tools (metal scoop, plastic shovel) to remove caked material.

Metal Scoop	Plastic Shovel	Plastic Squeegee
TETNB	2	5	100
TNPG	-30	-10	2
DETNP	1	3	60

4. Impact, most likely from an unauthorized tool, caused local ignition of TNPG and mass ignition of the DETNP

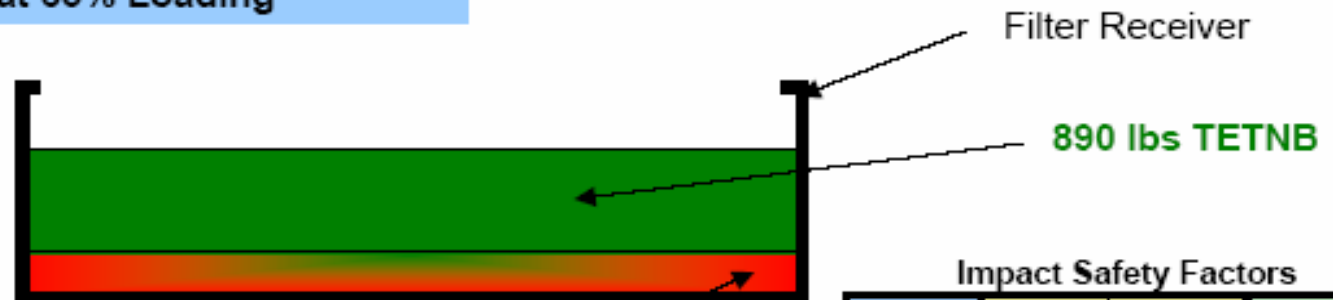
2. Being more water soluble, DETNP and TNPG were concentrated in the bottom of the receiver forming an unusual hard, dry cake

- Localized concentrations of up to 24% TNPG

Hard, dry caked TETNB, DETNP, and TNPG

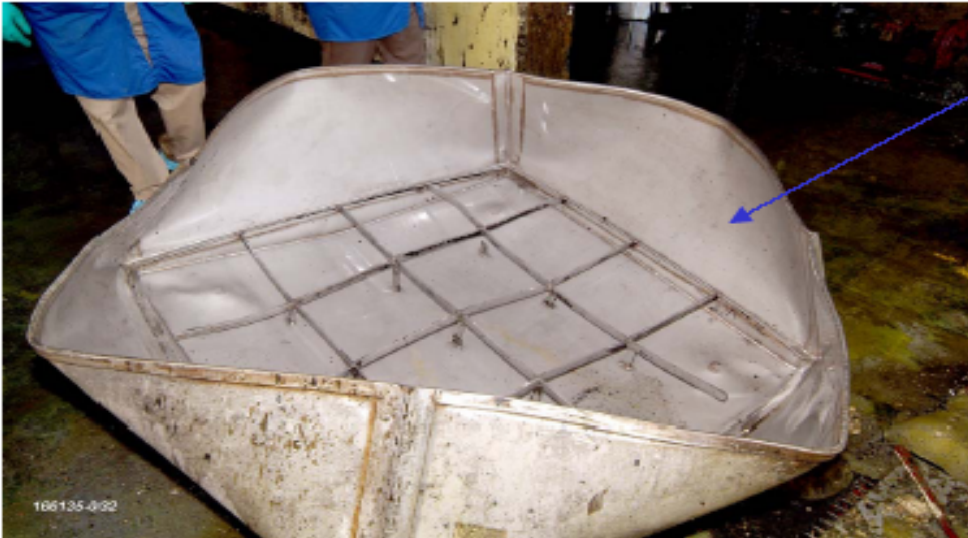
Filter Receiver

Incident occurred as TETNB was being removed from a filter receiver and being placed in 5-gallon buckets for transfer and storage

1. TETNB material in filter receiver was under-reacted and under-washed.
