Radiation Cancer Therapy Machine Mishaps in 1985-86 due to Safety Critical Software Control Errors

**Leadership ViTS Meeting
December 18, 2006**

**Jim Lloyd
Deputy Chief, Safety and Mission Assurance**

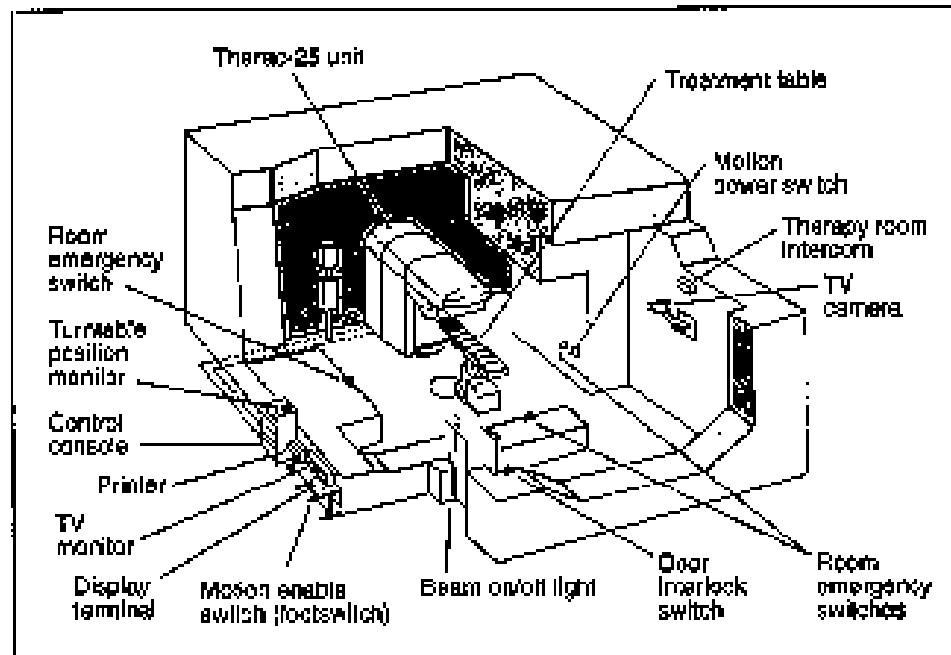
Figure 1. Typical Therac-25 facility.

In a 20-month period between June 1985 and January 1987, Therac-25 radiation therapy machines used in both the US and Canada administered massive overdoses of electron beam radiation to at least six cancer patients, with at least three deaths attributed to radiation overdose.
