Atlas Centaur (AC-67) Lightning Strike Mishap 1987

**Leadership VITS Meeting
March 5, 2007**

**Bryan O'Connor
Chief, Safety and Mission Assurance**

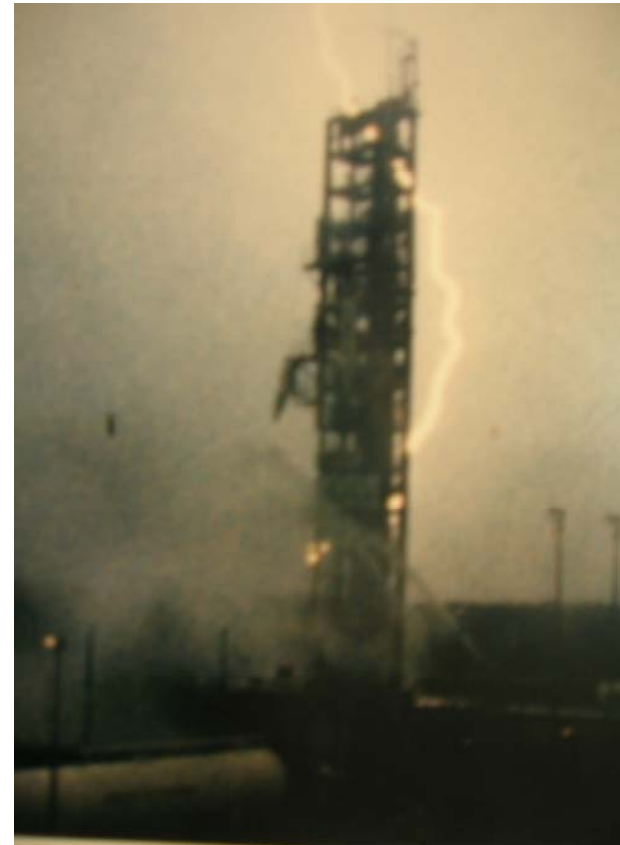
**On 26 March 1987,
NASA launched
Atlas/Centaur AC-67
from the Eastern Test
Range. The vehicle
triggered lightning 49
seconds after launch
resulting in GN&C
failure and structural
breakup.**

**Both launch vehicle
and Navy
communication
satellite were lost**

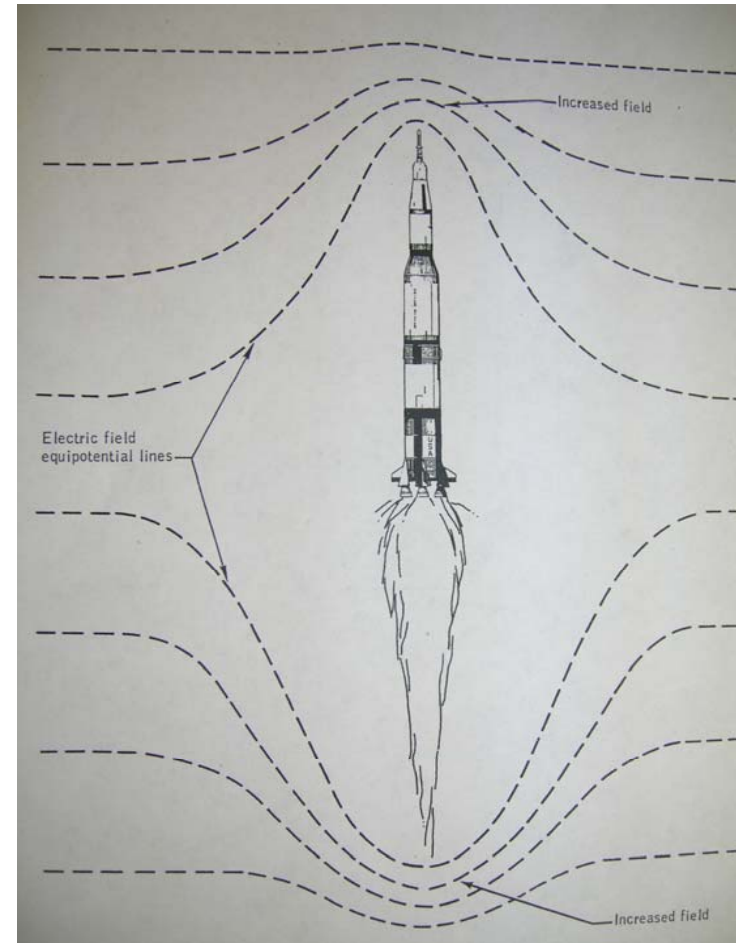
Lightning can be triggered when an aerospace vehicle with a conductive surface and an ionized exhaust plume distorts the electrical field equipotential lines, thus increasing the potential gradient at the top of the vehicle and below the exhaust plume.

(NASA Analysis of Apollo 12 Lightning Incident; Feb 1970)
