Eschede Train Disaster

Leadership ViTS Meeting
May 7, 2007

Bryan O'Connor
Chief, Safety and Mission Assurance

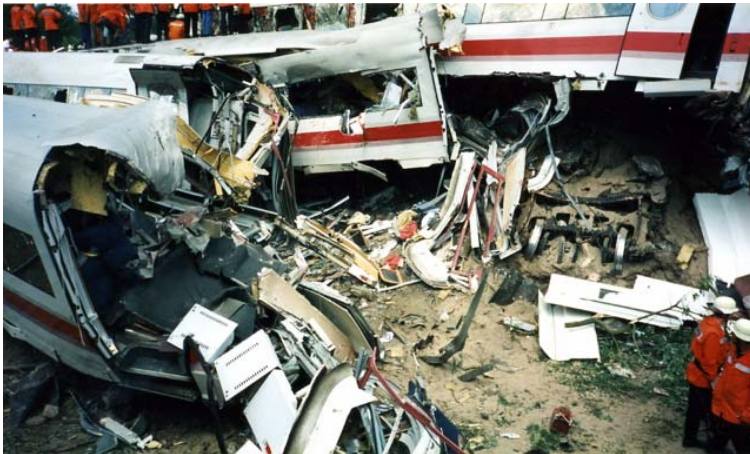
- In June of 1998, one of Germany's InterCity Express (ICE) trains, traveling at over 200kph, slammed into an overpass, killing 101 people.
- The accident happened to a high speed ICE train just outside the town of Eschede in northern Germany.
- As the train was traveling to the Eschede Station, a wheel rim on a passenger coach peeled away from the wheel body, puncturing the floor, and becoming embedded underneath the car.
- Passengers noticed the wheel rim when it came through the floor of the rail car.
 - Policy required the train manager investigate the damage before stopping the train.
 - No one activated the emergency brake.
- The train traveled over 3 km before derailing.
- Cars were crushed when an overpass, which was not designed to withstand impact of train derailment, collapsed.

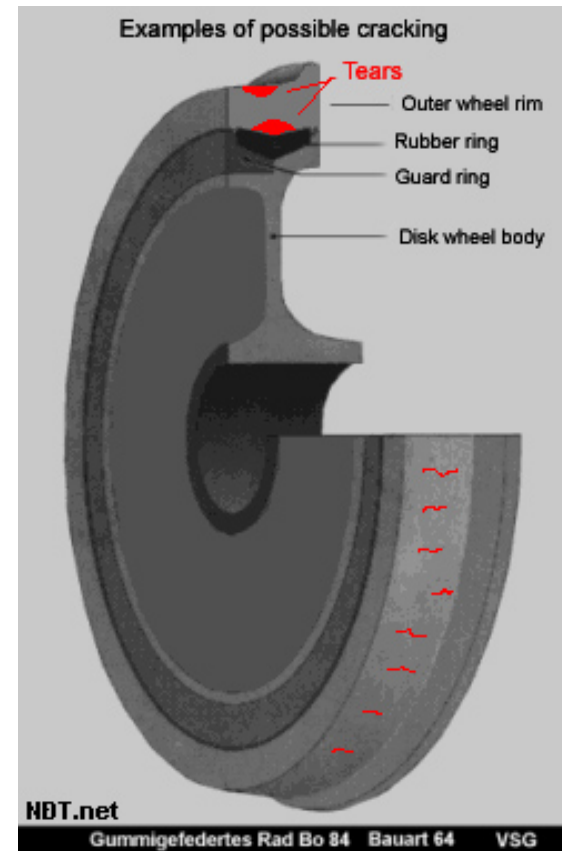
Fatal Wheel “Improvement”

- First generation ICE trains were made with single-cast or “**mono-block**” wheels.
- That design could result in **metal fatigue** and out-of-round conditions which caused vibrations at cruising speeds.
- Based on heritage streetcar design, the mono-block wheel was **modified to include a rubber damping ring** 20mm thick between the metal wheel rim and the wheel body.

- Delamination of wheel rim
- Failure to stop immediately upon delamination of wheel rim

- Inadequate testing and design verification
 - The rubber cushioned wheels, which had been used successfully on streetcars, were not suitable for the heavier load of ICE trains operating at much higher speeds.
 - At the time, Germany did not have the facilities to adequately test such designs, so many of the wheel design decisions were based on analysis and theory rather than test data.
- Inadequate independent verification of analyses
- Failure to establish and follow necessary operational margins of safety and “acceptable” wear and tear limits
- Failure to consider external hazards in operating area
- Flawed emergency response policies and procedures
