System Failure Case Studies

MARCH 2007

Volume 1 Issue 5

DERAILED

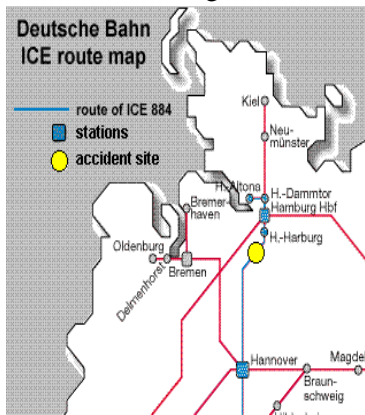
The rear axles of the third coach were switched onto a parallel track, twisting the coach perpendicular to the rails, and sending the car careening into the pylons of a

300 metric ton roadway overpass just beyond the second switch. Coach four, derailed by the violent deviation of car three, traveled underneath the bridge impacting an embankment, and killing three railway employees who were working nearby.

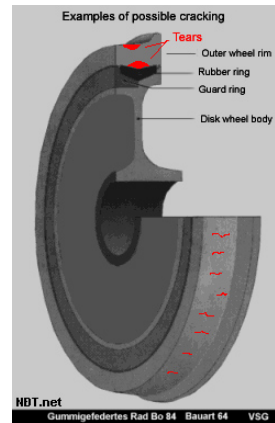
The Fraunhofer Institute in Germany was tasked with the accident investigation and traced its cause back to an improper application of a street-car wheel design. First generation ICE trains were made with single-cast or "mono-block" wheels. Engineers realized, however, that this design could result in metal fatigue and out-of-round conditions which caused

vibrations at cruising speeds. The mono-block wheel design was modified to include a rubber damping ring 20mm thick between the metal wheel rim and the wheel body. Researchers later learned that, although it reduced vibrations, this new design weakened the wheel, making it much more dangerous than the original. Normal operational wear further weakened the modified (thinner) wheel rims on the WCR, causing one to separate from the wheel body and become embedded in the floor of the first passenger coach.

After the accident, all ICE operations were suspended until a full scale investigation could be completed. The wheel-tire design was completely discontinued throughout Germany and was replaced by the original mono-block wheel design. Meanwhile, Germany’s entire transit network was checked for similar arrangements of switches near possible obstacles.

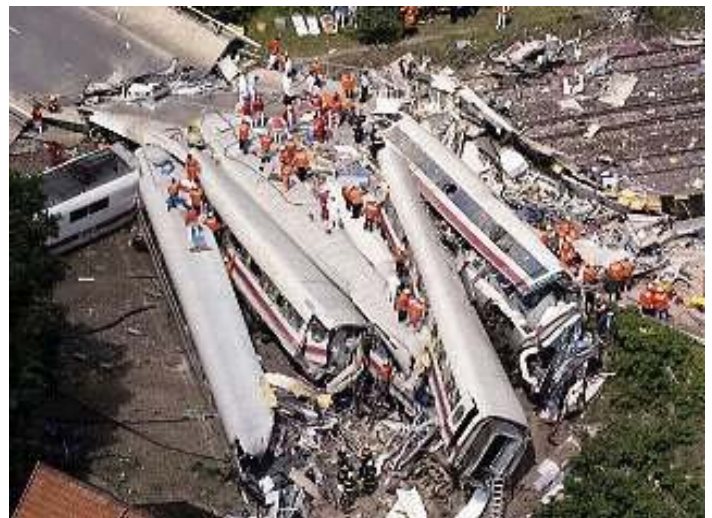
InterCity Express Train 884 derailed near Eschede, Germany, killing 101

The ICE 884, the Wilhelm Conrad Rontgen, derailed near Eschede, Germany while en route to Hamburg, Germany.
