System Failure Case Studies

APRIL 2007

Volume 1 Issue 6

INNOVATION PUSHED TOO FAR TOO FAST

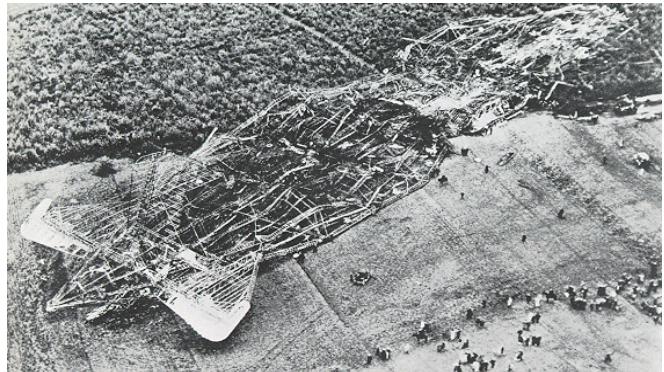
The charred remains of R101 near Beauvais, France.

Survivors reported that there was no violent movement upon impact and that the ship bounced slightly and then leveled. The force of the crash twisted the starboard forward engine around on its struts, bringing it into contact with and igniting hydrogen from the ruptured forward envelope. Flames quickly engulfed the R101, killing 48 of the 54 passengers and crew aboard.

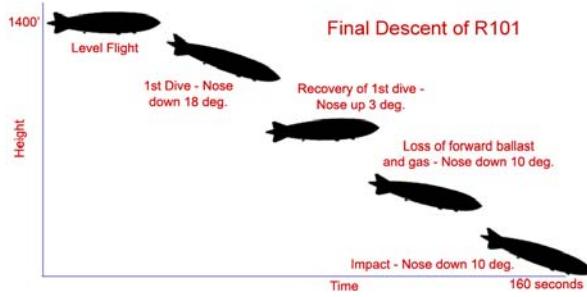
R101 then made a steep dive, causing many crew members to lose their balance and furniture to slide across the floor. The accident investigation suggests that severe weather caused a tear in the nose area, exposing a hydrogen envelope that rapidly deflated and started to accumulate rain water. The loss of hydrogen buoyancy combined with added weight of the rain-soaked nose section caused R101 to pitch down at an angle of 18 degrees for up to 90 seconds.

At an altitude of only 530 feet (R101 was 777 feet in length), the ship went into a second dive as the crew tried unsuccessfully to steady the ship. The Captain called for an emergency landing and sounded the bells to alert the passengers onboard. R101 impacted the ground at a relatively gentle 13.8 mph leaving a trench two feet deep and nine feet long where the nose touched down.

After the first dive, the R101 crew was able to regain control and steady the flight pattern. They were unable to do so after the second dive and crashed.
