# System Failure Case Studies

DECEMBER 2007

Volume 1 Issue 9

## FORRESTAL IN FLAMES

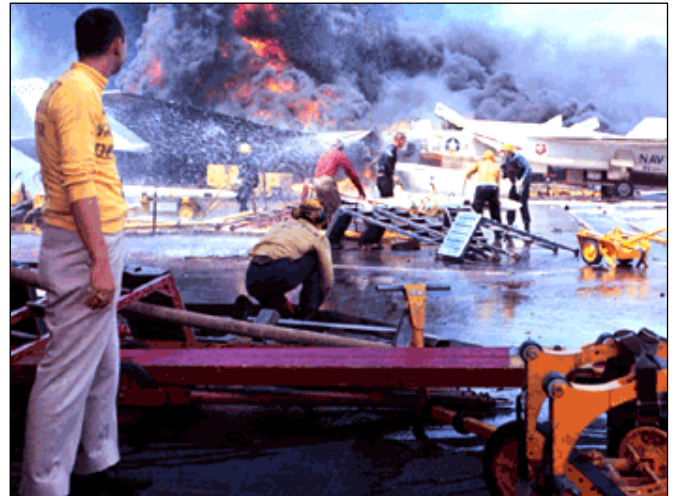
Deck of the Forrestal engulfed in flames July 29, 1967.

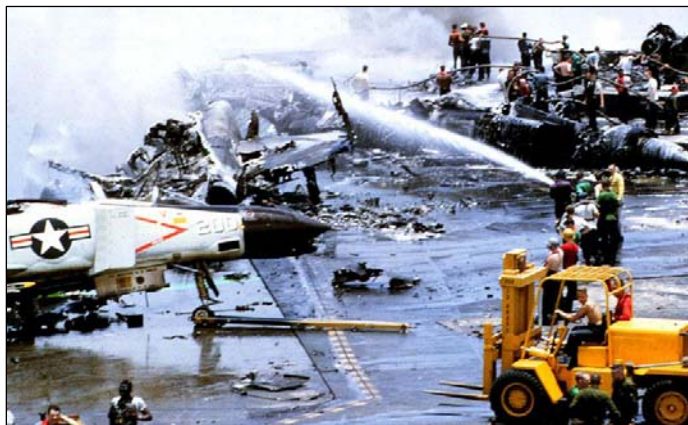
**Forrestal crew fights to quell the raging jet-fuel fires.**

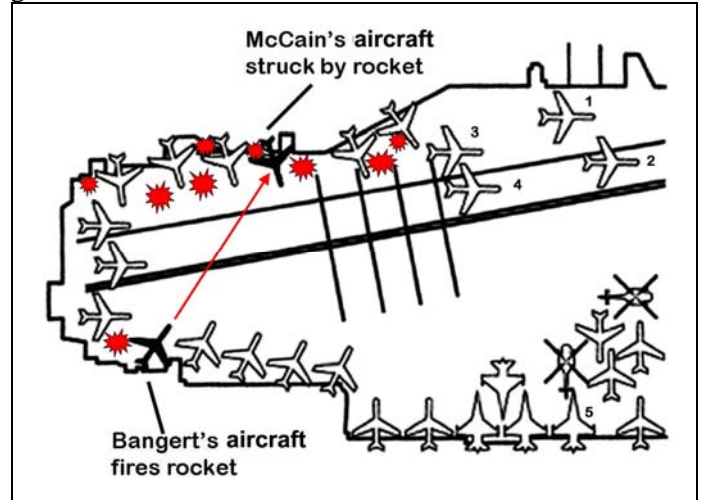
**Arrangement of aircraft at the time of the rocket misfire.**

At 10:51:21, he hit the power cutover switch, and one of his Zuni rockets blazed across the deck, chest high, severely burning members of Bangert's ground crew, severing a man's arm on its way across the deck and ripping open a loaded fuel tank of an A-4 Skyhawk (piloted by John McCain, now US Senator from Arizona). Hundreds of gallons of JP-5 fuel spewed onto the flight deck and ignited directly beneath the wing mounted 1000 pound B-bomb payload. One minute and 34 seconds later, the B-bomb exploded.

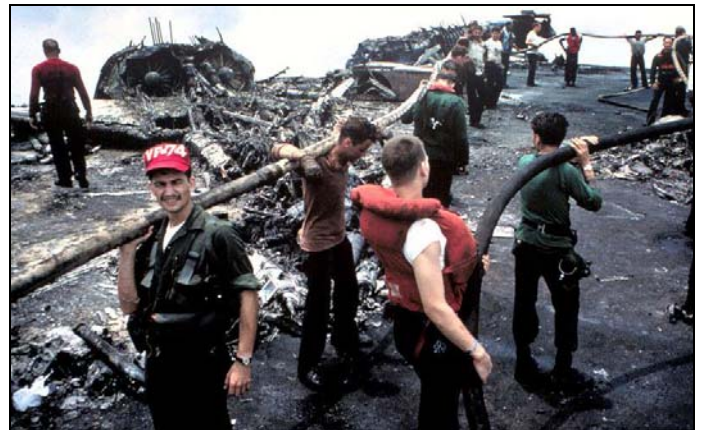
Inadequate Firefighter Training, Infrastructure & Equipment: Despite Captain Beling's efforts to accelerate fire-fighting training in the year before deployment, many of the crew remained untrained, especially in jet-fuel fires. With Damage Control Team #8 decimated, untrained sailors valiantly fought jet-fuel fires with water hoses (the wrong thing to do) rather than foam. Only half the ship's crew and none of the Air Wing crew had attended fire-fighting school in the previous three-year period. In addition, Air Wing sailors (40% of the Forrestal crew) were not trained to use an oxygen breathing apparatus and were not well oriented to Forrestal damage control processes and equipment. Numerous problems were also identified related to flight deck "foam station," design, operational readiness and training for foam station operators.

The crew continue to fight the blaze that killed 134 sailors.
