System Failure Case Studies

MAY 2008

TWO RODS DON'T MAKE IT RIGHT

Collapse of Walkways Kills 114.

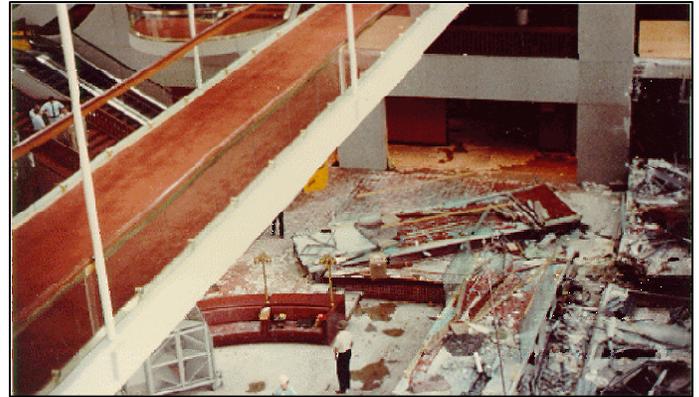
On July 17, 1981, nearly one year after its completion, the Hyatt Regency Hotel in Kansas City, Missouri filled its lobby with guests participating in and watching the evening “tea dance.” Suspended above the lobby were concrete walkways designed to connect both sides of the 2nd, 3rd, and 4th floors. Shortly into the dance, two of the walkways, packed with spectators, collapsed onto the crowded atrium floor below (Figure 1). The event was triggered by a failure in the connection between a supporting rod and the box beam of the fourth floor walkway. This disaster killed 114 people and injured approximately 200 more, which at the time was the deadliest structural collapse in U.S. history.

Figure 1: Pieces of the collapsed walkways in the atrium.

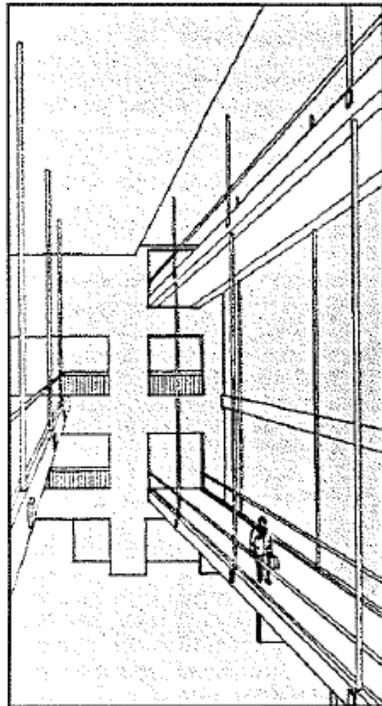
The initial planning for the Hyatt Regency Hotel began in 1976. The basic elements of the hotel design consisted of a 750 guest-room tower, a top-floor revolving restaurant on the 45th floor, and a four-story open atrium. Suspended across the atrium were three hanging walkways connecting opposite sides of the 2nd, 3rd, and 4th floors. The 2nd floor walkway was placed directly below the 4th floor walkway as shown in Figure 2.

Figure 2: Hanging walkways.

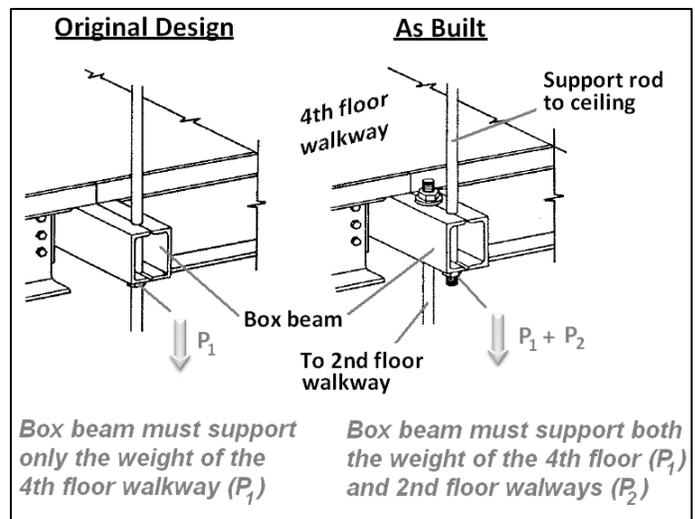
To simplify the process, Havens altered the design to a two-rod system, where the rods from the 2nd floor would attach separately to the 4th floor beams, and the 4th floor rods would attach to the same beams and connect to the roof (see Figure 3). This change was intended to make fabrication and connection of the steel rods easier and faster. However, this essentially doubled the load on the 4th floor walkway beams, as these beams now supported the 2nd floor walkway as well. In effect, this design change resulted in a new load path which introduced a compounding shear stress element to the 4th floor walkway box beam.

However, this essentially doubled the load on the 4th floor walkway beams, as these beams now supported the 2nd floor walkway as well. In effect, this design change resulted in a new load path which introduced a compounding shear stress element to the 4th floor walkway box beam.

Figure 3: Single-rod design versus two-rod modification.

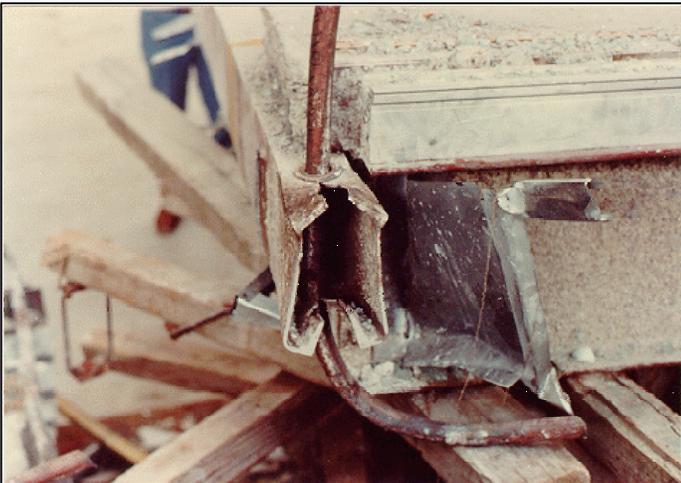
A year after the grand opening of the hotel, in 1981, during the evening “tea dance,” spectators noticed slight movements and swaying of the hanging walkways. Within moments, one of the connectors on the 4th floor walkway failed, as the weight of the 4th and 2nd floor walkway separated the box beam and pulled the beam loose of the nut and washer of the support rod. The jolt of the connectors breaking free caused a progressive failure of each of the remaining five connectors. As the 2nd floor walkway was attached to the 4th floor walkway, they both crashed down onto the crowded atrium floor below. Figure 4 shows the warped beam after the collapse.

An investigation by the NBS after the incident determined that the proximate cause of the collapse was a failure of the walkway box beam at a support rod connection. The box beam split open along the weld, allowing the nut and washer on the support rod to slip through the beam. In fact, the box beams on the 4th floor had already begun to yield even before the increased weight by the spectators. The weld on the 4th floor box beam had ruptured, allowing the beam to further yield and bend upward under the weight of the two walkways. The bending of the metal went far enough to allow the nut and washer to slip through the beam and break free. Once the first connection failed, the others failed almost immediately after.

Figure 4: Ruptured box beam on the collapsed walkway.
