System Failure Case Studies

JUNE 2008

TUNNEL OF TERROR

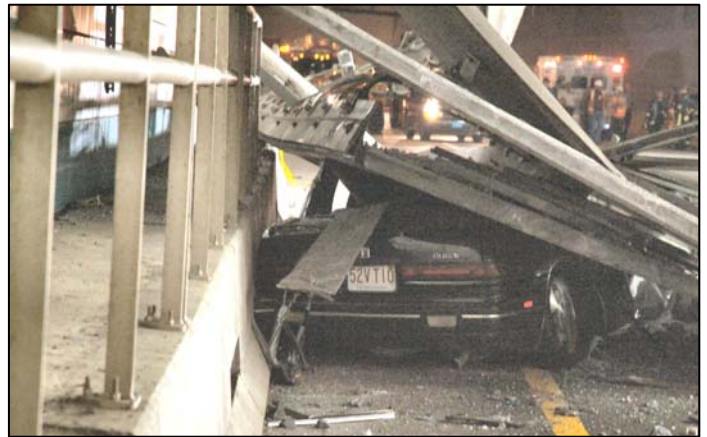
Figure 1: The passenger seat was completely crushed by the fallen concrete panels.

On July 10, 2006, at approximately 11 p.m., thousands of pounds of concrete collapsed onto a passing Buick sedan in the D Street portal tunnel, killing the front seat passenger and injuring the driver (Figure 1).

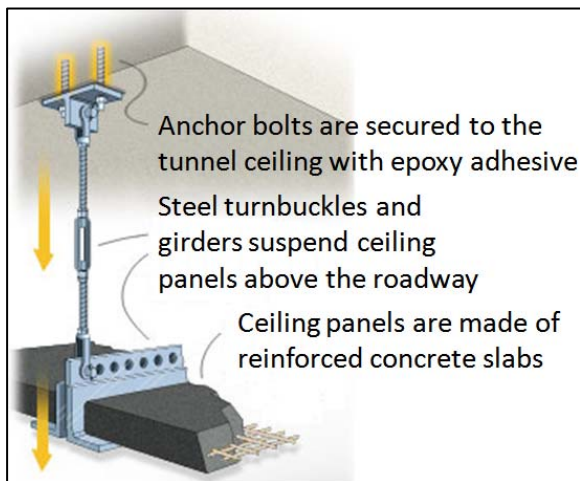
The stretch of highway where the 2006 failure occurred is referred to as the D Street portal, an element within the Interstate 90 (I-90) connector tunnel project, a part of the Central Artery/Tunnel (CA/T) Project, known colloquially as the “Big Dig.” The D Street portal is at the end of the I-90 connector tunnel, opposite to the entrance to the Ted Williams Tunnel, which runs under the Boston Harbor to Logan International Airport. While the tunnel itself was completed in 1996, suspended ceiling panels were installed in 1999 as part of the ventilation system. The panels consisted of reinforced concrete slabs (5,000 to 6,000 lbs each) inserted into steel frames which were suspended from the tunnel ceiling by bolts secured with epoxy resin (Figure 2).

Figure 2: Design of the suspended panels.

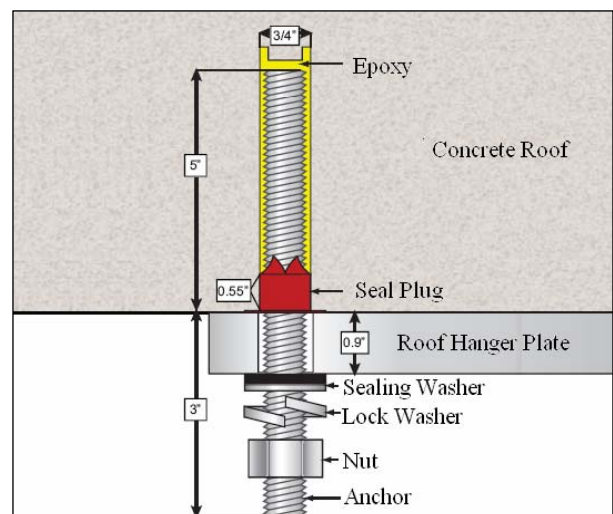
The epoxy adhesive material underwent creep deformation and fracture, allowing the anchor bolts to pull free from the tunnel roof. It was later determined that the anchor epoxy employed in the D Street anchors was the wrong formulation, one which was known to have poor creep resistance under sustained tensile loads.

The epoxy adhesive played a critical role in securing the ceiling anchor (Figure 3). No documentation was provided by the supplier, PFI, identifying which epoxy formulation was supplied, and neither GF nor BPB questioned which epoxy was used. All parties, including MCC, assumed that the epoxy provided by the supplier was suitable. The National Transportation Safety Board (NTSB) report cited PFI for failing to adequately com-

Figure 3: The epoxy adhesive was a critical component in securing the anchor bolts.

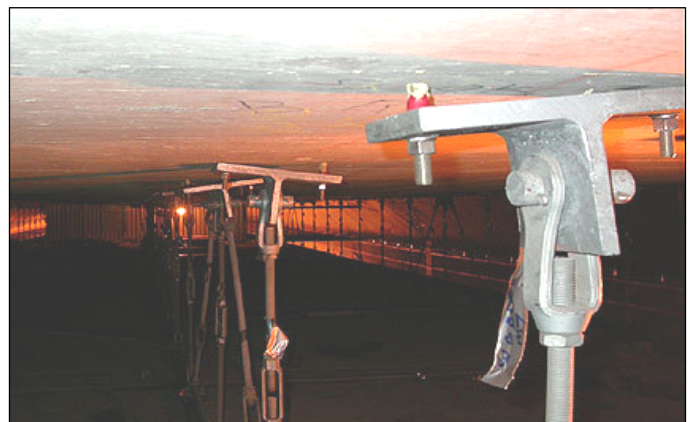
Figure 4: Numerous anchor bolts were found to have been affected by creep.

Post failure inspections showed that a significant number of adhesive anchors in the D Street portal and in other isolated locations in the I-90 connector tunnel were at risk for imminent failure (Figure 4). State inspectors deemed over a thousand hangers suspended by epoxy anchors unreliable. The ceiling in the D Street portal was taken down and not replaced; since the portal was at the end of the tunnel, the ceiling was not needed for ventilation in that area. A second mechanical expansion anchor bolt was ordered to be installed next to each suspect bolt in the remaining tunnel roof. On June 2, 2007, after nearly a year of repairs costing \$54 million, the tunnel was fully operational.
