No Left Turns: United Airlines Flight 232 Crash

Leadership ViTS Meeting
July 2008

Bryan O'Connor
Chief, Safety and Mission Assurance

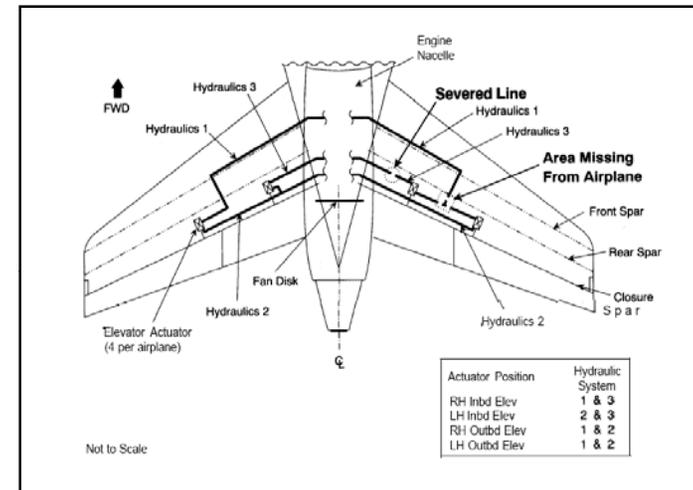
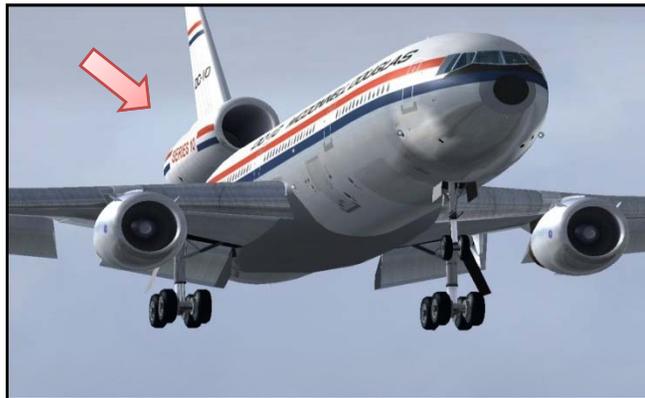
- On July 19, 1989, just after reaching the 37,000 ft. cruising altitude, the tail mounted (number 2) engine of United Airlines Flight 232 explosively ruptured.
- Fragments of the fan rotor disk ripped through both the DC-10 aircraft's horizontal stabilizers, severing the first and third hydraulics lines and also removing entire pieces of the first and second hydraulic systems (later recovered on the ground).
- All hydraulic fluid was drained within 2 minutes of the explosion. Without hydraulic fluid, there was no way to operate the aircraft's control surfaces or landing systems (rudder, ailerons, flaps, brakes, landing gear, etc.).

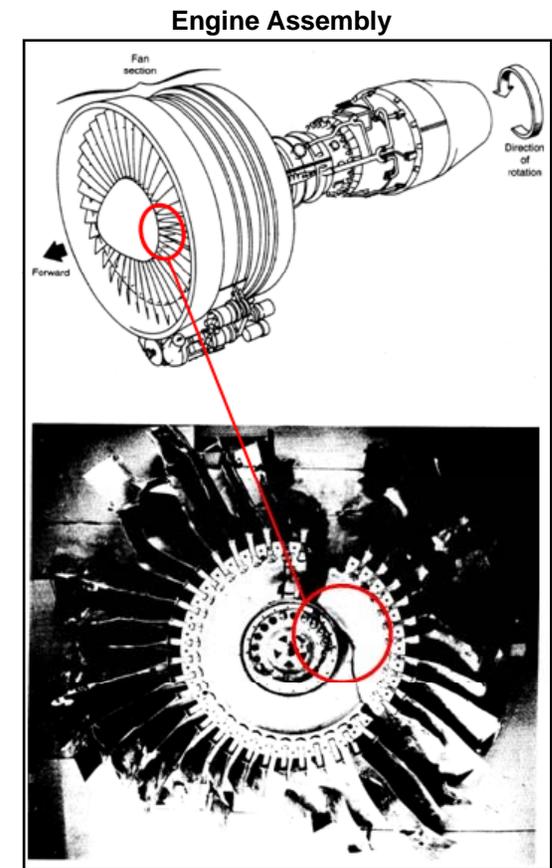
- The National Transportation Safety Board (NTSB) investigation found residue around the crack area from the Fluorescent Penetrant Inspection (FPI) technique used by United Airlines maintenance crews. Therefore, the NTSB cited human error in failing to detect the crack despite having inspected the affected area.

- Due to prolonged fatigue stresses, one or more cracks propagated to its critical crack length, causing the catastrophic failure of the fan rotor and the subsequent catastrophic failure of the engine.

Re-assembled fan rotor with crack(s)
