Fender Bender: DART's Automated Collision

Leadership ViTS Meeting
September 2008

Bryan O'Connor
Chief, Safety and Mission Assurance

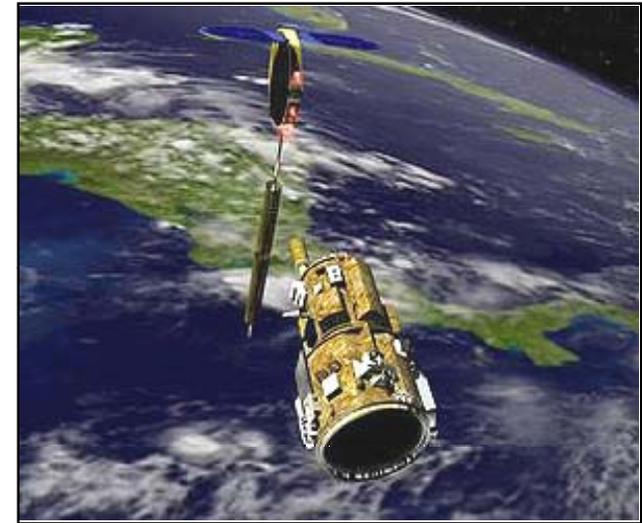
- Approximately 11 hours into the 24 hour mission, DART collided with MUBLCOM. Shortly afterwards, its fuel supply ran out, and DART transitioned to its Departure and Retirement sequence without having accomplished any of its 14 technology objectives.

DART (foreground), MUBLCOM (background)

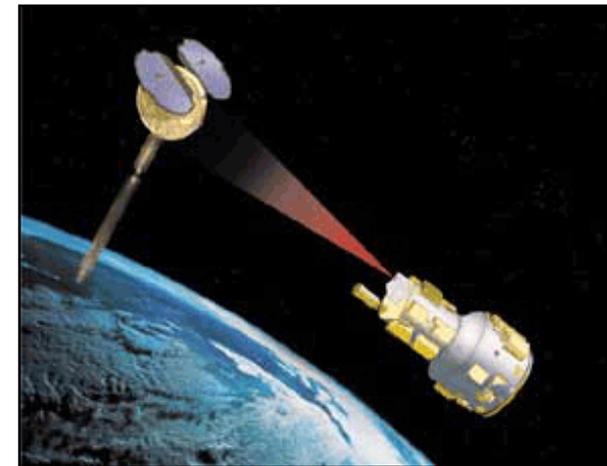
Error 1: The comparison of the velocity input from the GPS receiver to the software-based estimates had to be within an accuracy of ± 1 m/s or the estimates would diverge from the measurements and trigger a reset. However, the GPS design specified the accuracy to ± 2 m/s. The allowed imprecision sent DART into an infinite do-loop, resetting itself about once every 3 minutes.

Error 2: The gain setting was changed close to launch to accommodate for a unit conversion error found late in the testing phase. The new setting gave an inappropriately high weighting to the estimates relative to the measurements. While the original gain setting would have broken the infinite-loop bug from Error 1, the new setting perpetuated it ... and nobody caught it.

- The improperly designed and executed navigational system software prompted excessive and inaccurate thruster firings, causing DART to miss the waypoint needed to trigger switchover to AVGS navigational control. If switchover had occurred as planned, the GPS data would have been ignored, and the reset loop would have been broken.

DART (right) used estimates and measurements to determine its velocity and position relative to MUBLCOM (left).
