System Failure Case Studies

SEPTEMBER 2008

FENDER BENDER

The Demonstration of Autonomous Rendezvous Technology (DART) program began in May 2001, intending to demonstrate that a spacecraft could independently rendezvous with an orbiting satellite without human intervention. In April 2005, the DART spacecraft was successfully launched with both Phase I (Launch and Early Orbit) and Phase II (Rendezvous) considered successful. However, following a series of navigational system errors and problems with fuel management, DART crashed into its rendezvous partner spacecraft. Shortly afterwards, the mission prematurely ended without having achieved any of its Phase III (Proximity Operations) technical and scientific objectives. DART transitioned into Phase IV (Departure and Retirement) only 11 hours into its 24-hour mission plan. Analysis showed that multiple design errors and testing issues in the navigational system contributed to what NASA declared a “Type A” mishap.

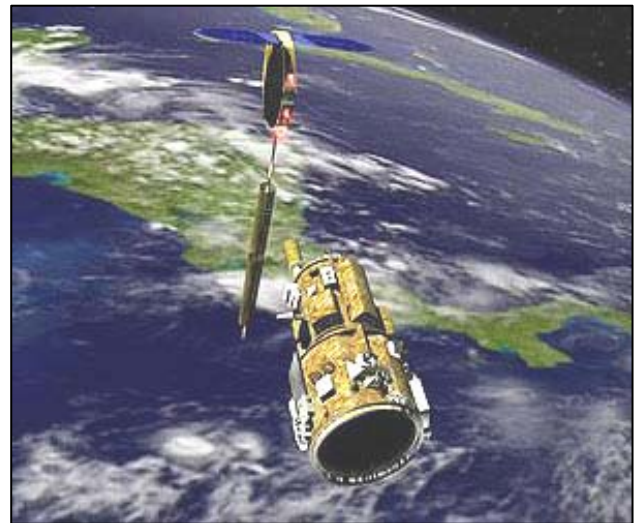
Figure 1: Artist rendition of the DART spacecraft (foreground) in orbit with the MUBLCOM satellite (background).

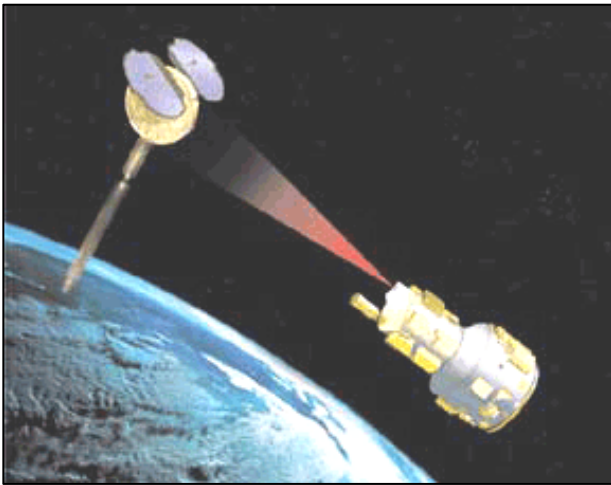
Figure 2: DART's (right) AVGS gathers data from laser signals reflected off MUBLCOM (left) in order to calculate range, bearing, and attitude (artist rendition).
