That Sinking Feeling: Total Loss of Petrobras P-36 *

* A floating oil drilling platform designed and operated by **Petróleo Brasileiro S/A** (aka Petrobras)

Leadership ViTS Meeting
October 2008

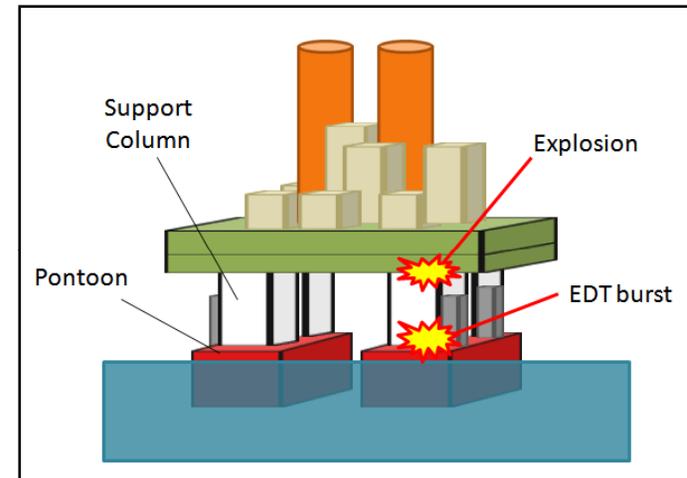
- An emergency drain tank (EDT) located in one of the four support columns had been shut down and supposedly isolated by the closure of a valve, however, leakage of volatile fluids and gases through the valve over-pressurized the tank and the tank violently burst at 12:22 am on March 15, 2001.

- The seawater service pipe adjacent to the EDT ruptured in the burst. Over the next 17 minutes, 1,723 alarms were triggered. Operations dispatched the fire-fighting team and activated the seawater service pipe, which instead of supplying water to the fire-fighting team was now flooding the support column.

- The volatile mixture of fluids and gases from the burst EDT was later ignited by an unidentified ignition source resulting in an explosion that **killed the 11 members** of the fire-fighting team.

- Flooding of the column also short circuited the seawater pump located at the bottom of the column in the pontoon. The valve to the ocean failed and locked in the open position allowing uncontrolled flooding of both the column and pontoon.

- Within minutes, P-36 tilted by 5 degrees. By 6:03 am, the rig was abandoned. At 8:15 am, the flooding exceeded the capability for the platform to maintain stable floatation and an entire corner of the rig submerged.

- Five days later the entire \$496 million oil rig hit the bottom of the Atlantic Ocean.

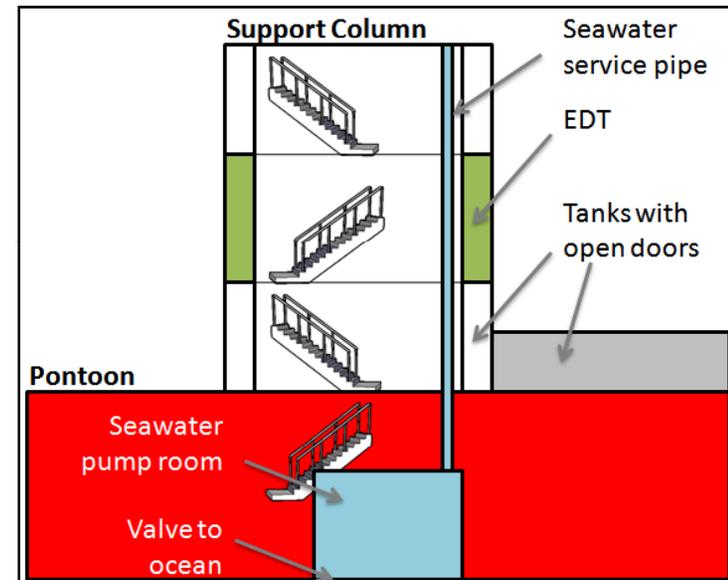
- EDTs are a key subsystem element of oil production operations and exist to store fluids and gases if over-pressurization of the pipes occurs. EDTs are usually located on the bottom deck of the platform, but to save space and money for the design of P-36, the EDTs were installed into the support columns.

- The seawater service pipe was installed inside the column adjacent to the EDT, running inside the support column and leading from the pump room located inside the pontoon.

- Doors inside the column and used to access tanks and compartments needed for control of buoyancy and stability had been left open for inspections scheduled later that day. These compartments were therefore susceptible to flooding easily.

- Each of the several floors inside the column and extending inside the pontoon contained air vents as a part of the ventilation system, which allowed flooding progressively into the upper levels.

- There were no records indicating the existence of any hazard analysis that might have identified the creation of a catastrophic hazard by placing so many safety-critical parts and subsystems next to one another and susceptible to a common cause failure.
