System Failure Case Studies

OCTOBER 2008

Volume 2 Issue 8

THAT SINKING FEELING

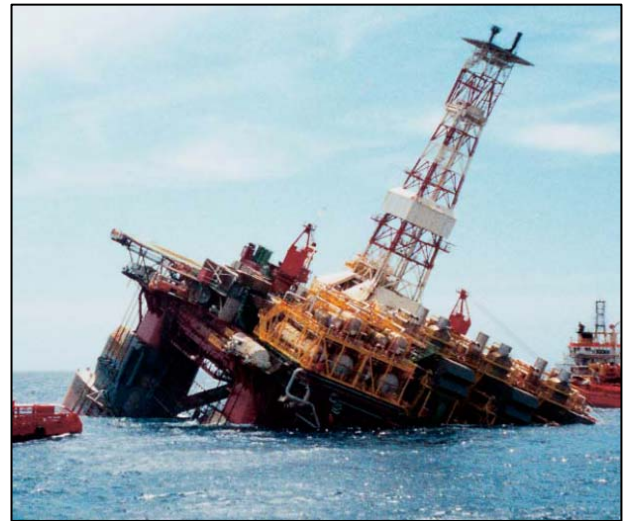
On March 20, 2001, the largest offshore oil production platform in the world sank to the bottom of the ocean about 150 kilometers off the coast of Brazil. A series of explosions claimed the lives of 11 crew members and crippled one of the four main support columns, which resulted in the massive flooding of Petrobras Platform 36 through an improbable but devastating chain of events. Approximately 1,200 m³ of diesel oil and 300 m³ of oil spilled into the Atlantic Ocean's Campos Basin, and the \$496 million rig was declared a total loss.

Figure 1: Petrobras P-36 sinks into the Atlantic Ocean.

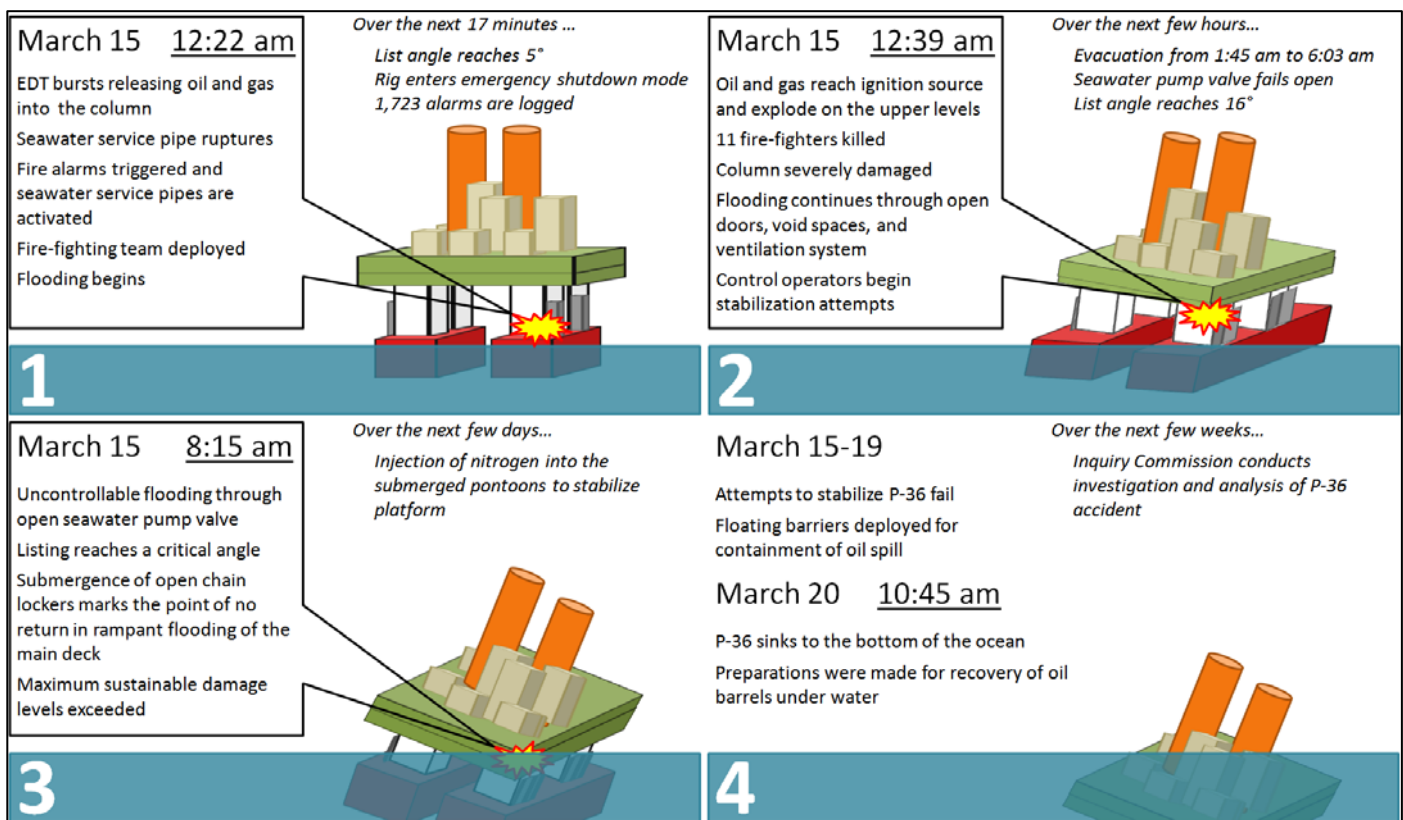
- Leakage of volatile fluids burst a shut down emergency drain tank and set off a violent chain of events

Figure 2: Sequence of events that culminated with the sinking of the world’s largest oil rig, P-36.

The final report from the P-36 Accident Inquiry Commission concluded that a complex series of improbable events (predominately in emergency systems) caused the P-36 disaster and that almost every contributing factor represented an opportunity to break the chain of events. The principal trigger event was the leakage of a mixture of water, oil, and gas into the shut down EDT, which built up excessive internal pressure and ultimately ruptured the tank. The tank's proximity to key structural and operational elements served as the catalyst for the successive events that culminated with the sinking of P-36.
