# Under Pressure:

## Sonat\* Separation Vessel Pressure Rupture

**Leadership ViTS Meeting**  
December 2008

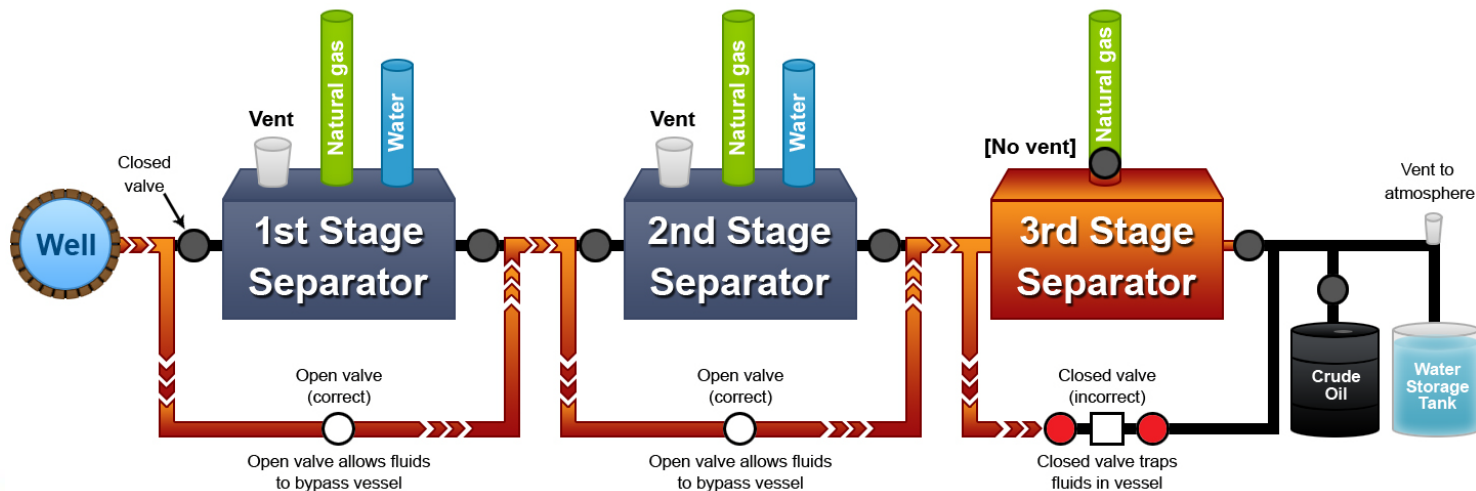
- Tank 3 had two manual valves and one pneumatic valve in its bypass line in addition to downstream valves.
- These Tank 3 valves were opened during an earlier operation, but at an unknown time they were incorrectly moved to the closed position. Tank 3 now had no means for relieving any pressure increase internal to the vessel.

***Without an outlet to vent the gas, the third stage separator vessel ruptured at approximately 6:15pm, releasing a fireball that killed four workers and ignited surrounding materials. The facility sustained over \$200K damage.***

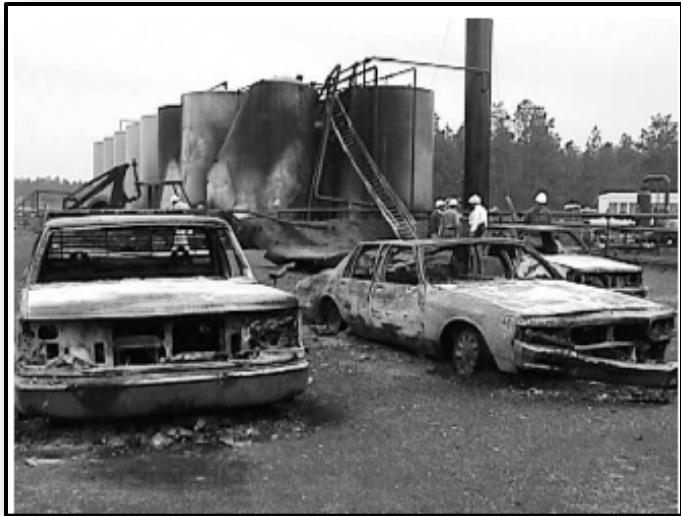
- The third separation vessel was designed to operate at atmospheric pressure, had no provision for relief of excess pressure, and could not be isolated from an adjacent bypass line.
- The first and second separation vessels operated above atmospheric pressure but well below maximum operating pressure. They were also equipped with pressure relief valves.
- There was no piping and instrumentation diagram (P&ID) for the system.
- There were no written operating instructions or checklists.

Two valves in the bypass of the third separator vessel and the valve on the outlet side of the vessel were closed, preventing flow out of the vessel and allowing pressure to build (in this instance, possibly as high as 800 PSI).
