SYSTEM FAILURE CASE STUDIES

DECEMBER 2008 VOLUME 2 ISSUE 10

Under Pressure

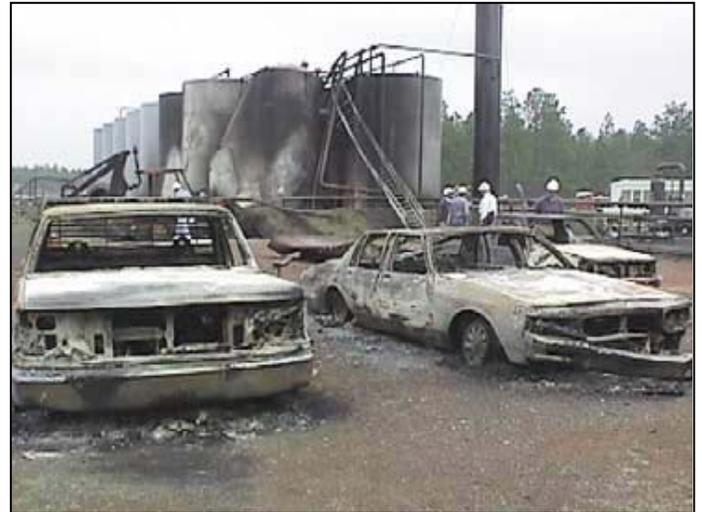
On March 4, 1998, the Sonat Exploration Company in Pitkin, LA, began purging an oil pipeline to prepare for a new oil well. The well contained a high-pressure mixture of crude oil, natural gas, and water that would be separated in a newly constructed separation “train.” Before beginning production, Sonat had to purge the pipeline to remove any air and gas already inside the pipes. The first stage of the purging operation was completed without incident. However, during the second stage of the purging process, one of the separation vessels became over-pressurized and ruptured, releasing flammable gas that subsequently ignited in a massive explosion. Four of the six workers on-site were killed immediately, and the incident caused \$200,000 of facility and equipment damage (Figure 1).

Figure 1: The exploded vessel (no longer present) was to the left of the damaged storage tanks and identical to its older counterpart on the right.

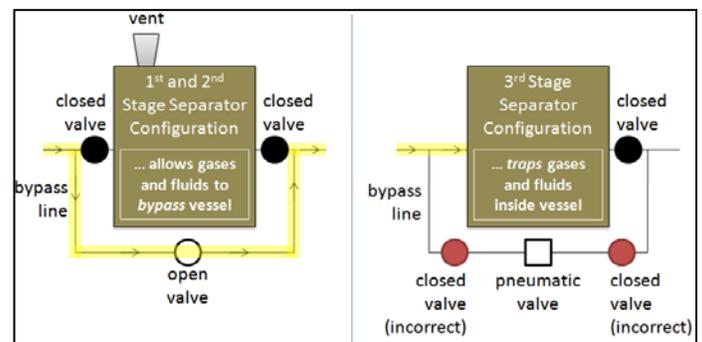
Figure 3: Key design differences between the 1st and 2nd separator vessels (left) and the 3rd separator vessel (right). The path of fluids and gases are highlighted.

Two critical valves in the bypass line were incorrectly in the closed position (see Figure 3), preventing the purged gases from venting into the atmosphere as necessary. Instead, the well fluids and pipeline gases were forced into the third stage separator vessel, where they were trapped. Different investigation groups, including the Chemical Safety Board (CSB),

the Oak Ridge National Laboratory, and Sonat itself, estimated that the pressure inside the vessel that was designed to operate at atmospheric pressure had risen to anywhere between 135 to 400 psig before bursting.

The design and construction of the facility, pipeline, tanks, and valves did not undergo formal design reviews, nor was the design properly documented in any sort of process or instrumentation diagram. Figure 3 displays the configurations for the three separator vessels, showing the key design differences between the first two and the third. First, the third stage separator vessel was the only one of the three designed to function at its maximum allowable pressure for safe operation, leaving very little margin for error. Second, it did not contain a valve to close off the inlet to the vessel. Therefore, even when operated properly, the vessel could not be blocked from the unwanted entry of fluids or gases. And finally, the vessel was not equipped with an atmospheric vent to protect against over-pressurization. The CSB investigation stated that a formal design review and hazard analysis process would have likely identified the design shortcomings for an over-pressurization scenario and that the absence of accurate engineering drawings for process and instrumentation was a severe impediment to an effective review process.

Recommendations issued by the CSB to Sonat included instituting a formal design review process for all oil and gas production facilities in Sonat's businesses. Additionally, CSB recommended implementing a program to ensure that equipment vulnerable to over-pressurization be equipped with adequate pressure relief systems and that compliance be audited. Further, it was recommended that Sonat develop written procedures for all the processes at oil and gas facilities, as well as provide formal training programs in applying these procedures. Finally, the CSB recommended that the API develop and issue guidelines specifically addressing safe start-up and operations of oil and gas production facilities.
