The Unknown Known:

USAF B-2 Type A Mishap

Leadership ViTS Meeting

January 2009

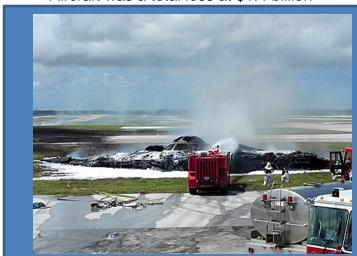
- At 10:30AM local time on February 25, 2008, the B-2 "Spirit of Kansas" lifted off from Andersen Air Force Base on the island Guam. Seventeen seconds later, the aircraft crashed on the airfield as both crewmembers ejected.
 - One of the two pilots was injured but is expected to fully recover
 - Aircraft was a total loss at \$1.4 billion

On the day of the incident, the system that feeds all air data to the four onboard computers that operate the Flight Control System (FCS) was incorrectly calibrated such that the FCS pitched the B-2 up into an unrecoverable attitude immediately after takeoff.

Moisture in the Port Transducer Units (PTUs) caused significant bias to be programmed into the ADS during calibration. Based on this skewed data, the flight computers calculated an inaccurate airspeed and negative angle of attack, which contributed to the early rotation, 30° pitch up, and subsequent stall and crash.
