SYSTEM FAILURE CASE STUDIES

JANUARY 2009 VOLUME 3 ISSUE 01

The Unknown Known

February 25, 2008: B-2 Bomber “Spirit of Kansas” crashes after takeoff at Andersen Air Force Base in Guam.

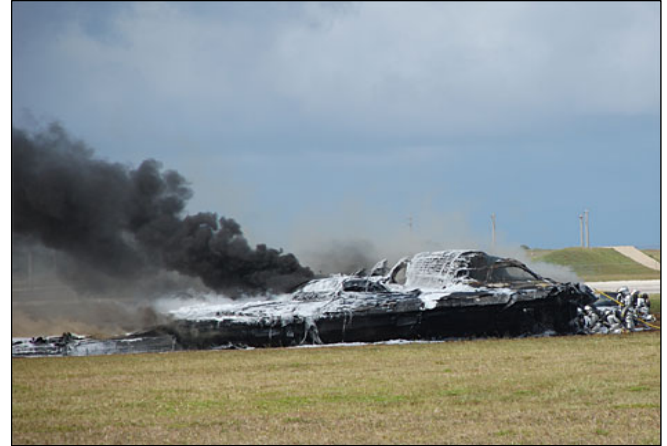
Figure 1: The Spirit of Kansas crashes in Guam

- Moisture in the Air Data System caused the miscalibration of several Port Transducer Units. This initiated a tightly coupled chain of events that culminated in the B-2’s crash.

The US Air Force accident board concluded that moisture in the PTU’s caused significant bias to be programmed into the ADS during calibration. Based on this skewed data, the flight computers calculated an inaccurate airspeed and negative angle of attack, which contributed to the early rotation, 30° pitch-up, and subsequent stall and crash. Hindered by inadequate altitude and airspeed, as well as degraded flight con-

Following the accident, the 509th Bomb Wing Commander ordered a "safety pause" in order to allow the unit to review procedures. During the "safety pause," the B-2 fleet was not officially grounded, but all flight operations were temporarily suspended. The B-2 fleet returned to flight on April 15th, 2008. As a result of the USAF findings, pitot heat was added to the PTU calibration procedure.

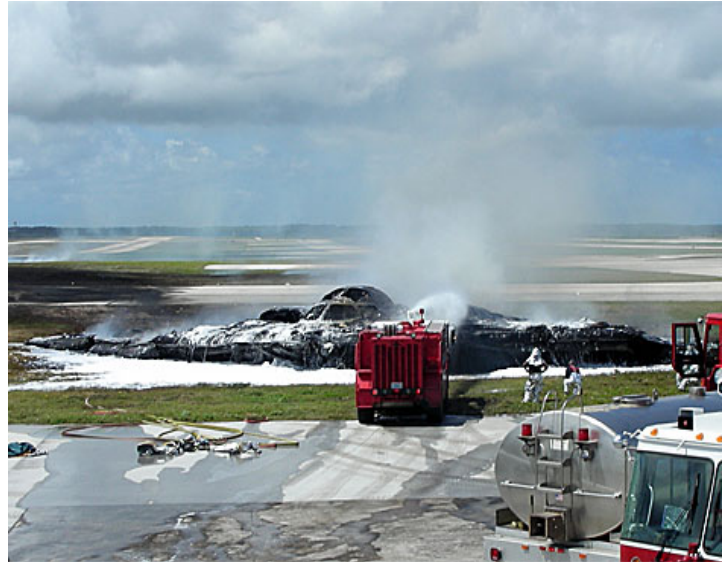
Figure 2: Emergency teams respond to the crash site

The "Spirit of Kansas" was a total write-off, with an estimated \$1.4 billion in property damage. While the pilot sustained only minor injuries, the co-pilot suffered compression fractures in his spine (he was expected to make a complete recovery). The investigation determined that both pilots acted appropriately during the mishap and followed procedure correctly.
