SYSTEM FAILURE CASE STUDIES

Cover Blown

Launched on March 4, 1999, the Wide-Field Infrared Explorer (WIRE) carried an infrared telescope that was meant to study the formation and evolution of galaxies. To prevent the satellite's heat from interfering with faint infrared signals, the telescope was stored in a cryostat cooled by tanks of frozen hydrogen. Approximately twenty minutes after WIRE separated from its launch vehicle, a transient electronic signal released the cryostat cover, exposing the hydrogen tanks to heat from the sun and earth. The hydrogen sublimated and escaped through the vents, sending the spacecraft into an uncontrolled spin. In less than thirty-six hours, the entire four-month supply of solid hydrogen needed to cool the telescope's infrared sensors was gone. The mission ended in failure just four days after launch.

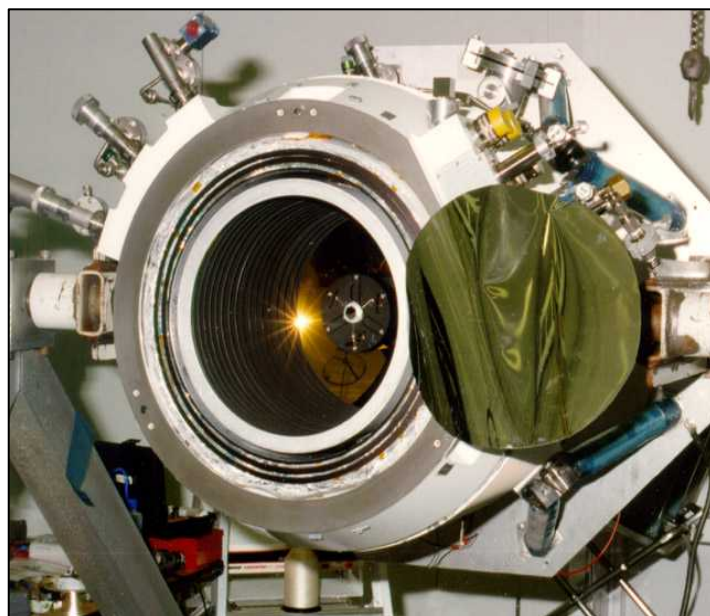
To ensure that heat from the telescope itself did not interfere with the faint infrared signals the sensors were trying to detect, the entire instrument was encased in a cryostat lined with two tanks of frozen hydrogen (Figure 1). The larger tank operated at 12 degrees Kelvin (K) to provide shielding for the primary tank, which kept the infrared detectors below 7 K. The telescope and interior of the cryostat were protected by a cryostat cover that would be released after WIRE was properly oriented and ready to begin its infrared survey (Figures 2 and 3).

Figure 1: The open cover reveals WIRE's telescope in the center of the cryostat.

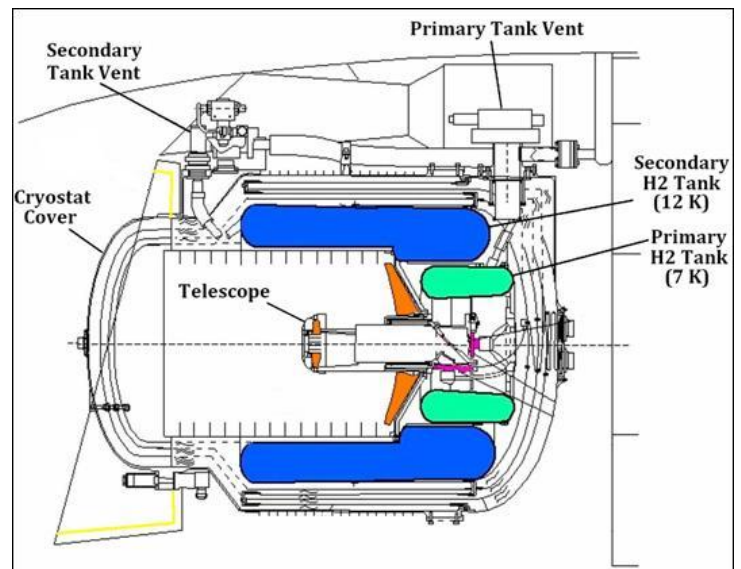
The vents opened successfully, but unknown to the ground crew, at this same time a transient electronic signal was sent to a pyro, releasing the cryostat cover. This cover was designed to shield the telescope and interior of the cryostat and should not have been jettisoned until after the spacecraft was properly oriented.

Figure 2: Cutaway of the cryostat showing the cryostat cover protecting the telescope and the two hydrogen tanks.

As the pyro box started up, its internal components were in an uncontrolled state for several milliseconds. During this time, a transient electronic signal prematurely fired the pyro and released the cryostat cover. Without its cover, the interior of the cryostat was exposed to heat loads one hundred times larger than anticipated, causing the hydrogen to sublimate. Without the hydrogen coolant, the infrared telescope could no longer distinguish between signal and noise.

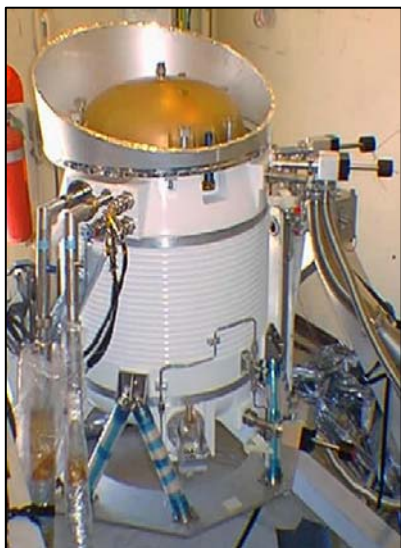
Figure 3: WIRE's cryostat cover (gold colored) shields the telescope and hydrogen tanks
