SYSTEM FAILURE CASE STUDIES

JUNE 2009 VOLUME 3 ISSUE 04

Triple Threat

In the summer of 2003, a Honeywell International Inc. Baton Rouge, Louisiana chemical plant experienced three safety incidents in one month. First, a chlorine leak caused an emergency shutdown of the entire plant. Second, a worker opened a mislabeled cylinder of a highly toxic chemical, fatally exposing himself to its vapors. Third, while resuming operations after the emergency shutdown, an equipment operator was sprayed with hydrogen fluoride.

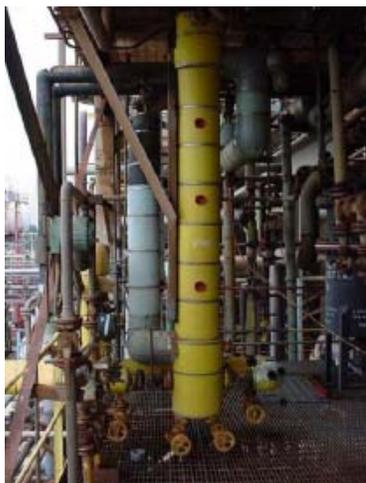
Figure 1: The Chlorine Cooler

Because chlorine boils at -29 degrees Fahrenheit, the transfer system cooled the chemical along its journey from the railcar to the chemical reactor where the refrigerant is produced. The cooler – an 8 foot carbon steel shell – contains tubes of chlorine surrounded by liquid coolant (Figure 1).

At 3:10 am, operators inside the coolant system control room noticed a chlorine smell. Chlorine had infiltrated the coolant lines via holes in the cooler tubes and traveled to the coolant pump, which was not designed to withstand chlorine's corrosivity. The pump seals failed and released the chlorine into the atmosphere (Figure 2). Chlorine gas spread rapidly throughout the plant, entering the control room through unplugged holes and joint gaps in the heating, ventilating, and air conditioning (HVAC) system. The operators were overwhelmed by the odor and, struggling to breathe, evacuated the control room with the cooling process still running. Over the next fifteen minutes, all plant personnel evacuated. Water deluge towers suppressed the chemical vapors while plant personnel notified authorities that the leak

First event: On July 20, chlorine escaped through holes in the cooler tubes, disabled the coolant pump and sprayed into the atmosphere. This triggered an emergency plant shutdown.

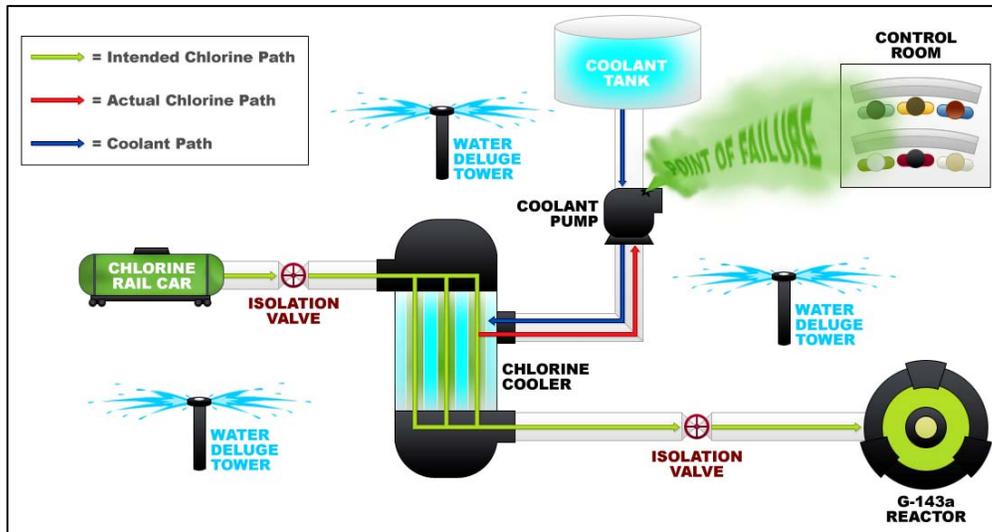
Figure 2: The Chlorine Cooling System

might affect areas outside the plant. During this time, the flow of liquid chlorine through the cooling system to the failed pump continued, because chlorine had corroded the control system that would have shut the process down. Fortunately, the wind was not strong that day (3-5 mph), so the chlorine gas did not spread quickly through the surrounding communities. At 6:46 am, over three and a half hours after the leak began, plant emergency response personnel manually closed the isolation valve between the chlorine railcar and the chlorine cooler to stop the leak. Eight employees were medically treated, and ten members of the general public also sought treatment.

The Baton Rouge plant did not apply the Occupational Safety and Health Administration (OSHA) Process Safety Management (PSM) Standard to its cooling system and control room even though the standard explicitly includes utilities like the cooling system. If the PSM standard had been applied, personnel might have investigated odors in the control room, conducted more routine maintenance of the HVAC system, and better protected operators. The hazard analyses that were conducted considered the coolant process as a whole, but not the coolant pump individually. The plant was not prepared for the possibility that chlorine might enter the coolant system.

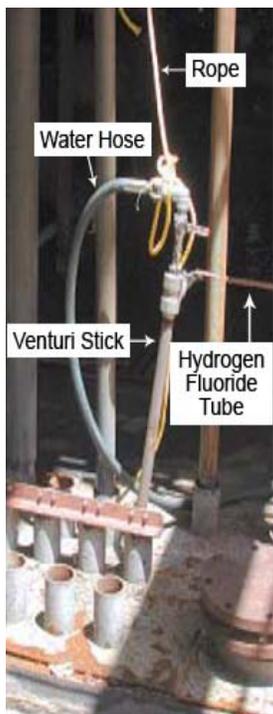
Figure 3:
The Venturi Stick

On August 12th, the operations department began emptying the vaporizer to prepare the plant to resume operations. The procedure used a venturi stick, a suction device using a water flow past an orifice to create a vacuum. Operators secured the venturi stick with a rope and, with the help of pressure from a flow of nitrogen, sucked the liquid hydrogen fluoride out of the vaporizer and into a drainage sewer (Figure 3). While setting up the venturi stick, operators wore the plant-required personal protective equipment, but they later removed their acid suits and respiratory protection.

At approximately 9 am the next morning, the operator noticed a block in the system and opened and closed some valves in order to clear it. This created a pressure surge that lifted the venturi stick out of the sewer and sprayed its contents into the area. The operator closed a valve to stop the flow of hydrogen fluoride. Once the system was shut down, the operator noticed a red mark on his arm and went immediately to the emergency shower. A supervisor came to help him but soon experienced difficulty breathing. Both workers went to the hospital and were released the next day with no major complications.

Similarly, employees did not think the use of the venturi stick with hydrogen fluoride was non-routine, because it was a documented process used in other parts of the plant. However, the venturi stick process the plant had developed was not appropriate for removing liquid hydrogen fluoride. A permanent system for this operation had been installed but did not function properly, so this alternate method was used.
