## SYSTEM FAILURE CASE STUDIES

# A Half-Inch to Failure

*At 6:05 pm, on Wednesday, August 1, 2007, the Interstate-35 West (I-35W) bridge over the Mississippi River in Minneapolis collapsed. On the day of the collapse, four of the bridge's eight lanes were closed for planned construction. Four weak connector plates fractured under the combined burden of rush hour traffic, concentrated construction equipment, and previous heavy renovations. The bridge fell 108 feet into the Mississippi River. The police, fire department, and U.S. Coast Guard immediately initiated rescue operations. Of the 190 people on or near the bridge, thirteen died and 145 were injured.*

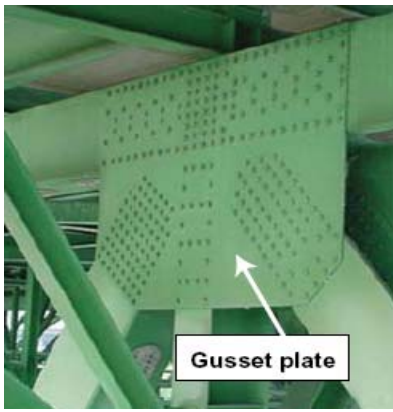
**Figure 2: I-35W  
Gusset Plate**

Steel truss bridges, like I-35W, were more frequently labeled structurally deficient; approximately 31% of the 465 steel truss bridges in the U.S. were listed as structurally deficient at the time of the collapse. Such bridges consist of straight beams of steel formed into triangular units (Figure 1). In large steel truss bridges, the ends of the beams are connected with riveted metal plates called gusset plates. I-35W's gusset plates connected three beams at each node: two diagonal beams and one vertical beam (Figure 2).

According to the National Transportation Safety Board, the gusset plates at the nodes that failed were only half as thick as they should have been. In addition to being too thin, some of the gusset plates were bowed, a distortion that further decreased the bridge's weight bearing capacity. The weak gusset plates fractured under the concentrated weight of the construction materials, the burden of rush hour traffic and the increased load from previous bridge modifications. The diagonal steel beams within the failed nodes shifted to the west and fractured the gusset plates around the ends of the diagonals (Figure 3). Once the diagonal beams separated, the rest of the truss fell.

The Safety Board traces the cause of the collapse to the original bridge design. Several of the gusset plates, including the gusset plates that fractured, were only half an inch thick when they should have been a full inch thick. The plates were not designed to support the bridge's original weight, let alone the additional weight of the 1977 and 1998 renovations. The Board believes that the original designers probably did not exercise quality control to ensure the calculations were correct for these gusset plates. Although the State reviewed the designer's original calculations before the bridge was built, it probably did not have the resources to fully verify the consultant's work. This was not an unusual

As a result of the National Transportation Safety Board’s findings, the FHWA now recommends that bridge owners inspect gusset plates “whenever planned modifications may significantly increase stresses.”

Bridge inspections in Minnesota were revamped. The State examined all 25 steel truss bridges in the state and found gusset plate problems in four bridges. The State repaired the gusset plates on three of the bridges, closed the fourth bridge and accelerated its replacement schedule. Other states also re-inspected their steel truss bridges, paying special attention to gusset plates.

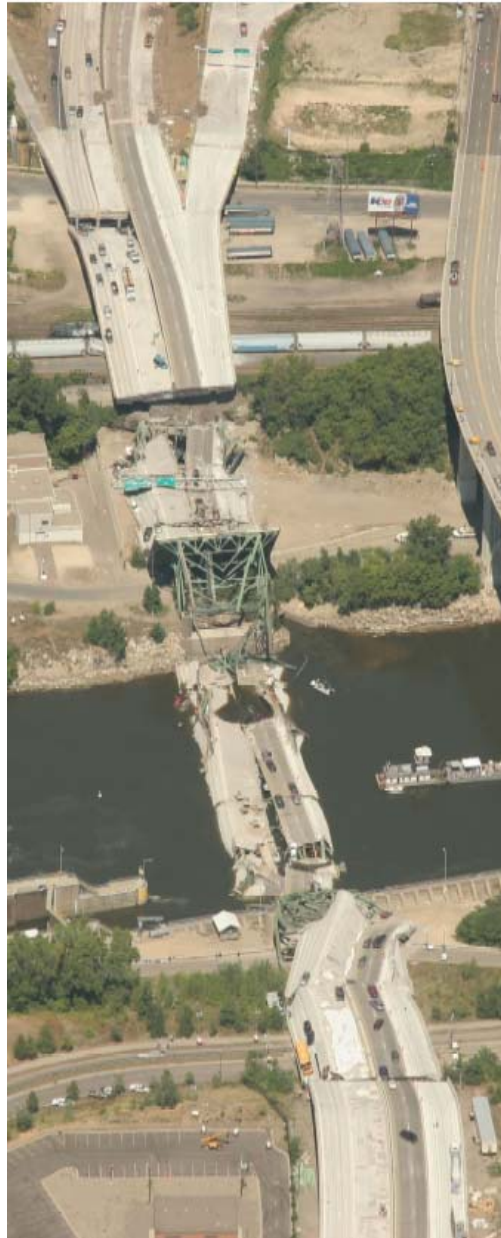
The bridge collapsed at 6:05 pm, when the gusset plates at a set of the nodes on the south side of the bridge fractured. Once the gusset plates broke, the rest of the bridge could not support the extra weight; within seconds, it fell into the Mississippi river.

**Figure 4: I-35W Bridge on August 2, 2007, the day after the collapse**
