The Tour Not Taken: The Comet Nucleus Tour (CONTOUR)

Leadership ViTS Meeting

October 2009

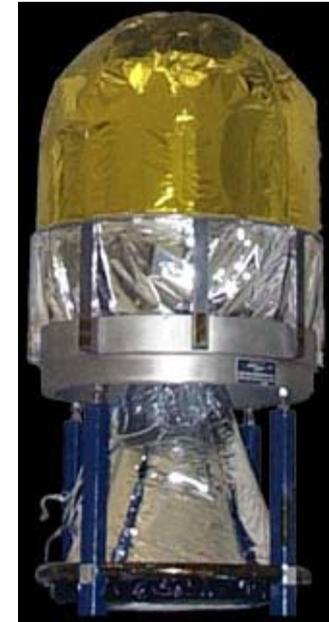
Figure 2: The Solid Rocket Motor (SRM)

As there was no telemetry coverage during the burn, investigators could not identify a conclusive proximate cause. One likely explanation is that the SRM was nested too far into the body, and heat from the motor's exhaust destroyed the spacecraft.
