SYSTEM FAILURE CASE STUDIES

JANUARY 2010 VOLUME 4 ISSUE 1

Down to the Wire

During the Solid Rocket Booster (SRB) recovery for the Space Shuttle mission STS-116, an injury occurred on the retrieval ship *MV Freedom Star*. On December 12, 2006, the ship was towing a booster into port when the tow wire jumped from its tow chute and struck a nearby crewman. The crewman sustained impact injuries to his abdominal region and minor abrasions to his arms and hands. He was hospitalized for twenty-four days.

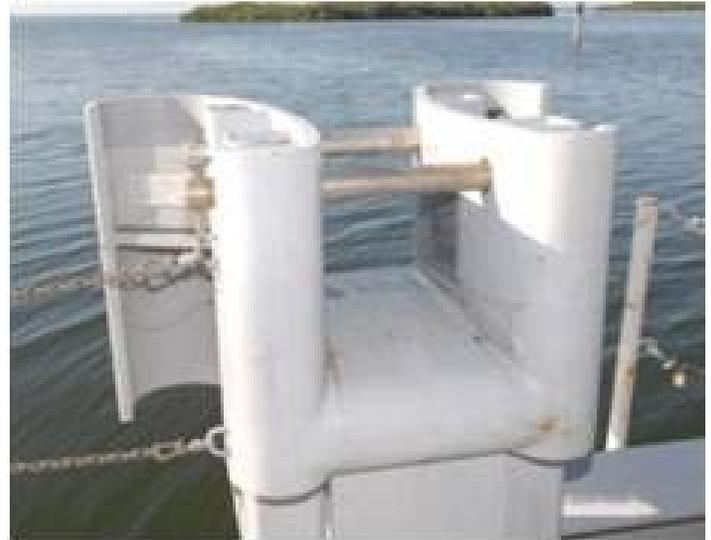
After removing the pins from the tow chute, the crewman lingered nearby, unaware that he had placed himself in a potential path of the wire under load. As the ship made right turns, only the chute resisted the wire's pull toward his side of the deck. Without the pins to keep it in place, the tow wire leaped out of the tow chute and struck the crewman.

Figure 3: The 67-ton shackle could not pass through the tow chute with the pins in place, as depicted above.

During previous recovery missions, the *Freedom Star* crew used a smaller 17-ton shackle to connect the tow wire to the SRB. This shackle easily passed through the tow chute with pins in place. However, the 17-ton shackle was difficult to assemble, needing a rubber mallet to bang it into place. Because of this, a new deck supervisor changed the configuration, choosing the 67-ton shackle instead, a decision that would prove critical on the day of the mishap. (Figure 4) The supervisor was able to do this without any review or approval because the *Freedom Star's* towing assembly had no formal configuration control. Other than a single diagram in the recovery operating procedure identifying the components, no drawings or assembly instructions existed. Crewmembers were both forced and freed to improvise, long traditional in deck-line-handling tasks.

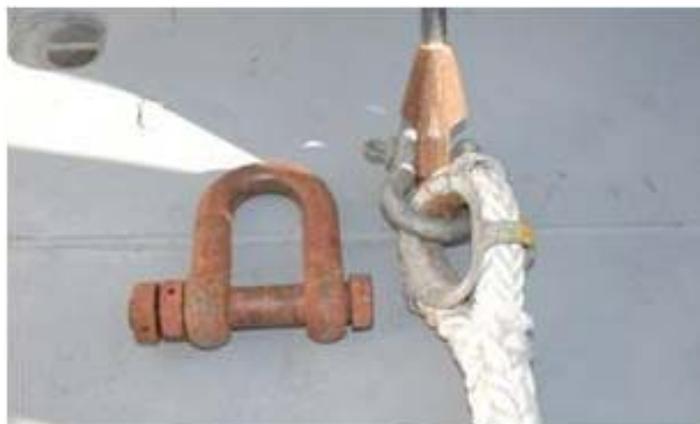
Figure 4: The 67-ton shackle (L) is significantly larger than the 17-ton shackle (R- Shown attached to tow line).
