Wire to Wire: *Swissair 111 Crash*

Leadership ViTS Meeting

February 2010

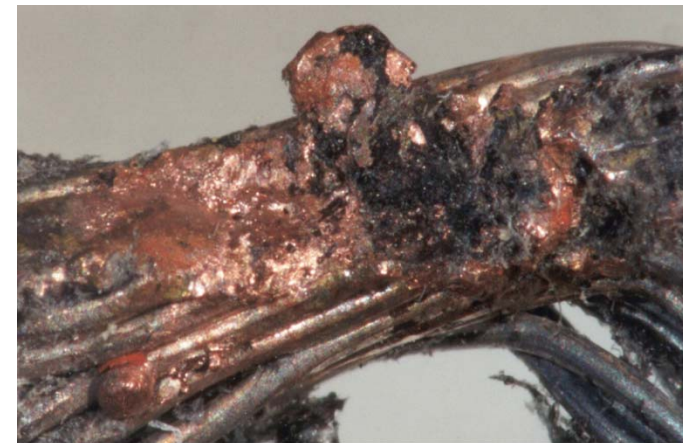
- TSB Investigators found an initiating wire arcing event occurred near the In-Flight Entertainment Network power supply unit cable, and easily ignited the flammable insulation blankets in the attic above the cockpit.
- The pilots' initial diagnosis of an unusual odor placed it as a benign air conditioning issue. Once the pilots realized that the smoky odor accompanied actual smoke, they declared an urgent situation and requested to land; however, during the time used to re-route the flight and commence an approach, subsequent systems failures made safe landing at Halifax impossible.

Recovered IFEN Cable segment with area of melted copper, indicating an arcing event occurred
