SYSTEM FAILURE CASE STUDIES

FEBRUARY 2010 VOLUME 4 ISSUE 2

Wire to Wire

Swissair Flight 111 crashes after a fire ignites in the cockpit attic

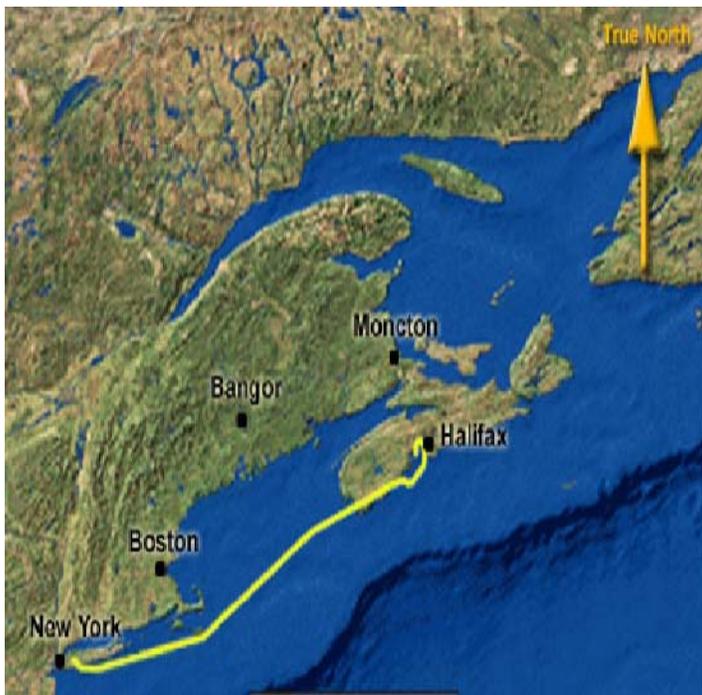
Figure 2: Actual SR 111 flight path.

The TSB report concluded that the fire grew faster than the crew could have made a safe landing at Halifax, regardless of flying or firefighting actions. Securing non-essential electric power per the emergency checklist thirteen minutes after smoke discovery resulted in much worse smoke, followed by loss of essential flight instruments. This left the crew disoriented, blind, and lost, circling South of Halifax to descend and dump fuel for landing. Declaring an emergency at 10:25 PM, SR 111 received emergency Halifax landing clearance. Controllers heard nothing more from the crew. Six minutes later, seismographic recorders in Halifax recorded aircraft-ocean impact as a seismic event. Only twenty-one minutes elapsed since the pilots first noted the unusual odor.

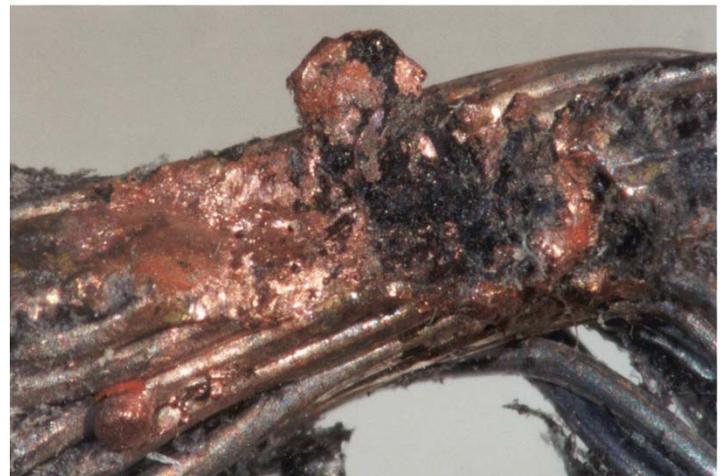
Full results of the very difficult TSB investigation were not made public until 2003. TSB Investigators found an initiating wire arcing event occurred near the In-Flight Entertainment Network power supply unit cable (Figure 3), and easily ignited the flammable insulation blankets in the attic above the cockpit.

In an arcing event such as the TSB found, vaporized copper expands to many thousands of times its formerly solid volume, generating enough heat and pressure to easily ignite nearby flammable materials. Airflow in the area was provided by an air conditioning system fan, and smoke

Figure 3: Recovered IFEN Cable segment with area of melted copper, indicating an arcing event occurred.

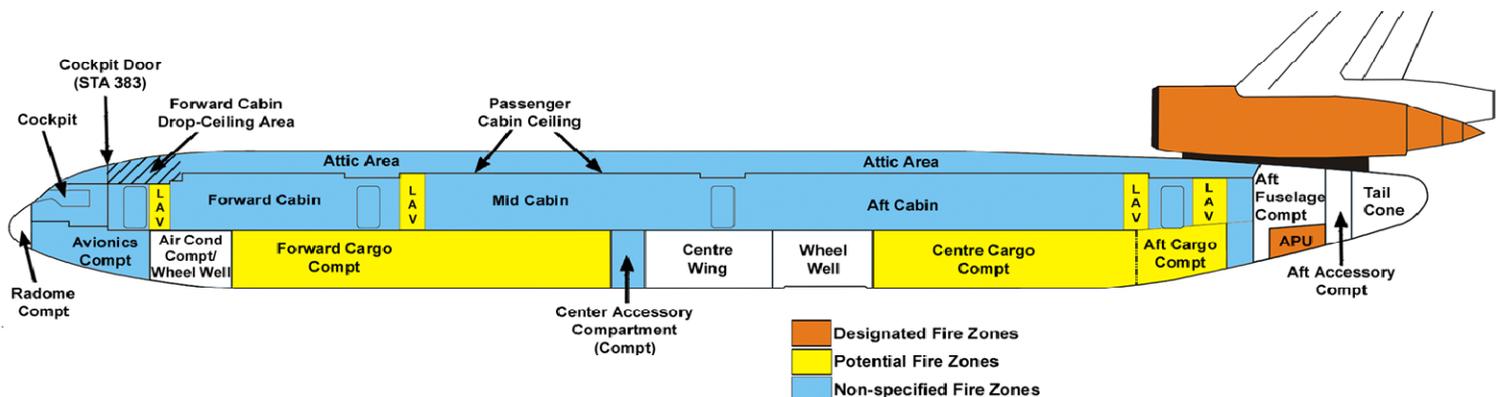
The mishap aircraft met existing aircraft regulatory requirements and was consistent with industry standards of the time for smoke and fire detection. One such industry standard was the separation of the plane into three separate fire zone categories (Figure 4): Designated Fire Zones (engines, auxiliary power unit), Potential Fire Zones (cargo compartments, lavatories) and Non-Specified Fire Zones (everything else). Because Designated Fire Zones and Potential Fire Zones have potential ignition sources and flammable materials, they are equipped with built-in fire detection and suppression capabilities. The remaining Non-Specified Fire Zones, such as the cockpit and the “attic” area above the cockpit, were solely dependent upon human intervention for both detection and suppression of an in-flight fire.

Although flammable materials existed in the Non-Specified Fire Zones, the potential for ignition was considered minimal. There was no recognized need to train aircraft crews for firefighting in places other than the interior cabin areas, or to design aircraft to allow for quick and easy access to hidden or enclosed spaces.

Figure 4: Diagram of MD-11 Fire Zone Designations
