SYSTEM FAILURE CASE STUDIES

APRIL 2010 VOLUME 4 ISSUE 4

Mission to Mars

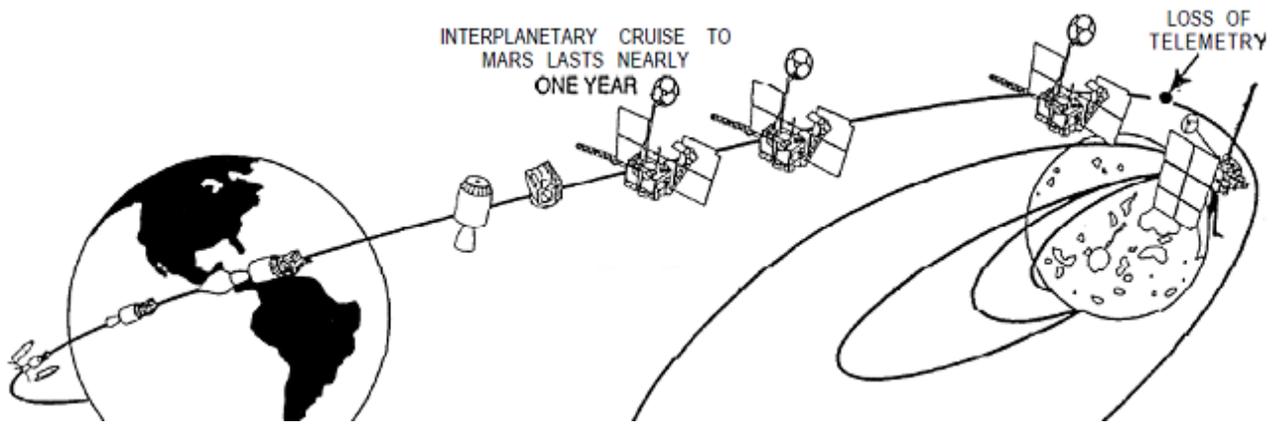
During this important mission event, the team was concerned that the firing of the valve might shock and damage the amplifiers in the telecommunications systems. In order to protect the amplifiers, the team made the decision to turn the spacecraft transmitters off during valve firing. Once the firing was complete, and the tank was pressurized, the transmitters would be commanded back into operation by the team. Figure 2 shows the trajectory of the spacecraft and the

Figure 2: Diagram of the planned journey to Mars. The point where telemetry was turned off is seen in the upper right.

The transmitters were to remain off for ten minutes. Taking into account the four minutes of warm-up time, the transmitters were to remain off for a total of 14 minutes. During this time, something happened to the spacecraft that prevented communication from being reestablished. The JPL Deep Space Network was reconfigured to optimize attempts at communication. Efforts continued into the next year but were unsuccessful.

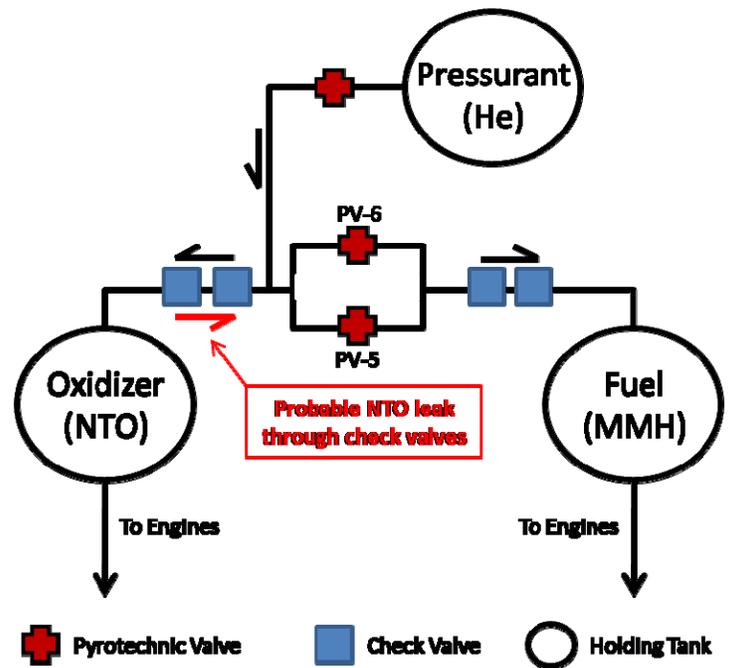
To attack the mystery, the Board employed a step-wise, process-of-elimination approach. Working backward in time from the loss of signal, fifty-nine different scenarios were theorized and studied across all spacecraft systems. The surviving scenario deemed most probable was the leak of the oxidizer (nitrogen tetroxide or NTO) through a series of check valves during their 11-month exposure to extreme cold (Figure 3). Even a few tenths of a gram of NTO mixed with the fuel (monomethyl hydrazine) in the tubing would have become explosive.

The board identified the propulsion pressurization system check valves as unfit for an interplanetary Mars mission.

Testing showed that the valves could keep leaks down to an acceptable level during the Earth-orbiting mission for which

Figure 3: Diagram of section in propulsion system where explosion may have occurred. Investigators believe Oxidizer leaked through check valves (indicated by red arrow) and mixed with fuel when pyro valves 5&6 were opened.

they were designed. During their long journey to Mars, however, the valves were exposed to much more radical temperature and pressure changes, over a much longer period than original testing had qualified them to sustain. The likelihood for vapor particles to leak and accumulate in the tubing increased to the point where only a tiny leak (tenths of a gram) posed a significant explosion hazard. In defense of the designers, no leak ‘standard’ or minimum had yet been established from previous NASA projects.
