# Deadly Efficiency:

## American Airlines Flight 191

### Leadership ViTS Meeting

July 2010

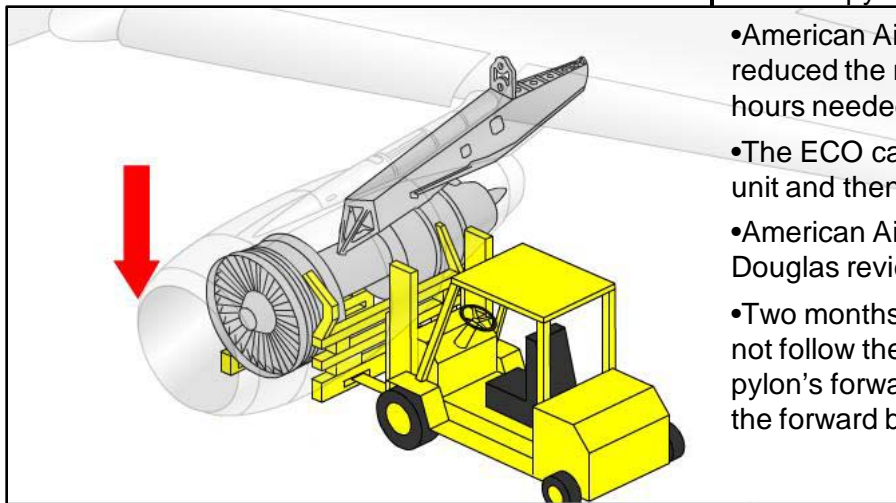
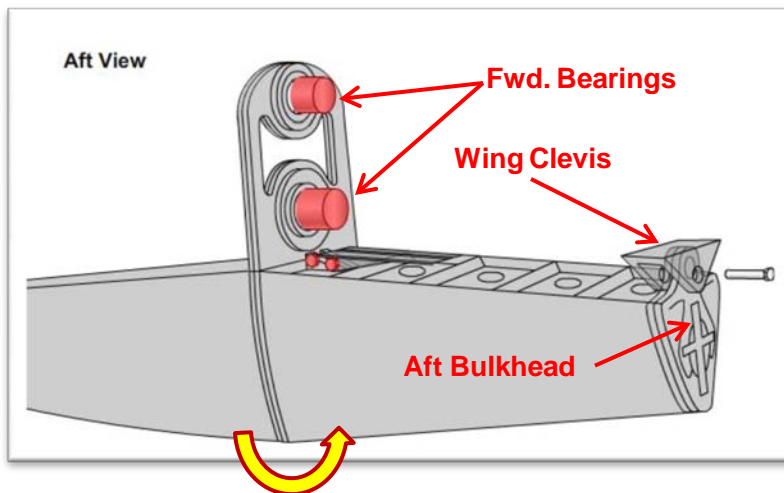
- Two months prior to the mishap flight, maintenance personnel did not follow the steps outlined in the ECO: instead of removing the pylon's forward bearings first, they removed the aft bearings prior to the forward bearings.

**During this procedure, manipulations of the forklift allowed the assembly to rotate, and the pylon's rear flange contacted the wing clevis. The force from this contact resulted in an undetected crack on the aft bulkhead that propagated on subsequent flights.**

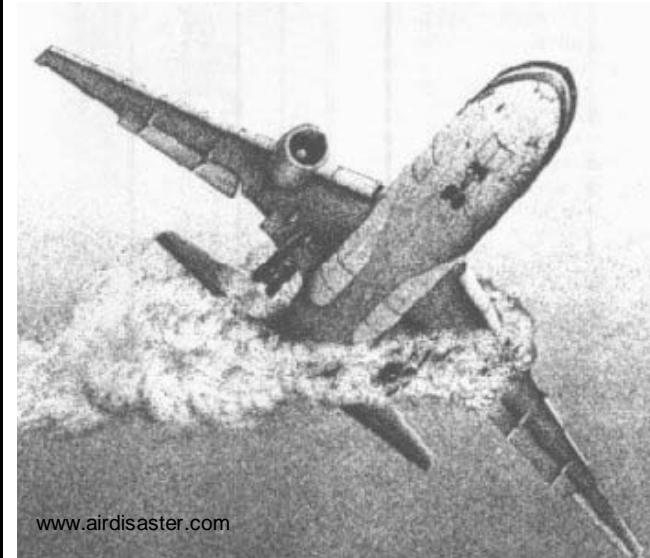
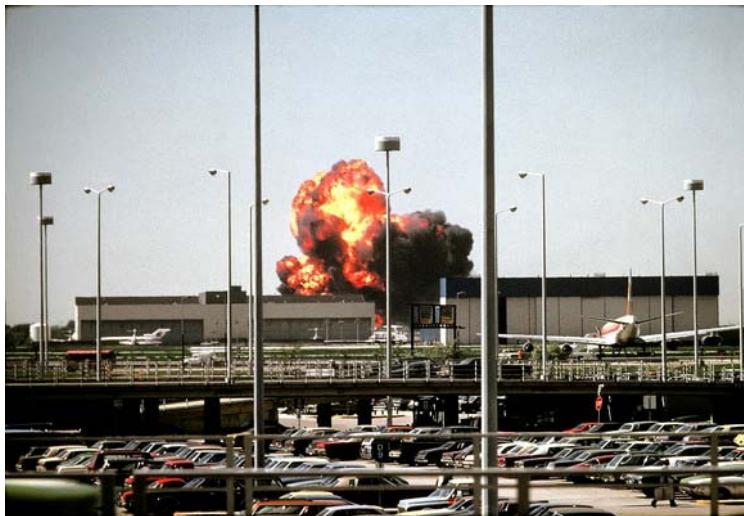
- May 25, 1979: American Airlines Flight 191 began its takeoff run.
- Just as the plane became airborne, the left engine tumbled over the wing and fell to the runway.
- Hydraulic fluid poured out of the severed lines, and electrical power to cockpit warning systems was cut off.
- The pilots could not see what happened and assumed an engine failure had occurred. They decreased airspeed from 165 to 153 knots according to standard procedure for engine failure during takeoff.

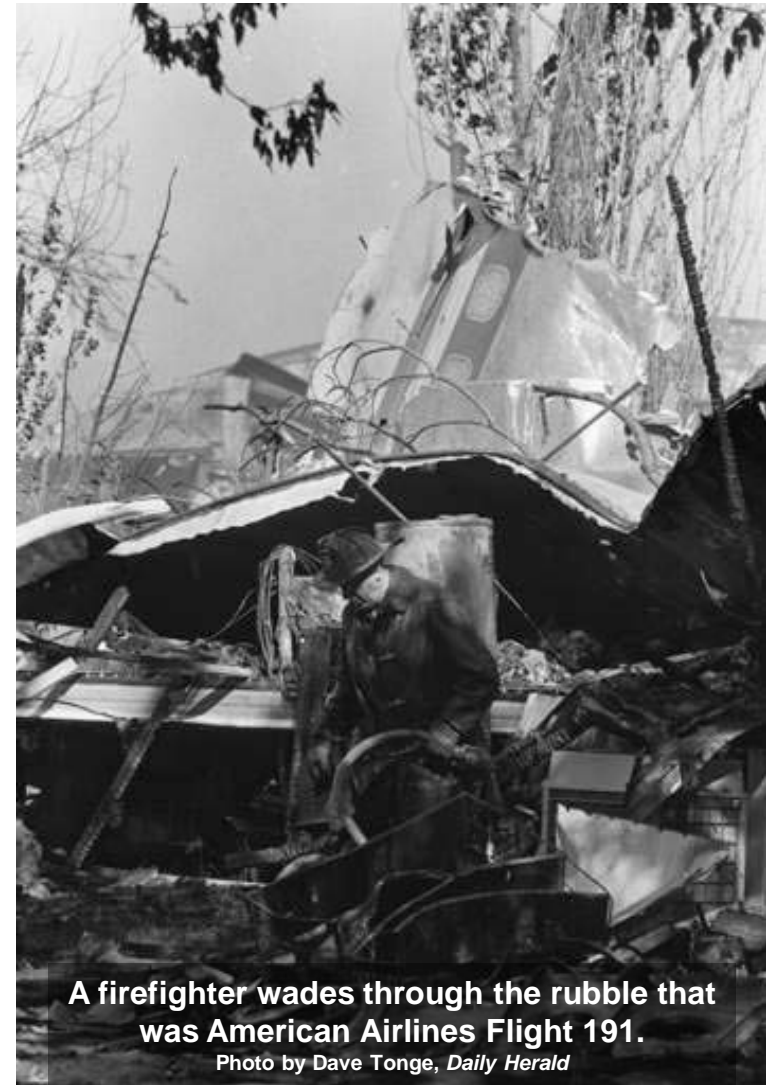
**A firefighter wades through the rubble that was American Airlines Flight 191.**
