## SYSTEM FAILURE CASE STUDIES

JULY 2010 VOLUME 4 ISSUE 7

# Deadly Efficiency

### American Airlines Flight 191 Crashes, Killing 273

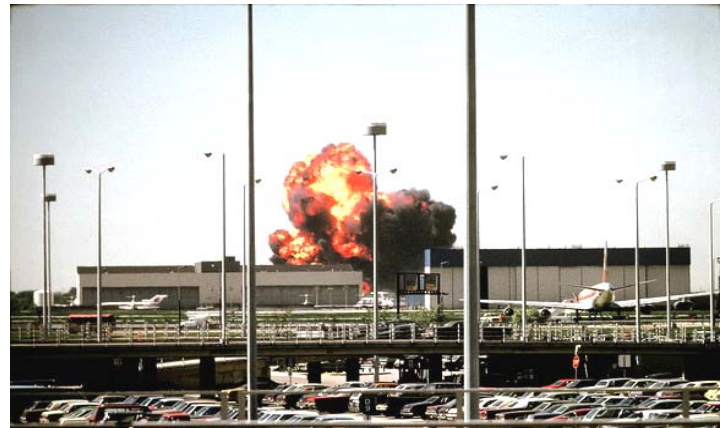
**Figure 1: American Airlines Flight 191 crashes only seconds after takeoff from Chicago O'Hare Airport**

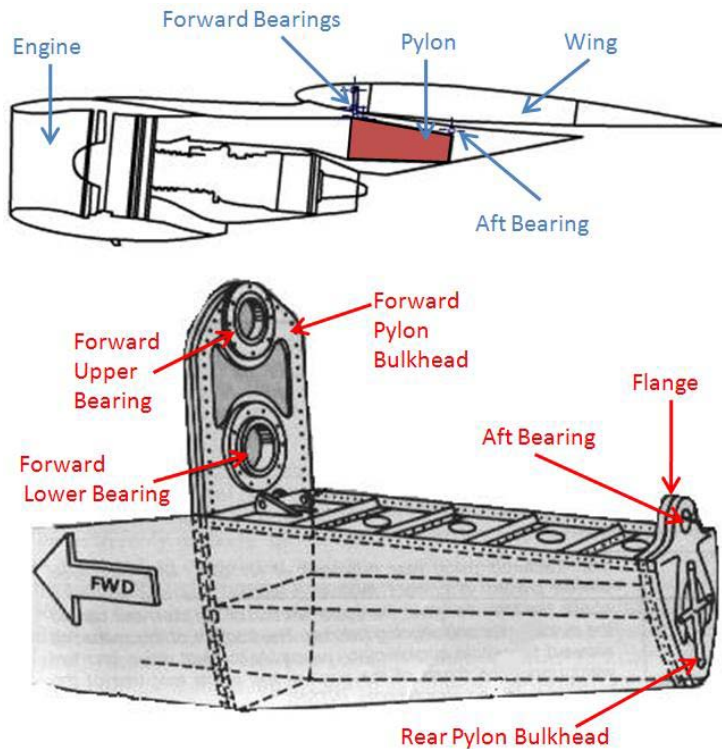
The McDonnell-Douglas DC-10 aircraft was powered by three General Electric engines, one on each wing and one on the tail. The wing-mounted engines were coupled to pylons that connected to the wings by means of three spherical bearings. Two of these joints were located in the pylon's forward bulkhead. The third was positioned in the rear bulkhead where it connected underneath the wing (Figure 2). The wing-mounted engines could not be seen from the cockpit.

In 1975 and again in 1978, McDonnell-Douglas issued service bulletins that called for the replacement of the bearings at the forward and aft bulkheads of the pylon (Figure 2). In replacing the bearings, McDonnell-Douglas specified that the engine be removed from the pylon before the pylon was removed from the wing. Dismantling the engine-eylon assembly required 79 disconnects of hydraulic and electrical lines. American Airlines devised a new proce-

**Figure 2: Forward and Aft wing attach points. The pylon is highlighted in red and magnified in gray.**

Investigation teams from the National Transportation Safety Board (NTSB) discovered a horizontal 10-inch fracture on the flange of the left pylon's rear bulkhead. The fracture was found to be the result of overstress initiated by a bending force near the center of the flange. During takeoff, the aft end of the pylon is forced upward. However, the fractured bulkhead, now incapable of sustaining such a load, tore loose and the whole assembly separated from the aircraft, leading to the simultaneous occurrence of three events: the retraction of the left wing leading-edge slats, the loss of the slat disagreement warning system, and the loss of the stall warning system. Had any of these events happened alone, the flight crew may have been able to cope with the situation, but their synchronized failure created a condition that precluded control of the aircraft.

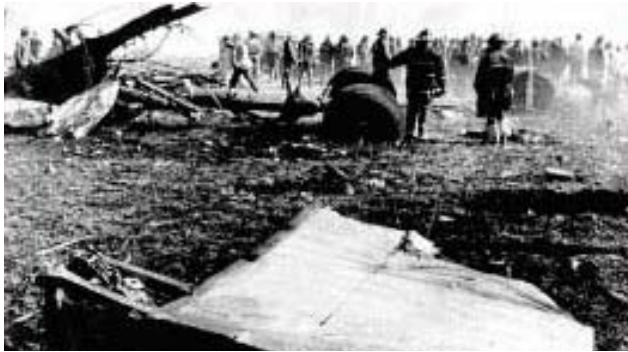
**Figure 3: Responders approach the wreckage of American Airlines Flight 191.**
