## SYSTEM FAILURE CASE STUDIES

AUGUST 2010 VOLUME 4 ISSUE 8

# Hit the Bricks

Launch of STS-124 damages launch pad: Repairs estimated at \$2.5 million

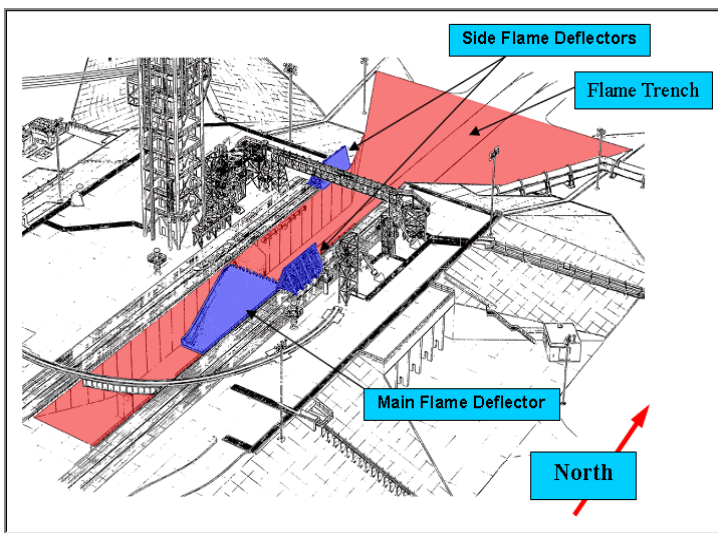
**Figure 2: The flame trench is 450 feet long, 58 feet wide and 42 feet deep. The mouth of the trench extends to a width of 300 feet at the north end.**

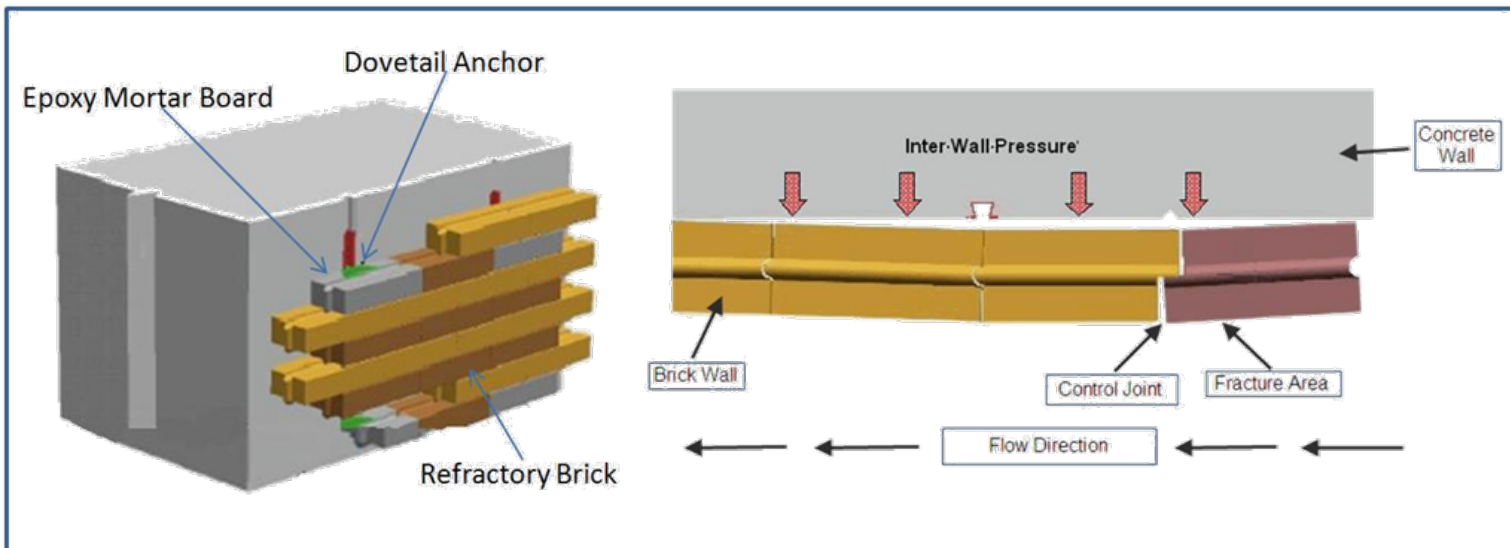
Forces from SRB ignition caused a section of the flame trench wall that had previously been repaired with Fondu Fyre to tear away, creating a fracture in the brick lining. Hot gas seeped through this fracture and built up between the concrete wall and the covering of refractory bricks. The bricks, secured only with aging epoxy and corroded anchors, gave way to the pressure of the hot gas and burst away from the concrete at the control joint (Figure 3). Since the bricks were installed with a tongue and groove mechanism, their interlocking design propagated a cascading effect that blasted the bricks varying distances, some exceeding 1,800

NASA investigators received full Shuttle program cooperation to access evidence. Completing a complex, challenging assignment in 30 days after the mishap, the investigation report described severe carbonation of the epoxy and extensive corrosion in the steel anchors. Because inspection teams lacked procedures and criteria that would have helped them detect this deterioration, the condition went unnoticed. Space Shuttle Discovery was then cleared for launch. During liftoff, the bricks were unable to withstand the pressure of the hot gas, which blew them away from the wall.

**Figure 3: Cutaway depicting construction design of brick lining. The refractory bricks yielded to the pressure of the gas between the concrete wall and brick lining because carbonation of the epoxy reduced its adhesion and because repeated exposure to salt, water, and hydrochloric acid corroded the dovetail anchors.**

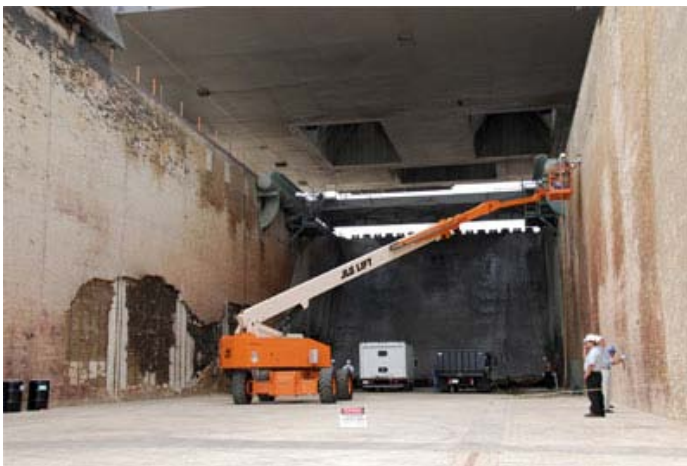
**Figure 4: Workers strip loose bricks from the flame trench wall for the Fondu Fyre application.**

To repair the flame trench, workers stripped refractory bricks from a 25 by 100 foot section of the east wall and a 25 by 80 foot section of the west wall (Figure 4). The exposed area was then covered with steel mesh, and Fondu Fyre was applied over the lattice. Repairs were completed in time for Atlantis' STS-125 mission (Hubble Space Telescope maintenance).
