Descent Into the Void: Soyuz-11 Depressurization

Leadership ViTS Meeting

September 2010

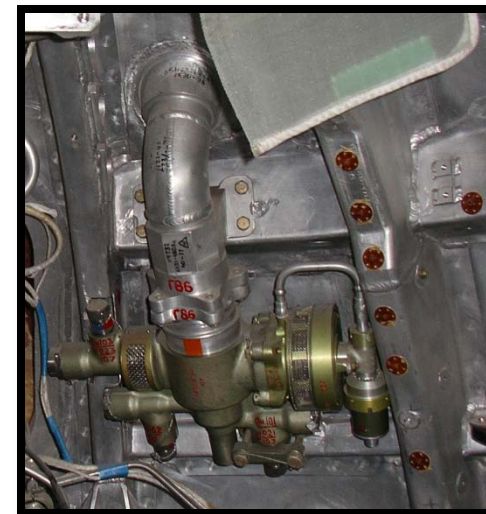
Pyrotechnic powder traces found in the throat of the ventilation/equalization valve determined that the valve had malfunctioned. This was confirmed by analysis of the attitude control system, which indicated that the thrusters fired to counteract the force of gases escaping from the valve. Engineers later determined the 6 explosive cartridges and 6 explosive bolts that separated the orbital module from the descent capsule **fired simultaneously instead of sequentially (delay between the two)**; the resultant off-nominal shock jarred a ball joint in the valve loose, forcing the valve open and rupturing a seal at 105 miles altitude, versus the 2.7 miles altitude as designed.

- Ventilation valve design did not meet the worst-case scenario of structural shock resulting from simultaneous firing of the orbital/descent module separation pyrotechnic system.
- Ventilation valves design was sensitive to the unanticipated higher shock loads from the explosive bolts firing simultaneously.
- Ventilation valves did not have associated alarms in the event that the seals somehow opened prematurely, so the crew spent precious seconds searching for the leak's source.
- Ventilation valves were placed behind the control panel – a location inaccessible to the crew.
- Ventilation valves lacked a backup closure procedure or mechanism, so once the crew members realized where the leak was coming from, they were powerless to correct the situation.

Redesigned Ventilation/Equalization Valve now provides relief for high pressure in the descent module and also functions to equalize pressure once parachutes have been deployed.
