## SYSTEM FAILURE CASE STUDIES

SEPTEMBER 2010 VOLUME 4 ISSUE 9

# Descent into the Void

### Capsule Decompression Kills Three Cosmonauts

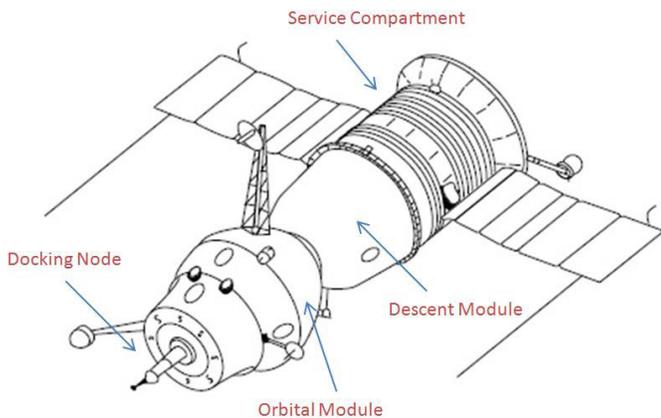
seal of the cabin. Pressure tests of the cabin show a slight loss, but it took 1.5 hours for the cabin to fully depressurize with the valve closed. What had forced the valve to open too soon? At approximately 723 seconds after retrofire, the descent module separated from the service compartment and orbital module. This orbital/descent module separation exposed the ventilation/equalization valves and the pressure relief valve to vacuum. Then, contrary to design intent, the 6 pyrotechnic-cartridges and the 6 pyrotechnic bolts used to separate the orbital module from the descent module fired simultaneously instead of sequentially with a delay between the bolts and cartridges. The resulting off-nominal separation shock to the descent module opened one of the two ventilation/equalization valve and pressure regulator outlets to vacuum.

**Figure 3: The descent module nominally separated from the other compartments when 12 explosive bolts fired sequentially.**

Pressure inside the descent module leaked into the vacuum of space when a pyrotechnic ventilation/equalization valve designed to open when the vehicle reached an altitude of 2.5 miles (4 km) instead opened at a height of 105 miles (170 km). In an effort to determine what caused the valve to open early, engineers simulated varying loads on the valve, and deduced that the pyrotechnic fasteners that should have fired sequentially during capsule separation from the orbital module and descent module fired simultaneously instead. The resultant force jarred a ball joint in the pyrotechnic valve mechanism loose. This forced the valve open and depressurized *Soyuz-11*. Other pyrotechnics blew a valve seal clear at about 4 km altitude per design intent to equalize cabin pressure with the atmosphere—but the prematurely open valve had already done so in vacuum. Analysis of automatic attitude control system thruster firings made to counter the force of escaping cabin pressure, along with the pyrotechnic powder traces found in the throat of the valve determined when the valve had malfunctioned, causing the depressurization.

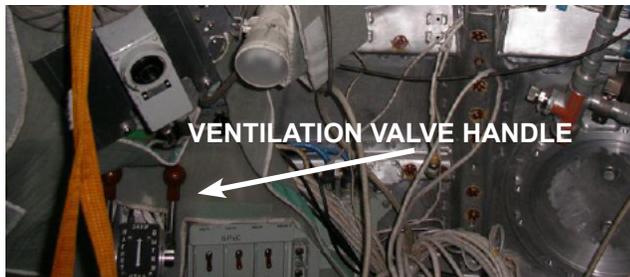
**Figure 4: Manual ventilation valve handles were added to the Soyuz spacecraft.**

spacecraft was redesigned with increased valve reliability versus shock loads. Emergency pressurization equipment was added to the spacecraft. A manually operated valve, accessible to the crew, was placed in series with the pyrotechnic valves in both the ventilation inlet and outlet (Figure 4). Cosmonauts were issued and required to wear pressure suits for launch and landing; *Soyuz* crews were reduced to two to account for the additional equipment volume. Later, redesigned space suits occupied less space and allowed a *Soyuz* to be flown with three suited crewmembers. In October of 1971, *Salyut* was no more; its on-board supplies expired, the first human space station was commanded to a destructive re-entry over the Pacific Ocean.
