Brace for Impact:

MV Bright Field Allision

Leadership ViTS Meeting

October 2010

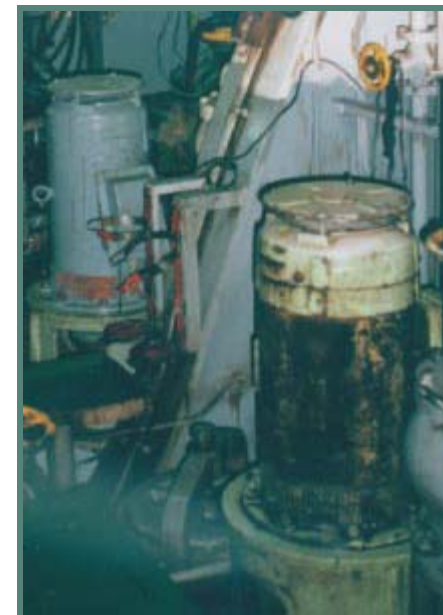
The *Bright Field's* #1 and #2 engine oil pumps

The oil system's alarm should have notified crews of falling pressure, but the alarm was incorrectly calibrated. The sump was maintained well below the acceptable volume, and alarms indicating low sump levels had been readjusted to allow this practice. The decreased volume caused the sump's capacity to circulate in 1/3 the normal time; air bubbles entrained in the oil could not dissipate, and air bubbles entering suction collapsed. Millions of collapsing bubbles lowered overall system pressure. Eventually, pressure fell to unacceptable levels, automatically stopping the engine and leaving the *Bright Field* unable to maneuver through the strong currents which swept it toward the river's left descending bank.

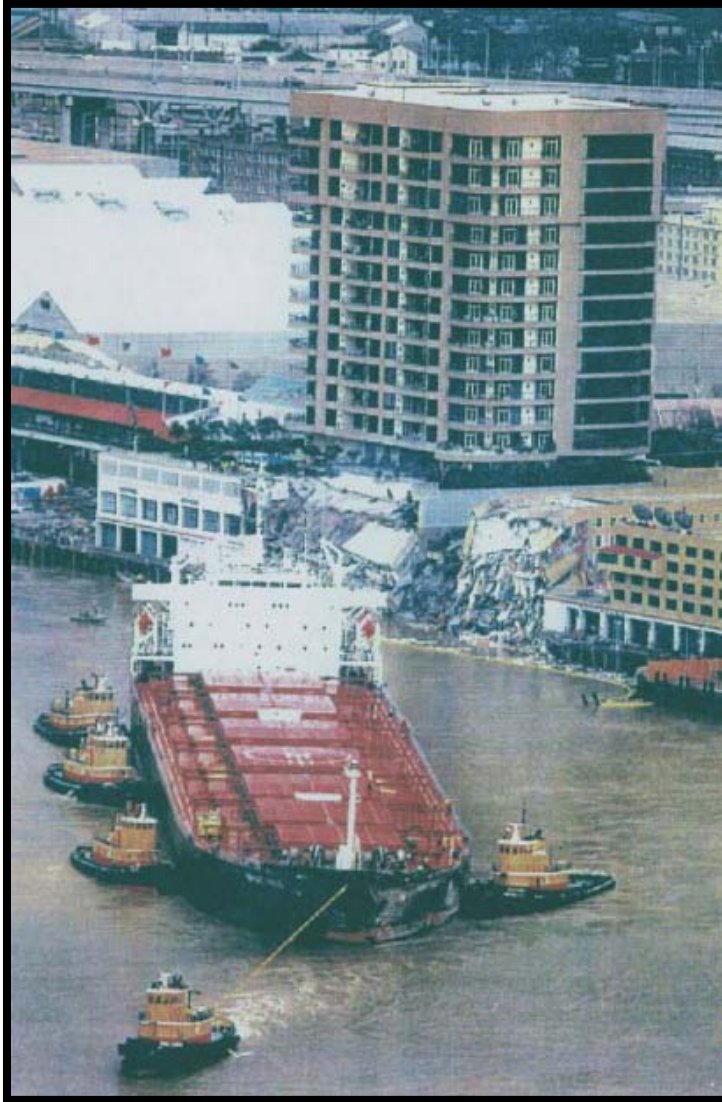
Tugboats tow the Bright Field away from the allision site.
