## SYSTEM FAILURE CASE STUDIES

OCTOBER 2010 VOLUME 4 ISSUE 10

# Brace for Impact

### Liberian Bulk Carrier Allides With Riverfront Mall: 67 Injured.

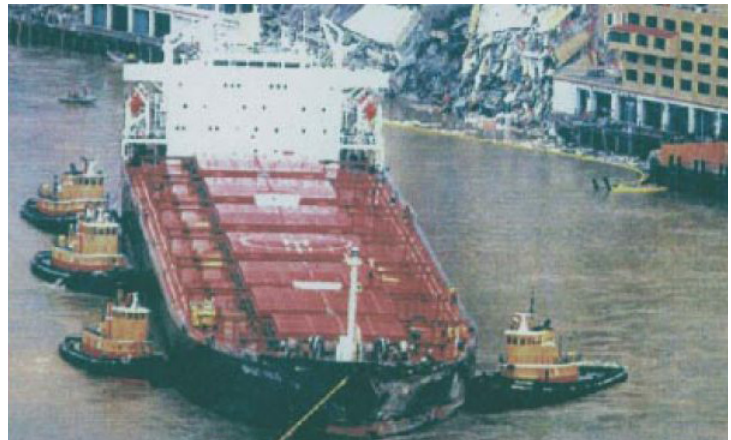
**Figure 1:** 'Allision' is the nautical term used when a moving vessel strikes a stationary object. Here, tugboats guide the MV *Bright Field* away from the allision site in New Orleans.

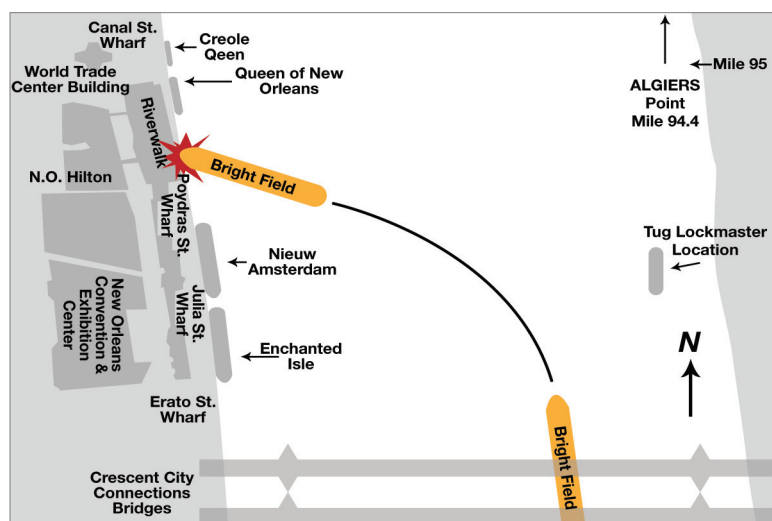
As the *Bright Field* passed beneath the Crescent City Connection Bridges (Figure 3), the pilot noticed that the ever present vibrations induced by the engine had ceased. He asked the captain and second mate if there was a problem, but instead of answering him, they conferred together in Chinese. At this point, the pilot noticed the rpm indicator had dropped from 72 to 30, reflecting a significant loss of propulsion power. Without propulsion, the *Bright Field* would be unable to battle the river currents to navigate successfully around Algiers’s point. Faced with this realization, the pilot sent urgent radio transmissions warning people on the harbor and on entertainment vessels moored along the wharf that he had lost control of his ship. Then he sounded the warning whistle while the second mate called the engine room and, in Chinese, demanded an immediate increase in engine rpm.

**Figure 3: Path of the Bright Field (not to scale)**

Similar arguments can be made for the ships moored along the river's left descending bank that day (Figure 3). Although the left descending bank was found to be at higher risk for allision than the right descending bank, passenger vessels may have been allowed to dock there because the likelihood of an accident was considered low. The *Bright Field* did not impact any of the ships moored in the immediate area, but if the engine had tripped seconds earlier or seconds later, the *Bright Field* may have impacted one or more of the other boats. Consequences would have been lethal for passengers on board. Upon receiving warning of the *Bright Field's* propulsion loss, crewmembers and passengers on the other vessels panicked. Several attempted to jump from the deck to the wharf because evacuation procedures were disorganized and unclear. The entertainment vessels did not have efficient or effective evacuation processes, reflecting unpreparedness for just such a low probability but high consequence event.

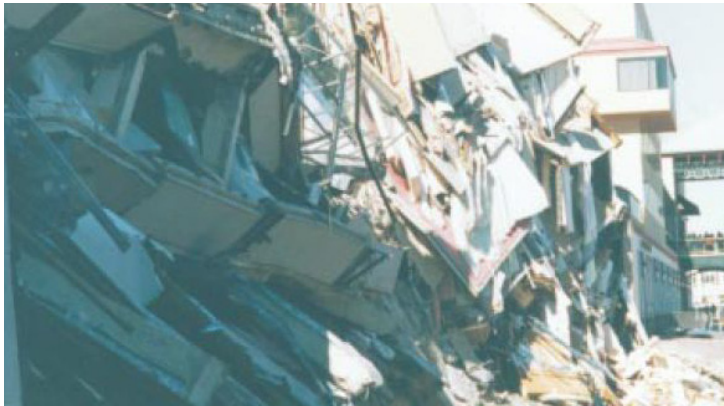
engineer did not inform the second mate that this transition time could be saved because rpm could now be increased from the bridge since engine power had been restored. According to the ship's logs, the *Bright Field* regained power and the engine reached 52 rpm approximately 2 minutes after the engine trip. Unfortunately, too much time had already elapsed. Roughly three minutes after the engine trip, the *Bright Field's* bow rammed into the Poydras Street Wharf at a 45-degree angle. It crushed approximately 50 to 60 feet of the harbor before skidding sideways until it was parallel to the Riverwalk. It stopped in a position between a cruise ship and a gaming boat anchored along the wharf. Remarkably, the *Bright Field* did not impact either of the vessels, but instead struck a shopping complex, a Hilton hotel, and a condominium parking garage (Figure 4). Sixty-seven people were injured while attempting to evacuate the buildings or the nearby gaming and cruise ships. No one on board the *Bright Field* was injured, and no fatalities resulted from the accident. Repairs to the *Bright Field*, Riverwalk, and shoreside buildings cost \$20 million.

Figure 4: Damage to riverfront property
