SYSTEM FAILURE CASE STUDIES

Spektr of Failure

Automated supply vehicle collides with Space Station Mir

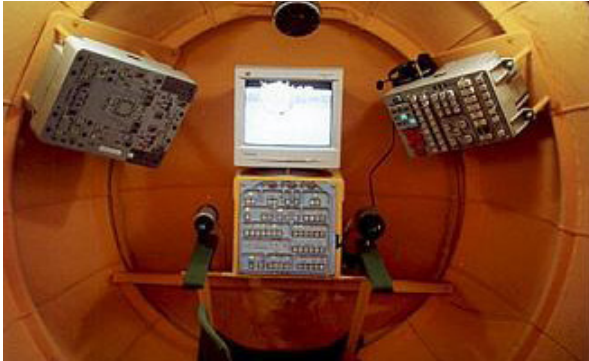
parently, RF radiation emitted through the antenna interfered with the camera signal. TsUP addressed this issue simply by turning off the emitter. This left Tsibliyev without telemetry of speed, range and range rate data. Ground control instructed astronaut Michael Foale and cosmonaut Aleksandr Lazutkin to manually calculate the speed, range and range rate using a handheld laser rangefinder and a stopwatch. American engineers were not consulted or informed of this fallback measure until after the mishap.

Figure 2: The TORU Docking System.

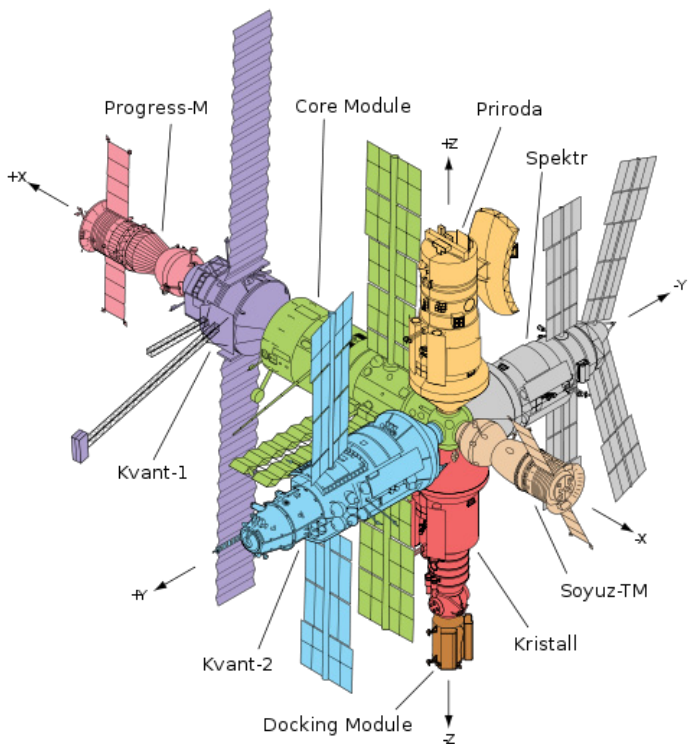
Ninety seconds remained before the final docking time when Lazutkin saw the Progress emerge suddenly, looming from behind one of *Mir*'s solar arrays. Urgently, he commanded Foale to flee to the *Soyuz* and prepare for evacuation. Suddenly learning of Progress' proximity, Tsibliyev clamped down the braking lever, but despite his commands, Progress coasted past the docking node over Base Block at high relative speed (three meters per second). *Mir*'s hull now filled Tsibliyev's entire screen. Then, Progress slammed into a solar array and ricocheted into the *Spektr* module, rocking the entire station (Figure 4). The crew felt the pressure change in their ears almost immediately and heard a loud hissing noise. Progress had punctured the hull somewhere on *Spektr*. If the crew did not act quickly, they would suffocate.

Figure 3: Core Module (Base Block) is shaded in green. Progress should have docked to Kvant-1. Instead, it collided with Spektr.

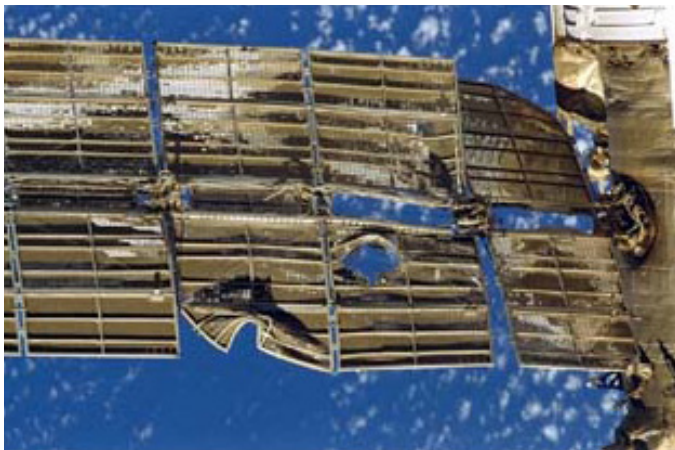
Figure 4: *Mir* solar array with collision-induced damage
